# 4 Hutchinson

Address: 5220 French  
 Parcel: 21040178  
 District: 4  
 SNF Area: n/a  
 Owner: City of Detroit  
 Site Area: 3.82 ac  
 Gross Floor Area: 56,700 sf  
 Floors: 2  
 Plan Type: I  
 School Type:  
 Year Built: 1916, 1923  
 Zoned: R2  
 Base Rehab Cost (est): \$879K  
 Total Rehab Cost (est): \$11.5M

## Building Overview

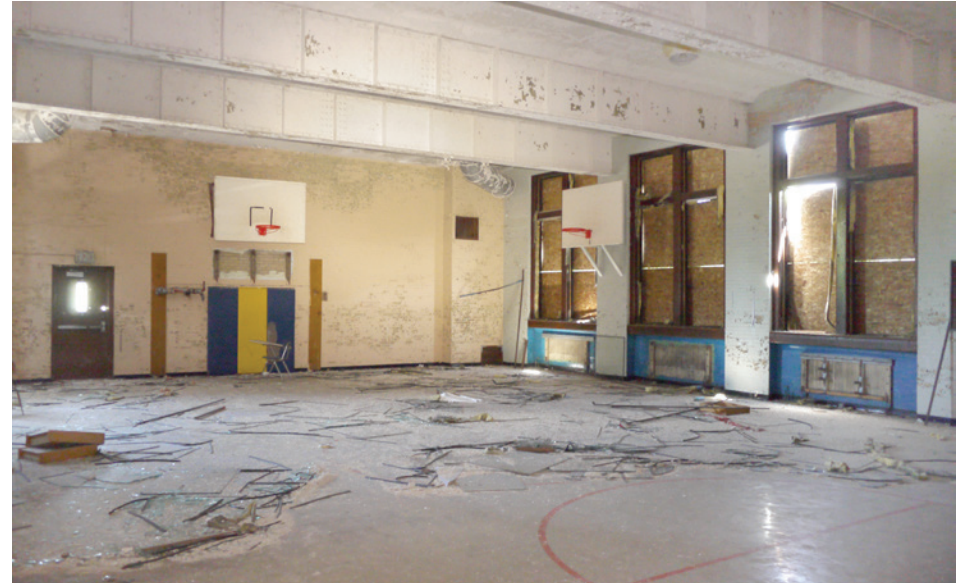
The gymnasium is in good shape, and appears to have been in use recently—debris has been swept away from beneath the basket. There does not appear to be water damage, and the floors have not bowed like most other gyms observed in this study.

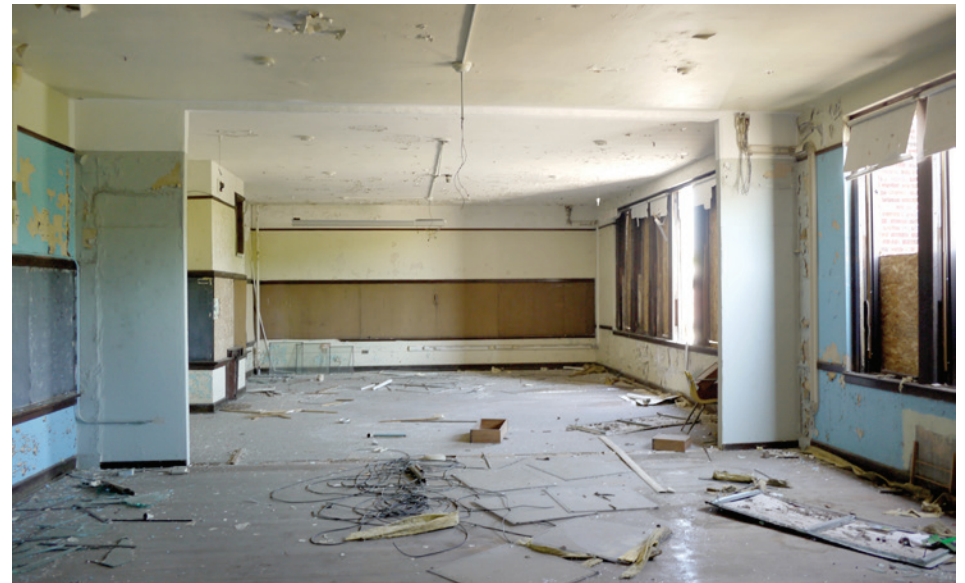
Two second-floor classrooms have been turned into one long room by removing the partition wall.

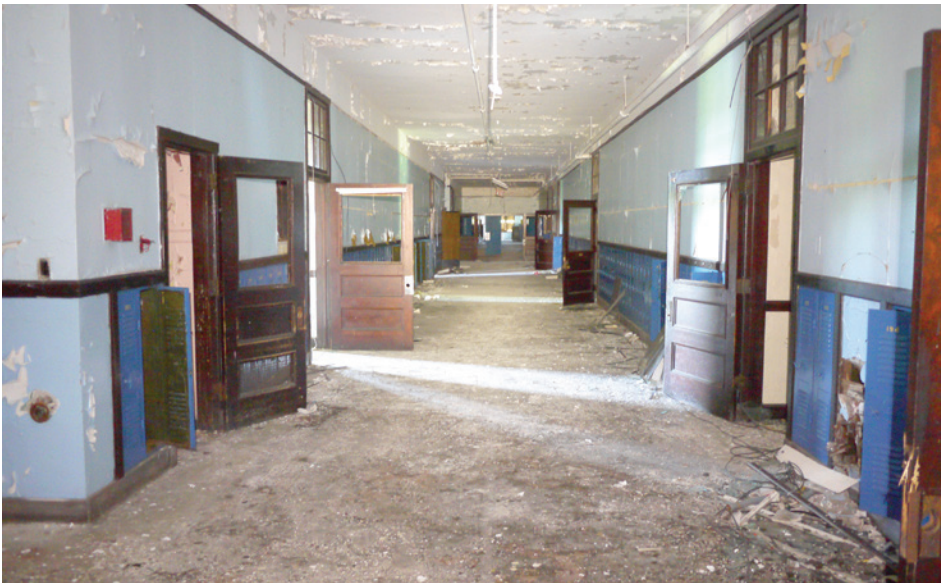
The first floor corridor of the 1923 unit, looking towards the 1916 unit. A short run of stairs is visible in the distance, where the two units join.

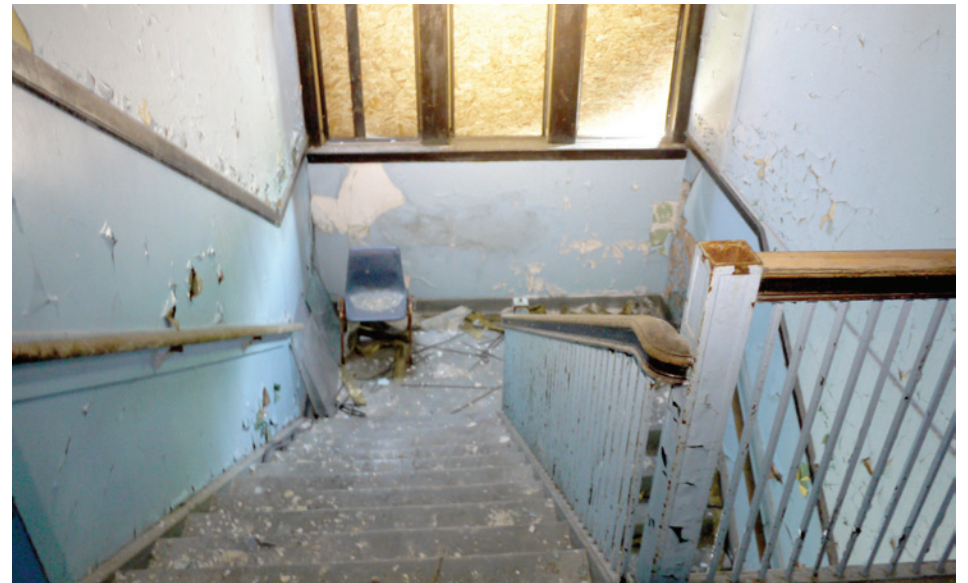
Stairwells in the original unit are tall and narrow; with flights of stairs at every entrance and a split-level first floor, this building is not ADA accessible.
