7 Weatherby

Address: 12099 Fielding
Parcel: 22103299.002
District: 7
SNF Area: n/a
Owner: City of Detroit
Site Area: 2.98 ac
Gross Floor Area: 27,400 sf
Floors: 2
Plan Type: L
School Type: Elementary
Year Built: 1956
Zoned: R1
Base Rehab Cost (est): \$428K
Total Rehab Cost (est): \$6.6M

Building Overview

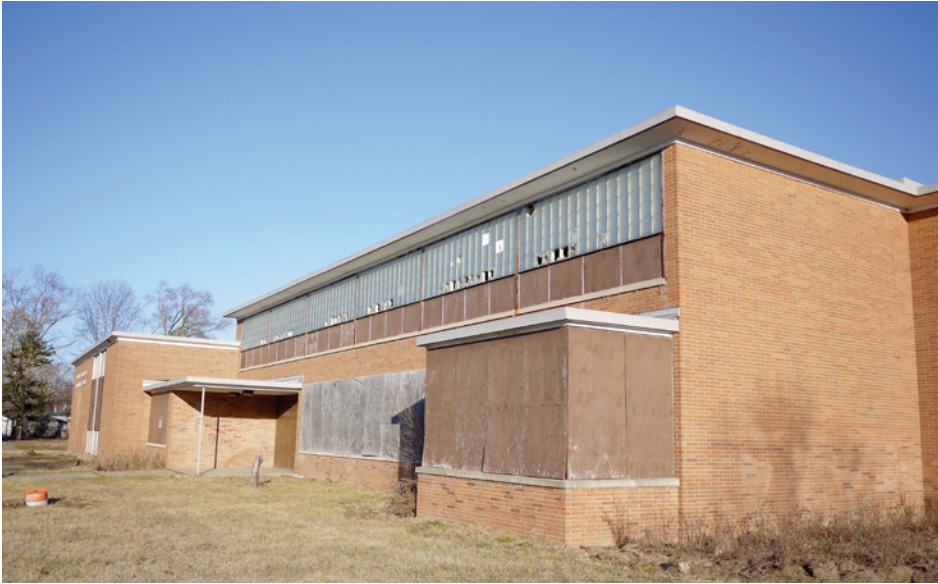
The main (south) facade of the school, showing continuous bands of glass block extending along the entire classroom wing. The windows are largely intact.

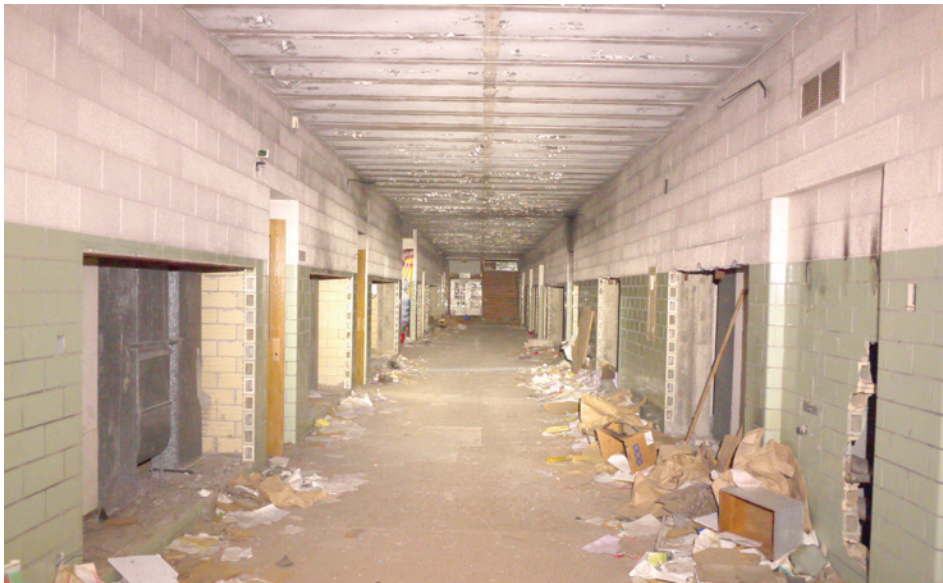
Lockers, metal fixtures, and plumbing has been scrapped throughout

The building has been extensively scrapped, but finishes and structure remain in relatively good condition. The school's corridors feature glazed block finishes with a unique shade of jade green.
