# 4 Guyton

Address: 355 Philip  
 Parcel: 21059093  
 District: 4  
 SNF Area: Jefferson-Chalmers  
 Owner: City of Detroit  
 Site Area: 4.46 ac  
 Gross Floor Area: 46,100 sf  
 Floors: 2  
 Plan Type: L  
 School Type: Elementary  
 Year Built: 1922, 1925  
 Zoned: R1  
 Base Rehab Cost (est): \$1.6M  
 Total Rehab Cost (est): \$11.3M

# Building Distress

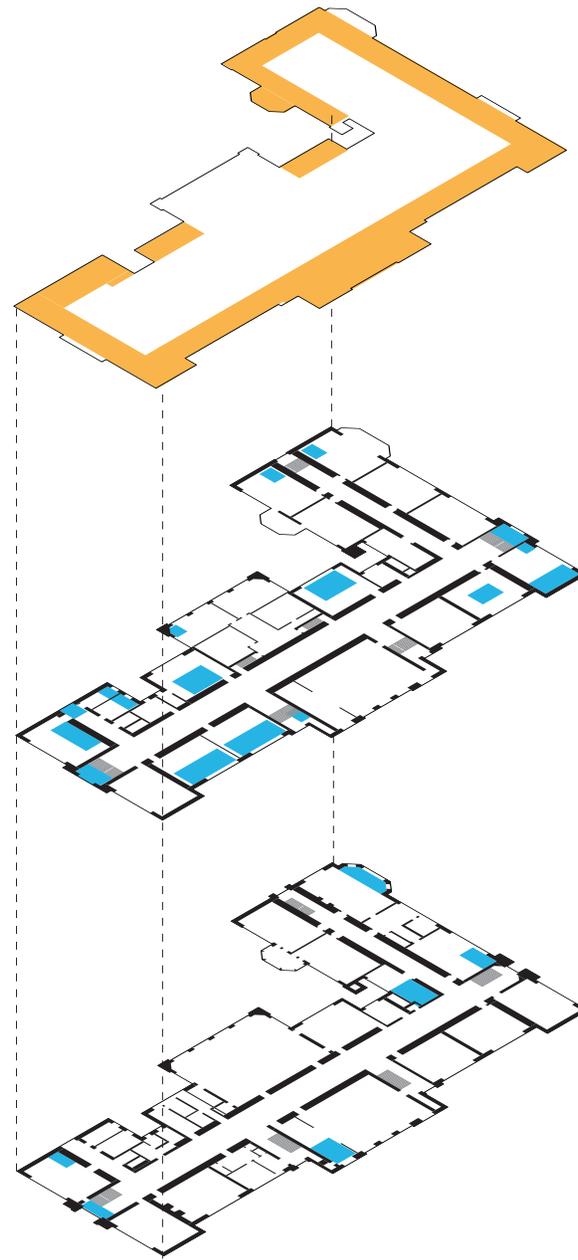
- Sloped roof areas are deteriorated and require replacement. Replace copper flashing, downspouts, and asphalt-shingled areas. Wood deck decayed; inspect and replace.
- Low-slope roof areas appear to be performing; inspect and repair as necessary.

- Widespread damage to plaster ceilings due to water infiltration.
- Water infiltration at stairwells

- Localized water damage due to infiltration from second floor.

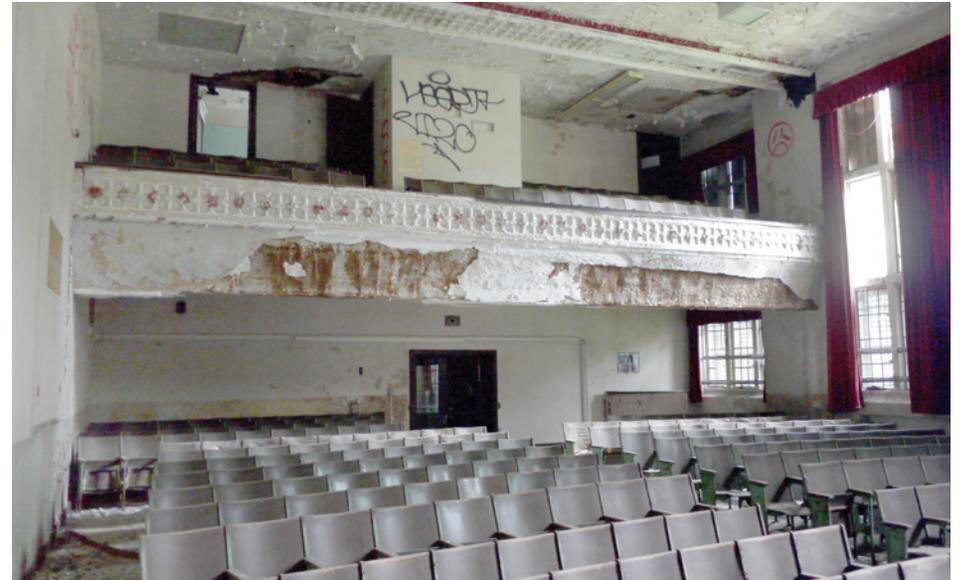
The auditorium has been damaged by the elements, but features a balcony, tall windows, and ornate decorative plasterwork.

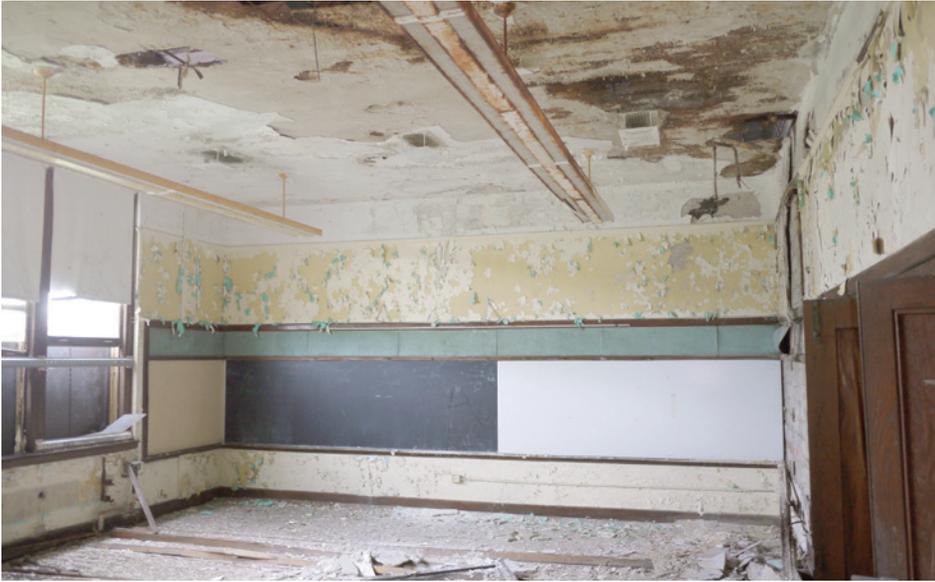
Many classroom finishes are still intact, including many wood-framed double-hung windows. Intact historic windows are a rarity in vacant school properties.

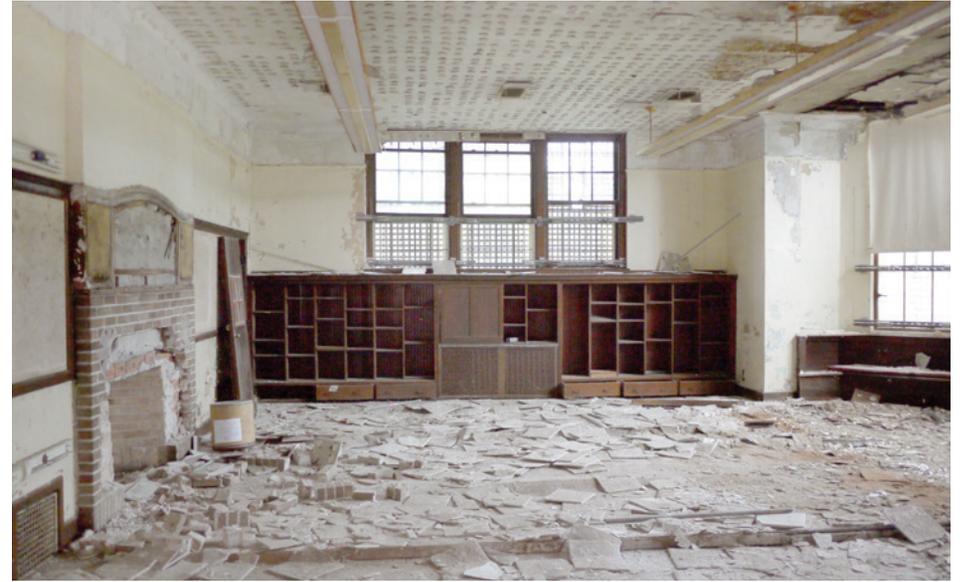
The kindergarten is spacious and once featured beautiful details; however, vandalism and water damage have taken a toll on the woodwork and tiled fireplace.

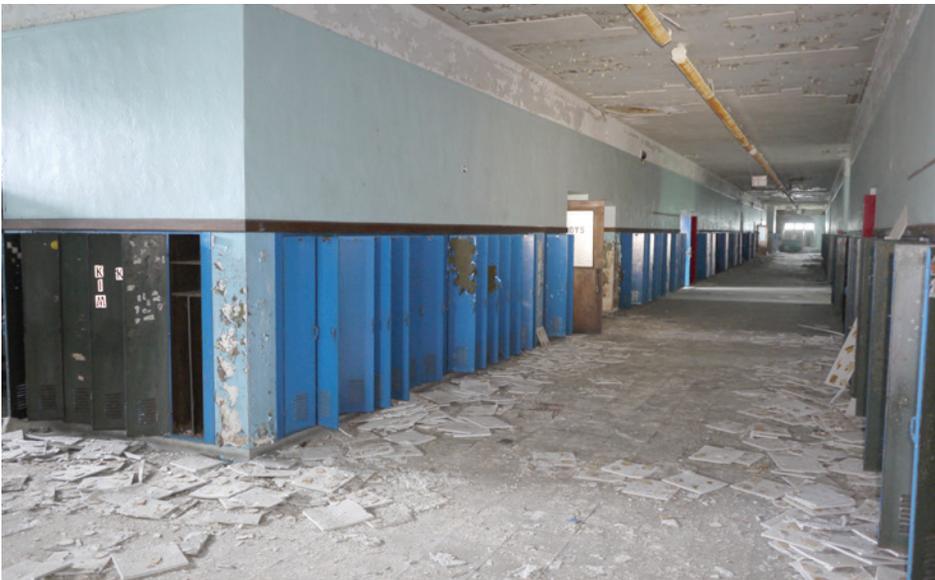
The spacious second-story main corridor is 14' wide. The plaster finishes and lockers are still in relatively good condition.

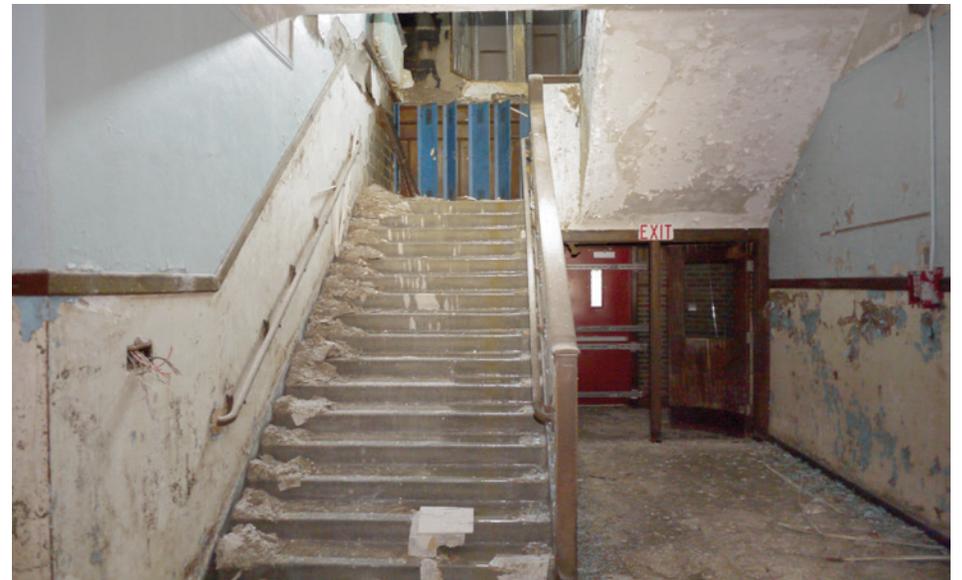
Building was visited during a heavy rain, and water was observed pouring into stairwells in all parts of the building. City staff report that this is a recurring issue, with thick ice forming in stairways and corridors during winter.

A rain storm caused water to pour down stairs at the north end of the building. The roof has been repaired, but water infiltration continues to be a widespread issue and a threat to the building.
