# 6 Hanneman

Address: 6420 McGraw  
Parcel: 18003118  
District: 6  
SNF Area: n/a  
Owner: City  
Site Area: 1.87 ac  
Gross Floor Area: 42,700 sf  
Floors: 3  
Plan Type: I  
School Type: Elementary  
Year Built: 1916  
Zoned: R2  
Base Rehab Cost (est): \$1.3M  
Total Rehab Cost (est): \$10.0M

## Building Overview

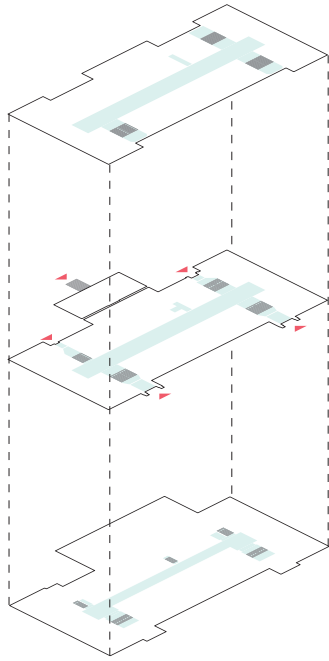
Hanneman has one double-loaded central corridor per floor, with two pairs of stairs at each end. On the two upper levels, the corridor is a generous 14' wide with 12' ceilings. In the basement, the corridor narrows to 8' wide and has low clearance. There are entrances near each of the four corners of the building. Each entrance has a flight of stairs, so the building is not handicap accessible.

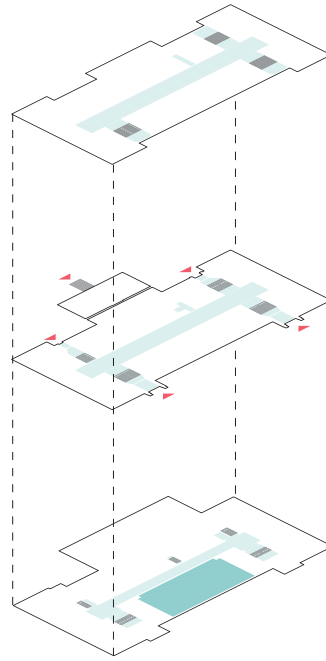
There is a long and narrow gym in the basement. The gym is roughly 30x70' and is sunken lower than the rest of the basement to allow for 13' ceilings. The space is interrupted by a row of five structural columns. The school once had a small auditorium on the upper floor above the kindergarten, but it was converted in to two classrooms.

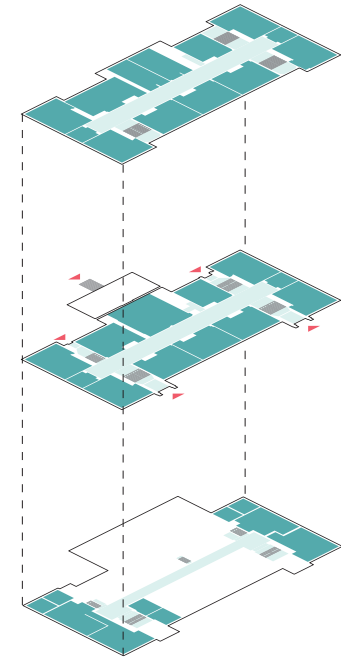
Hanneman features 23 classrooms and a large kindergarten. The kindergarten has a door to a raised terrace which sits above the boiler room, and a large stairway down to the rear playground.

Typical classrooms are approximately 23x32' with 11'10" ceilings.

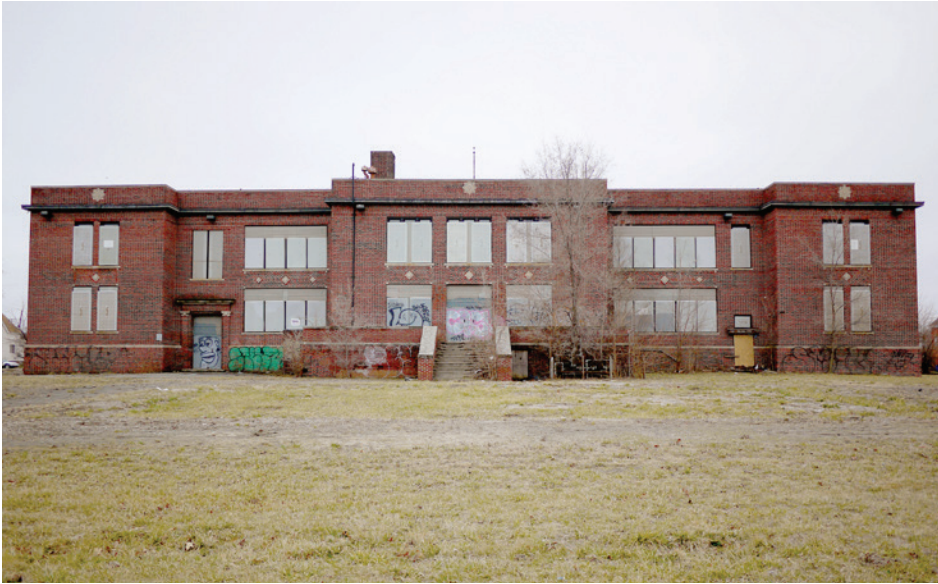
Rear elevation seen from the school yard. The stairs in the center of the building lead to a large outdoor terrace with access into the school's former kindergarten.

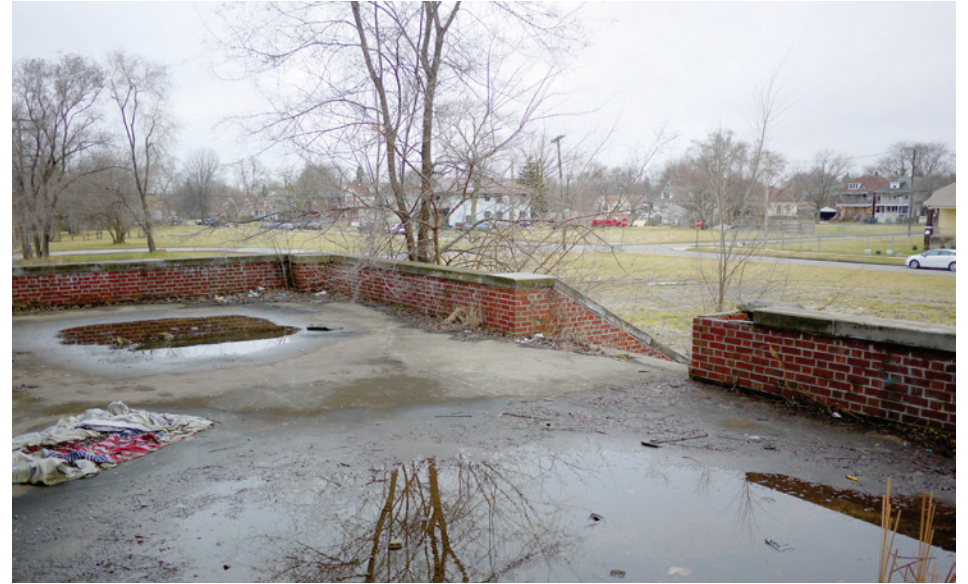
The kindergarten's rear terrace overlooks the school yard.

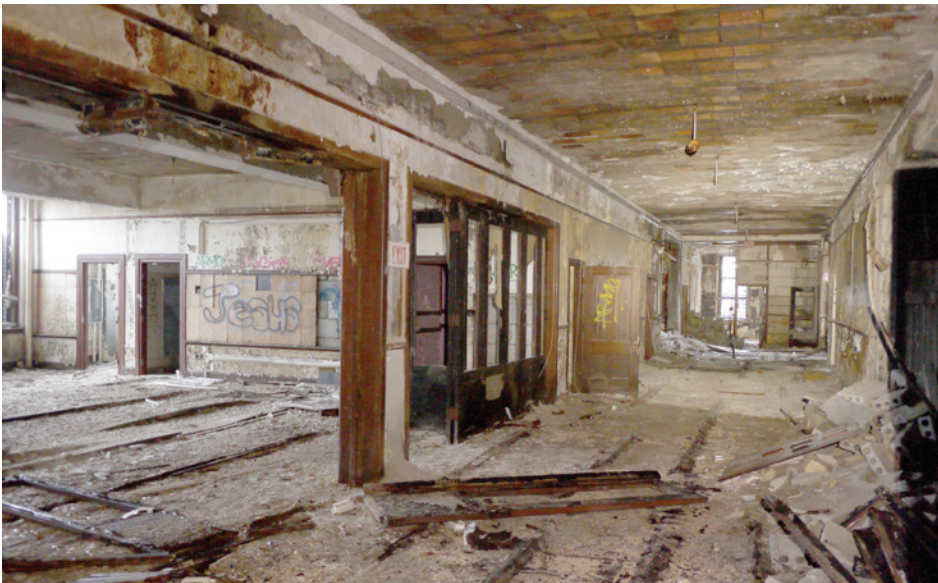
The former kindergarten has an operable wall that allows the space to be completely opened to the main corridor. On the opposite wall is access to the raised outdoor terrace.

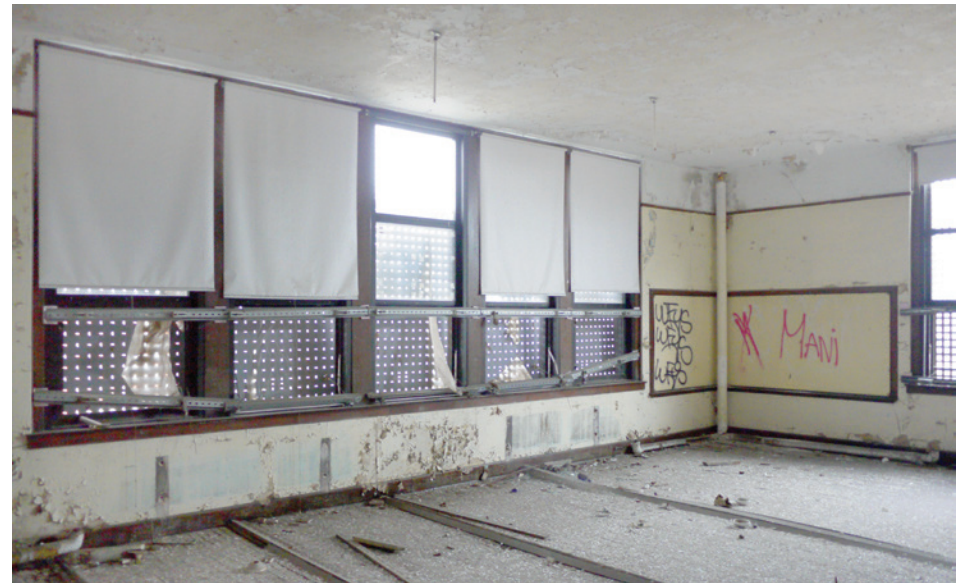
Hanneman features eight large corner classrooms with large windows on two sides. Partition walls could be removed to create even larger spaces with natural light on three sides.

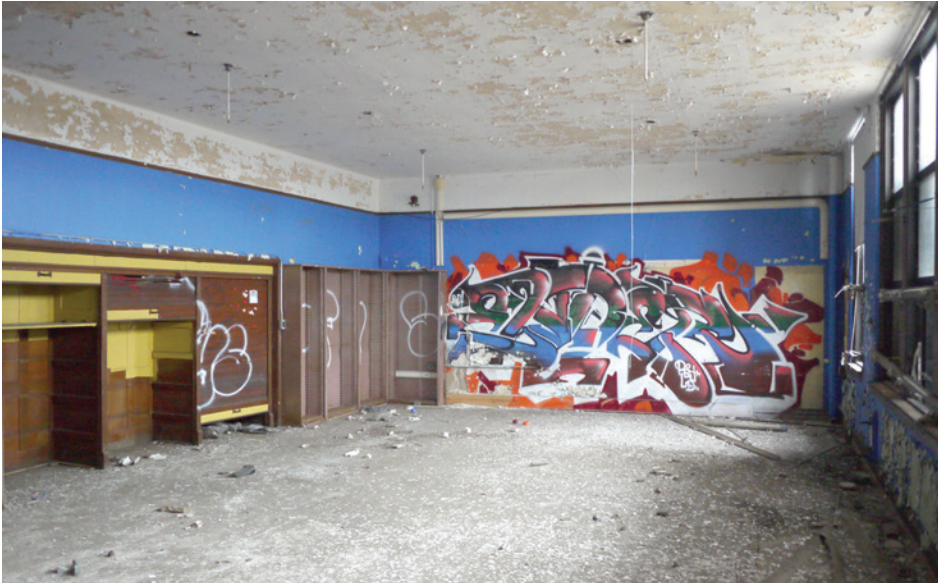
The second floor library is 8' longer than a typical classroom, and features roll-up wood cabinets. Woodwork and walls have been painted over and tagged, but are otherwise in good condition.

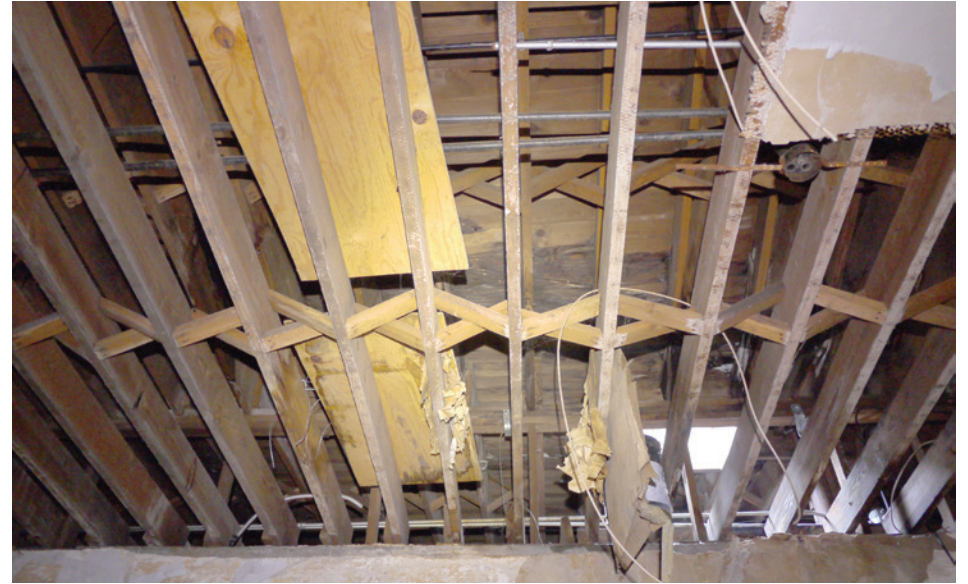
Hanneman has a wood-framed roof sitting on load-bearing brick exterior walls with an internal concrete frame. The roof is water damaged and requires replacement.

Interior finishes are damaged due to heavy water infiltration through roof. Structure and facade are in good condition.

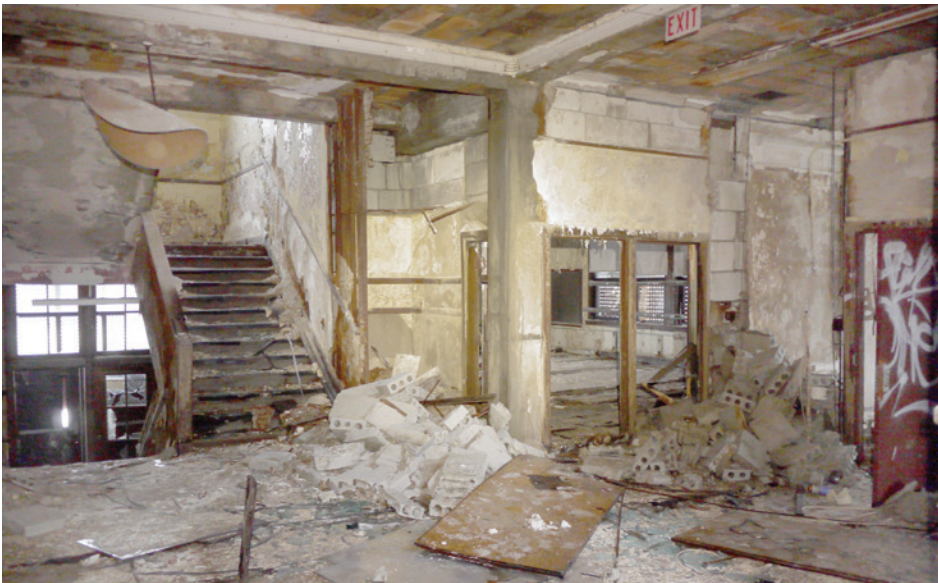
Gypsum block walls on the first floor have collapsed due to water infiltration, revealing the concrete frame. This photo shows the large cross-shaped landing between two facing stairs.

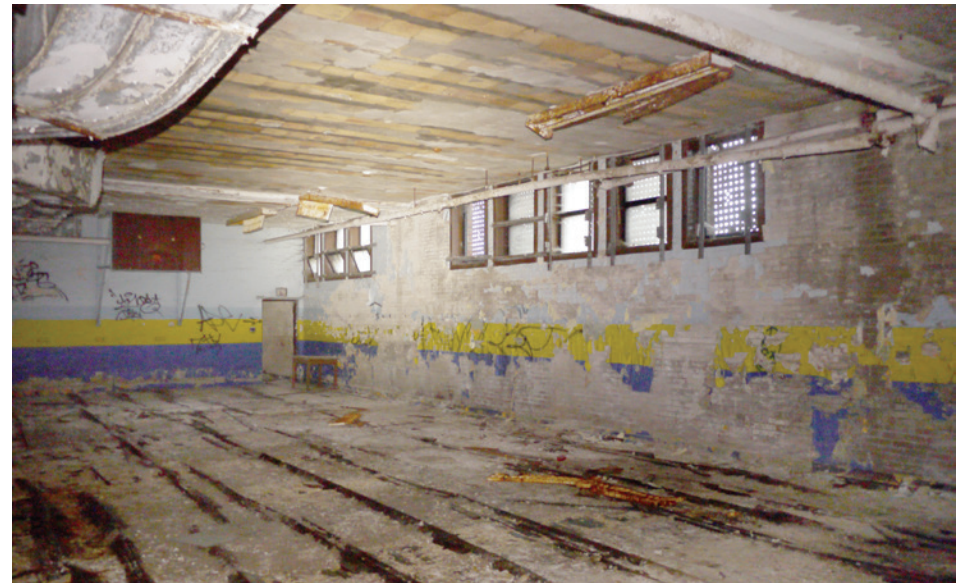
The basement-level gym is both longer and narrower than typical elementary school gyms. It is sunken four feet lower than the rest of the basement to achieve thirteen-foot ceilings.
