# 1 Burt

Address: 20710 Pilgrim  
 Parcel: 22104487  
 District: 1  
 SNF Area: Northwest/Grand River  
 Owner: City of Detroit  
 Site Area: 3.43 ac  
 Gross Floor Area: 46,200 sf  
 Floors: 2  
 Plan Type: U  
 School Type: Elementary  
 Year Built: 1925, 1959  
 Zoned: R1  
 Base Rehab Cost (est): \$2.0M  
 Total Rehab Cost (est): \$12.1M

## Building Overview

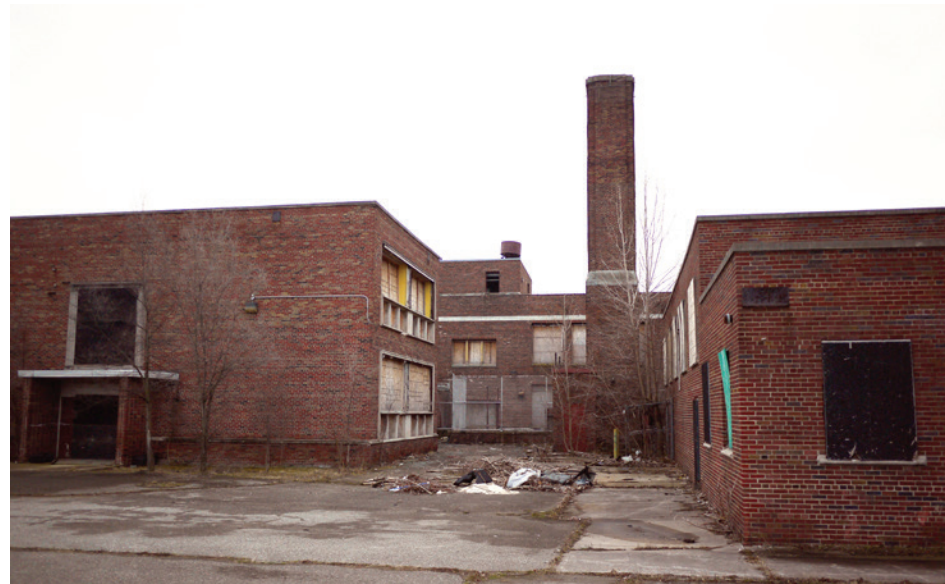
Courtyard and modern-style 1959 wings viewed from the north. The 1959 wings featured large glass-block ribbon windows, a contrast to traditional windows in the original unit.

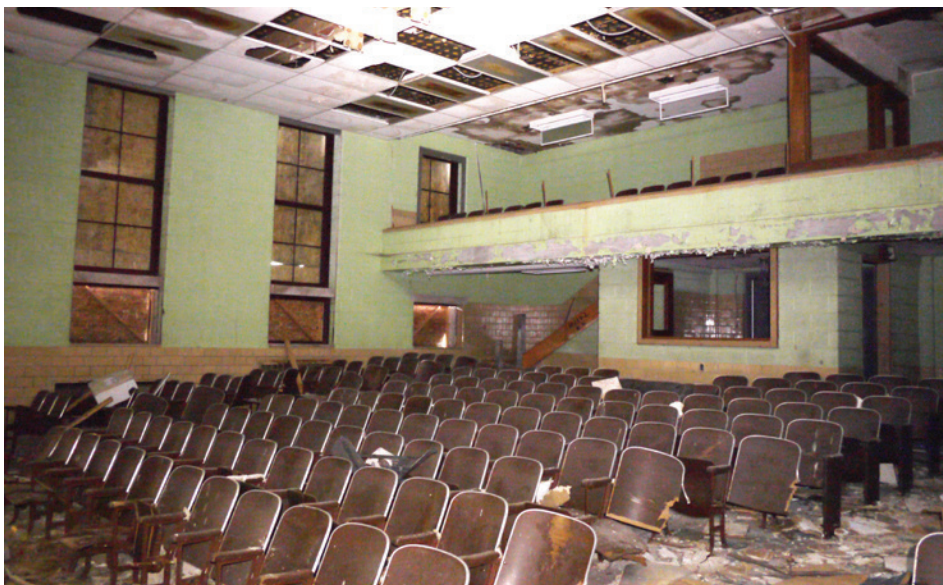
The 1959 auditorium features an enclosed vestibule, a small second-floor balcony, and tall windows on both sides. Finishes are simple, painted CMU block.

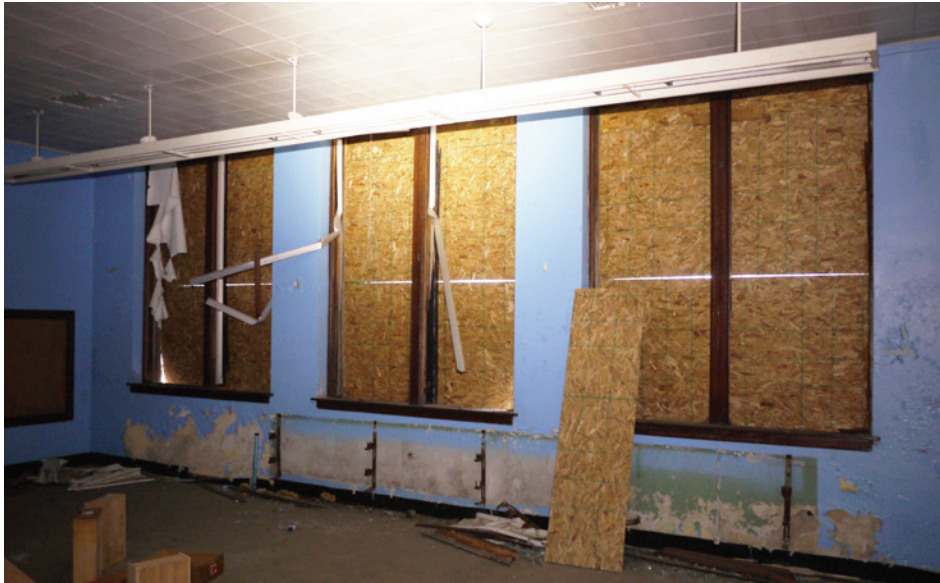
Window configuration and finishes in typical 1925 classroom. Original wood frame windows and their metal replacements are gone; radiators have also been scrapped.

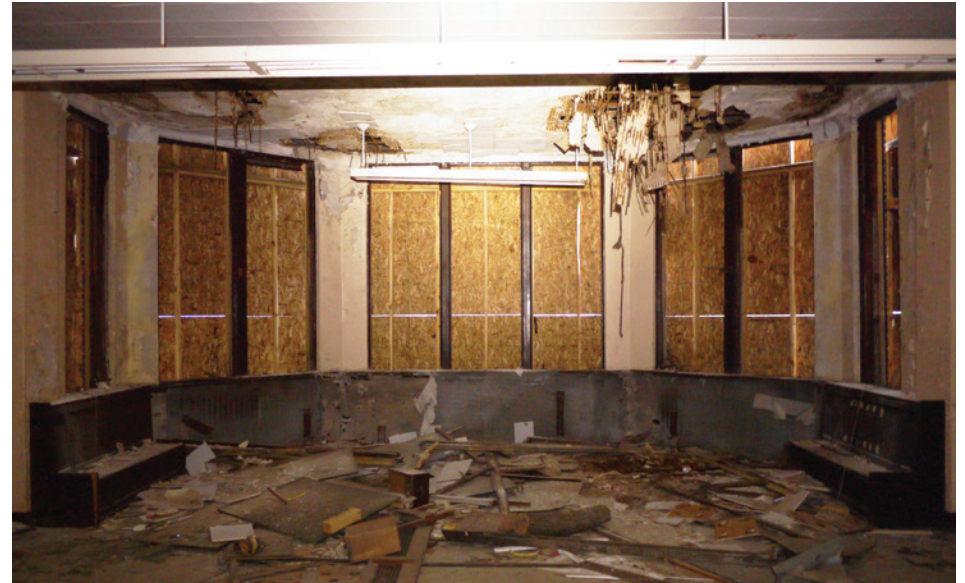
Kindergarten bay window in original 1925 unit. Windows, original wood benches, and radiators have been removed. Water infiltration at the protruding roof has caused plaster failure.

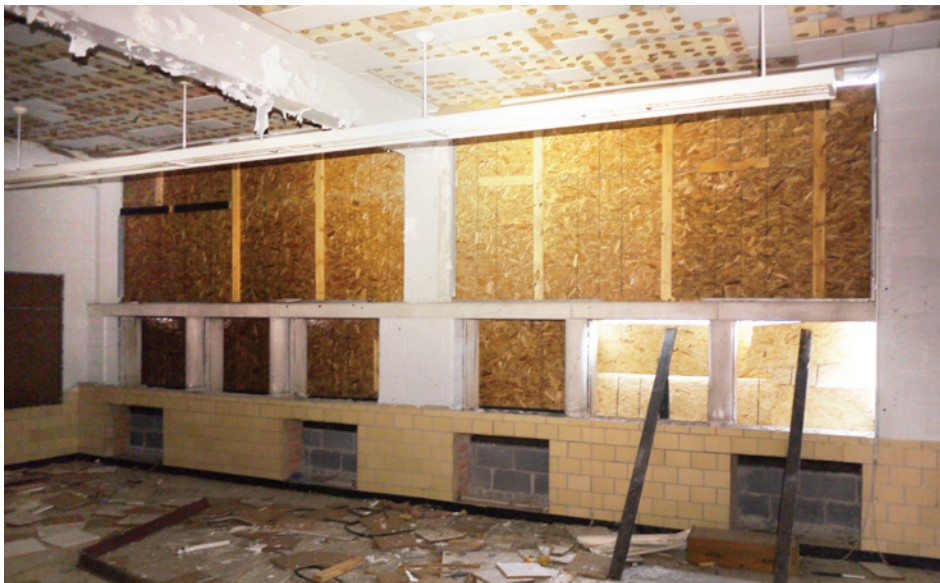
Typical window configuration and concrete block finishes in modern 1959 classrooms.

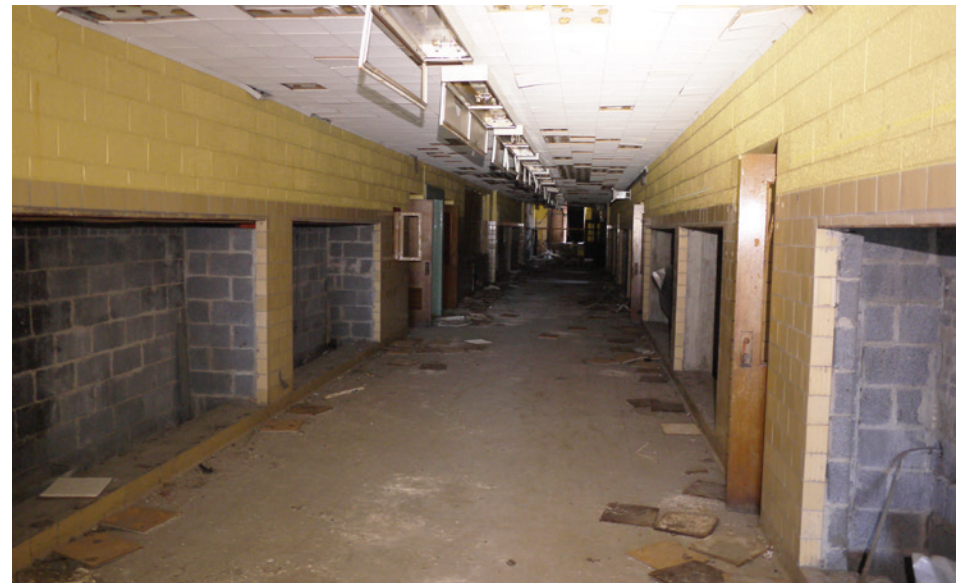
Typical corridor in 1959 addition. Lockers and ductwork have been scrapped, but otherwise the corridor is clean and in serviceable condition.
