# 7 Oakman

Address: 12920 Wadsworth

## Building Overview

# Building Distress

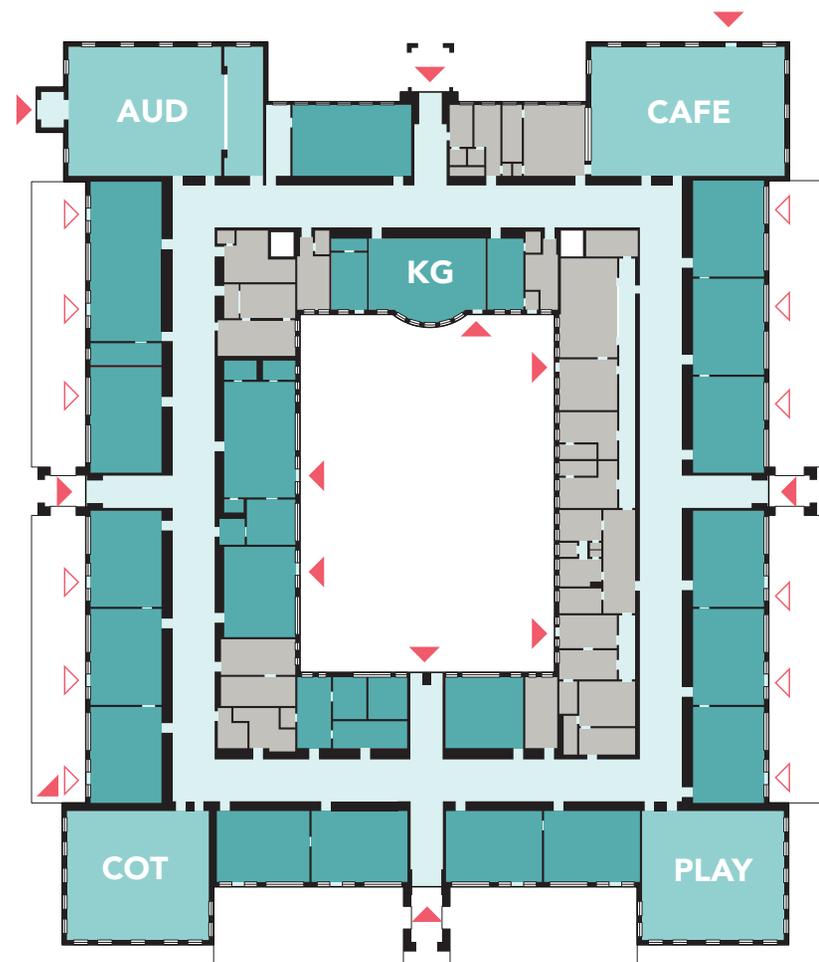
## First Floor

40,450 sf net floor area  
8,700 sf enclosed courtyard

- CMU bearing walls or CMU-encased concrete frame

- Steel frame and gypsum deck with slate shingles, exterior drains (sloped)
- Concrete slab/beam with mod-bit membrane, interior drain (low-slope)

- Concrete slab

- Brick masonry with CMU backup
- Decorative stone, steel, and cast-iron accents

- CMU and glazed-tile walls
- Terrazo and VCT floors
- Aluminum-frame replacement windows

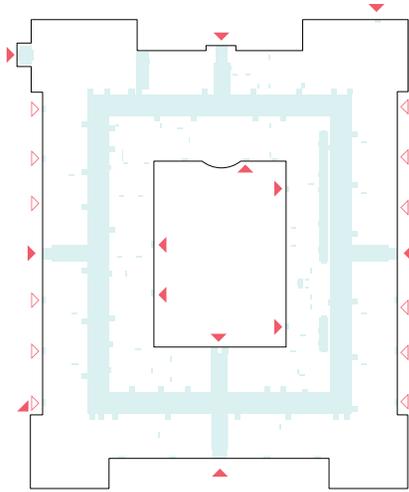
### Circulation

Oakman has a rectangular courtyard layout, with a double-loaded main corridor forming a single ring. The four main corridors are 13' wide with 10'3" ceilings. Entrance corridors are 10' wide.

There are four main entrances in the center of each elevation; the primary entrance is to the south. Each of the large corner spaces and exterior classrooms also has their own entrances.

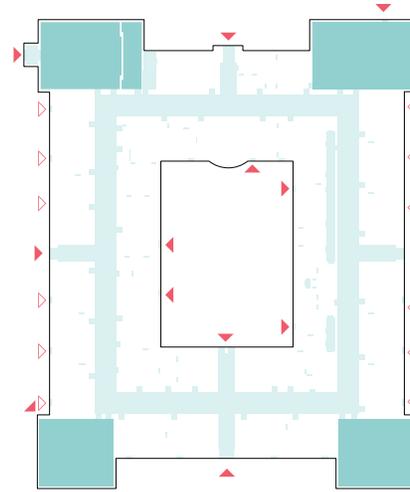
### Common Areas

Oakman features a unique corner-anchor arrangement of its common areas. The school features separate playroom/gym, auditorium, cafeteria, and "cot room" each located in the corner of the building, and each with exterior access.

The auditorium and lunch room at the north corners are 40x60'm while the cot and play rooms in the south are 40x44'. The spaces have sloped ceilings between 15-19' high.

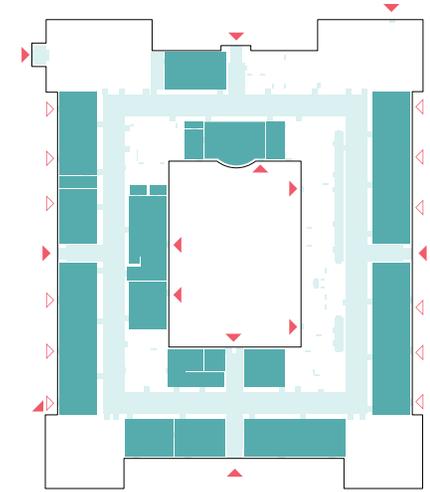
### Classroom Areas

Classroom areas are located on all four sides of the building, with the majority of classrooms facing the three street frontages. Each street-facing classroom formerly had a doorway that opened onto shared terraces. Courtyard-facing classrooms have direct access to the large central courtyard. Classrooms are typically arranged in blocks of two or three conjoined rooms. Typical classrooms are 22x29'9" with 12' ceilings.

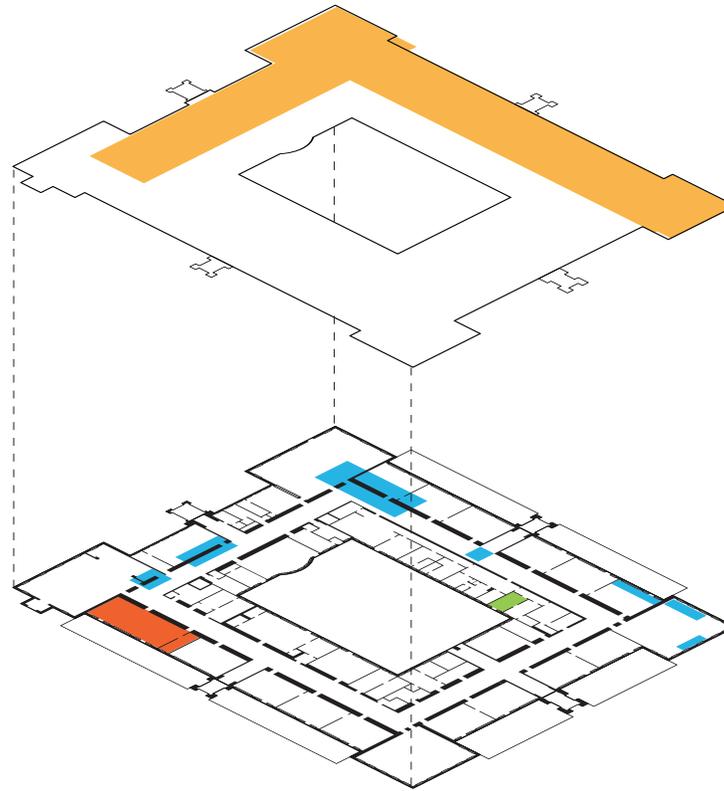
- Structural deterioration of roof deck over auditorium and gymnasium.
- Slate tiles have fallen from sloped roof sections and require replacement/repair; extent of damage difficult to assess due to snow cover at time of visit.
- Inspect and repair clogged roof drains.

- Overall good condition, with most finishes and windows intact.
- Water infiltration in classrooms on east side of building.
- Fire damage in classrooms in northwest corner of building.
- Metal windows are intact around exterior of building, but have been scrapped from courtyard-facing rooms.

- Roof Damage
- Structural Damage
- Water Damage
- Fire Damage
- Scrapping Damage

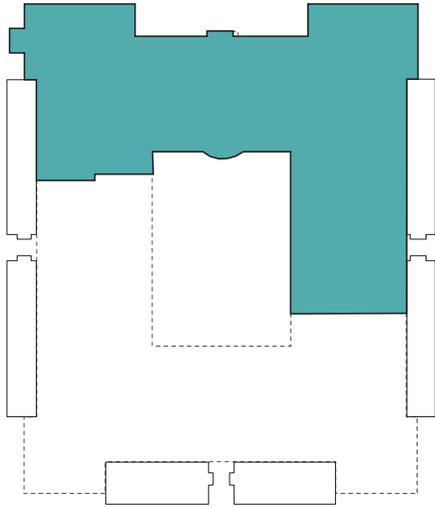
### Original Unit - North (1929)

Site plans for Oakman show the building in two sections, north and south. The north unit is labeled "First Unit 1929", while the south unit is unlabeled.

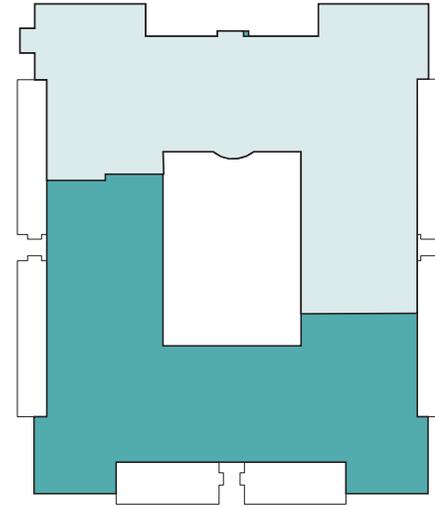
### Original Unit - South (1929)

Records show that the south unit was also completed in 1929, though it is drawn without dates or labels on the 1929 site plans. The south half of the school may have been designed as a separate unit to provide the option to construct the school in phases instead of all at once.

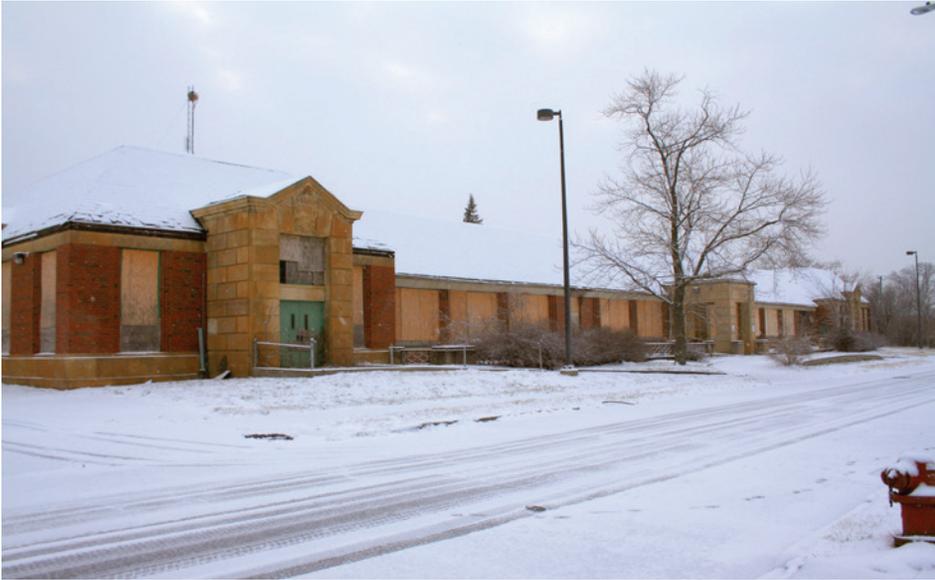
Oakman's west elevation viewed from the northwest corner. The nearest visible entrance on the left leads to the auditorium. One of the four primary school entrances is visible in the center of the building, marked by a stone portico.

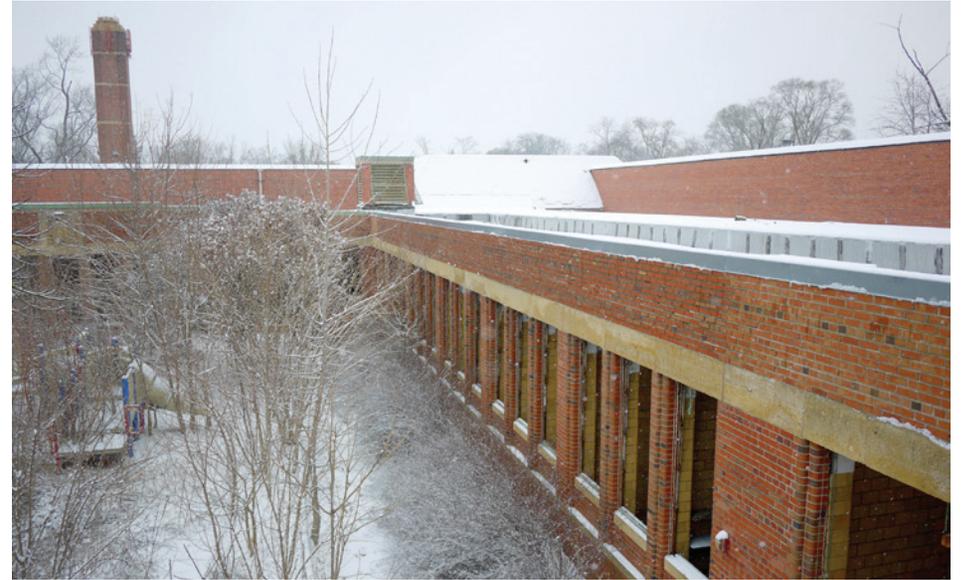
The inner courtyard viewed from a small roof deck. The courtyard is accessible from classrooms on all four sides. The rooms on the right of this image are part of the former physical therapy wing, which is made up of many small rooms and offices that served the school's disabled students.

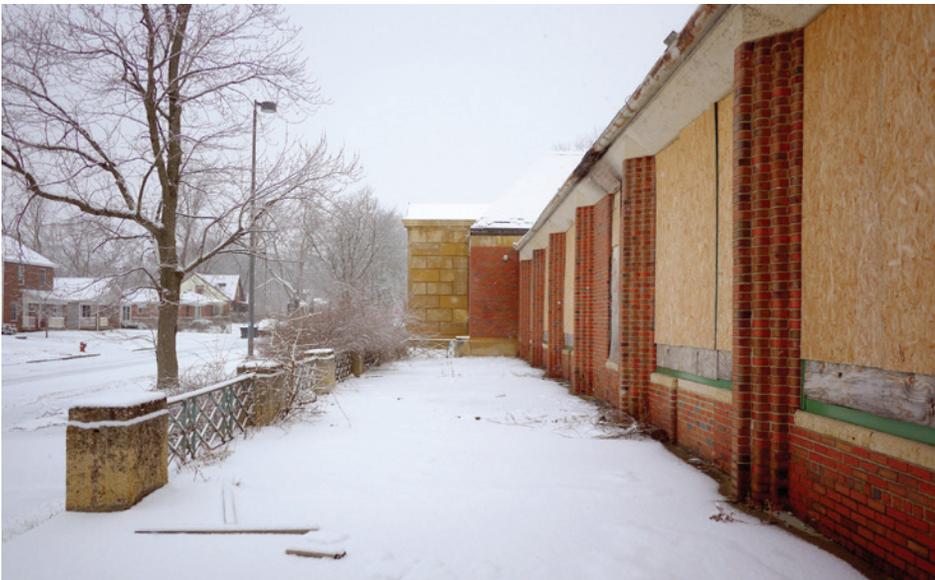
Oakman has exterior terraces on the south, east, and west sides. Classrooms around the outside of the building once had access to these terraces, but the doors are now gone. The brick infill where a door once stood is visible beneath the second window from the right (bottom right corner of photo)

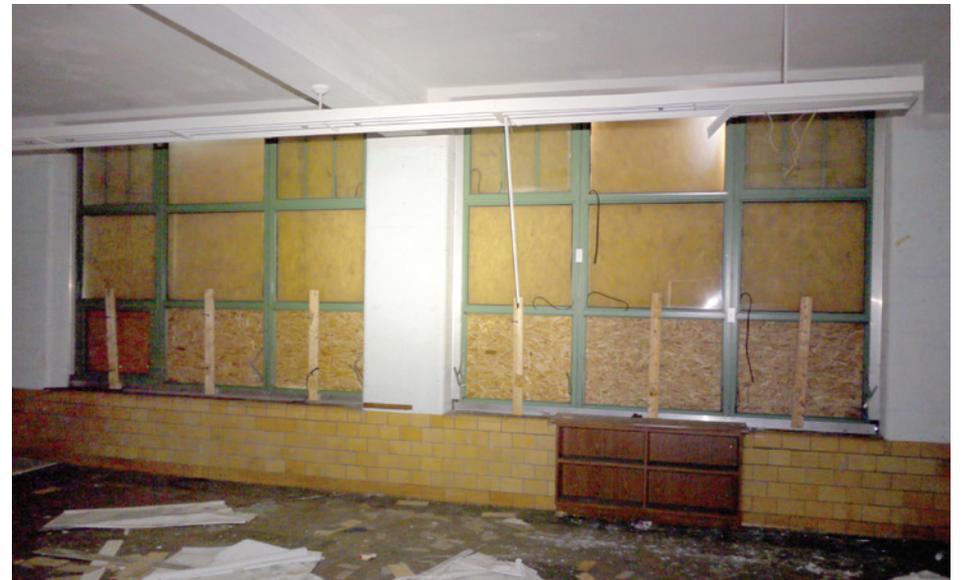
Typical classroom windows are modern aluminum-frame replacements. The wood shelf visible in the bottom right of the image is filling in the opening where there was once a door leading to the exterior terrace.

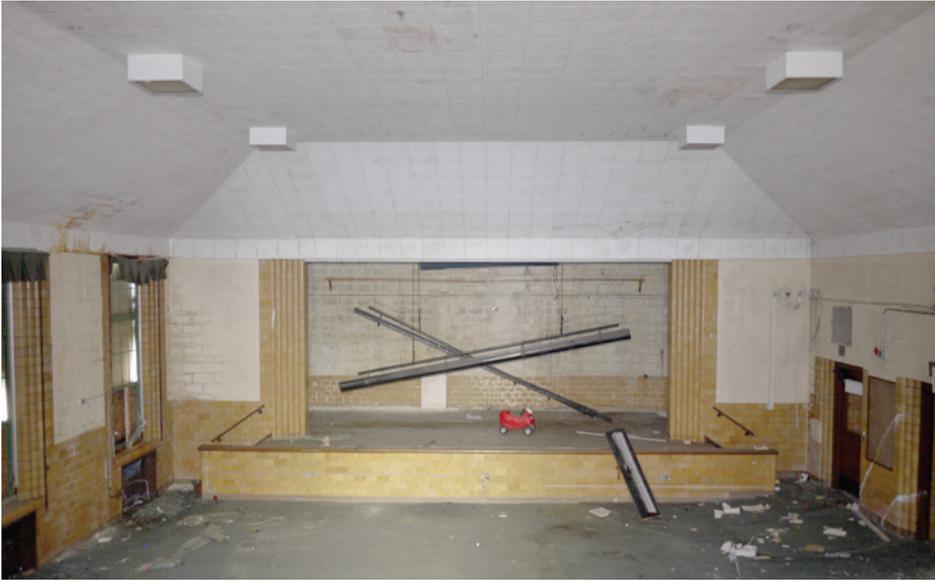
The school's corners are anchored by four large spaces with similar dimensions. The auditorium is distinguished from the other three spaces by its extended stage, a mezzanine projector room, and a dedicated street entrance with vestibule. It also has fewer windows than the other corner rooms.

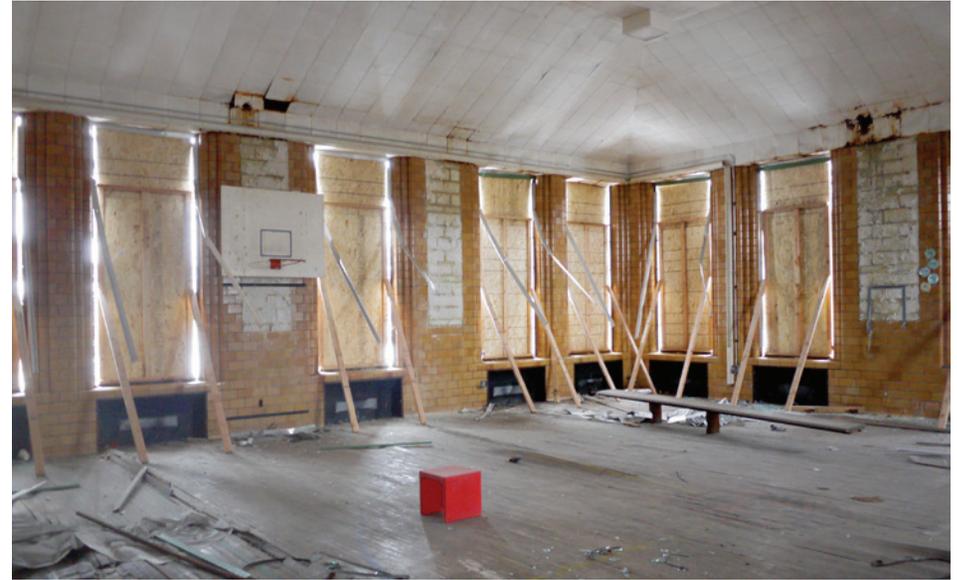
The play room/gymnasium anchors the southeast corner. It is surrounded by tall windows and was brightly lit even with its windows covered in plywood. This image highlights the extensive use of rounded glazed block throughout the building.

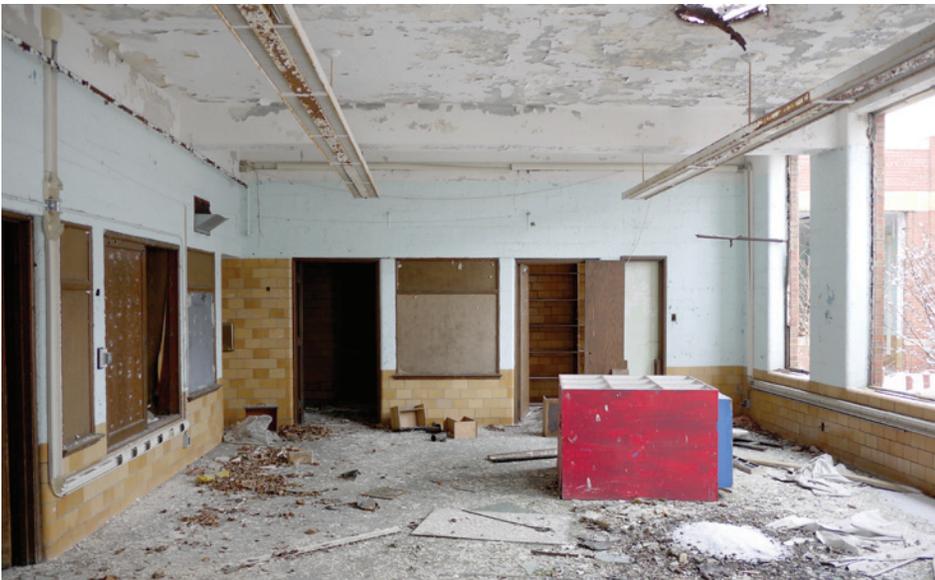
The "sewing & cooking" room is an example of a courtyard-facing classroom. Classrooms facing the interior have tall windows and direct access to the large courtyards. The durable concrete and glazed block finishes are in good condition.

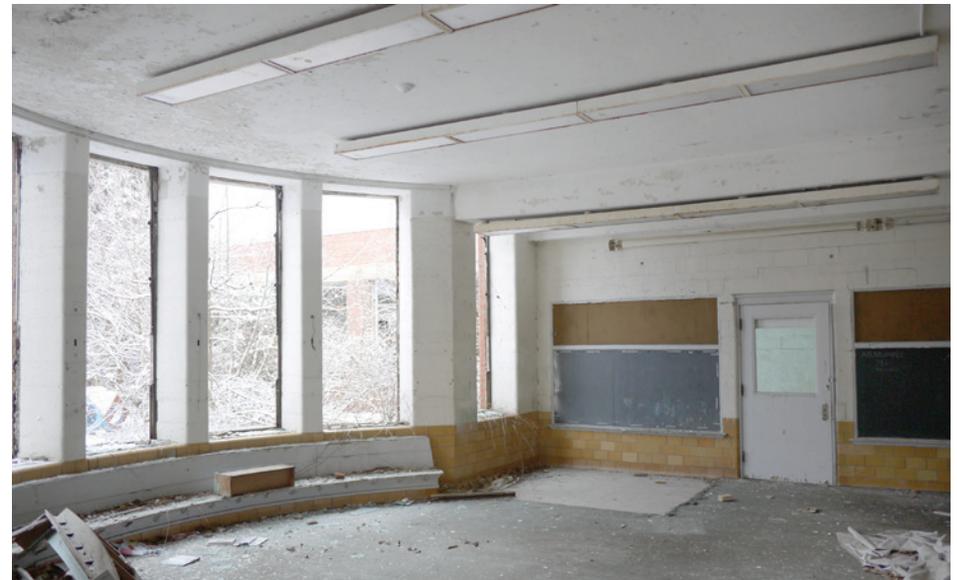
The kindergarten features a shallow bay window that extends into the central courtyard. This space also has direct access to the courtyard play area.
