6 Ruthruff

Address: 6311 W Chicago

Building Overview

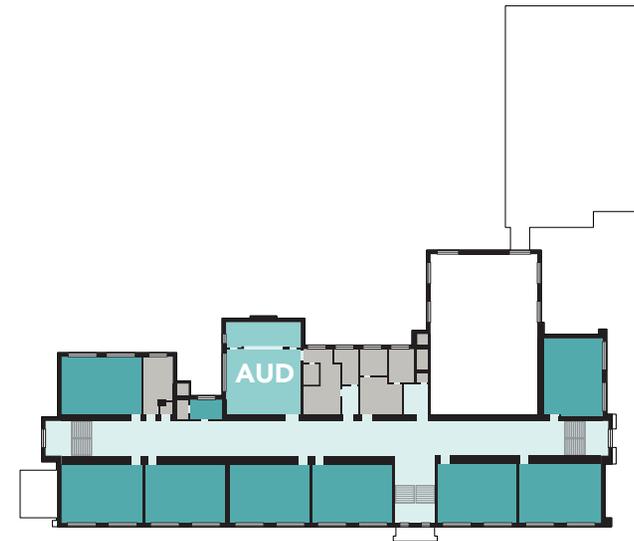
Second Floor

The original building has a single double-loaded corridor with stairwells at the ends and a primary entrance and stair in the middle. Corridors are 13' wide, with 12'7" ceilings on the first floor, and 10'2" on the second.

Ruthruff has a typical 40x60' gymnasium on the ground floor. It has a small auditorium located on the second floor above the kindergarten. At 28'x23'6", the auditorium is much smaller than those typically found in elementary schools. The space has a high vaulted ceiling. The stage has been walled off.

Classrooms are primarily arranged along the front of the building, facing Livernois. The opposite side of the corridor is primarily used for common areas, restrooms, locker rooms, offices, and storage spaces. Typical classrooms are approximately 22x30' with 12' ceilings.

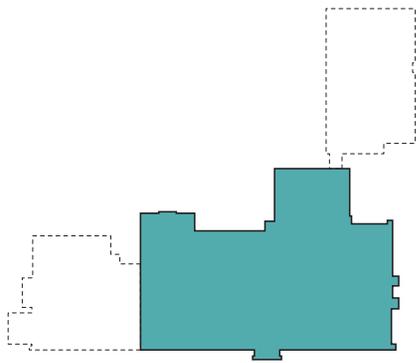
Original Unit (1927)

The original two-story unit featured ten classrooms, a kindergarten, gymnasium, and a small second-floor auditorium. This school is somewhat unique in that the gym and auditorium were built in the first phase, not later.

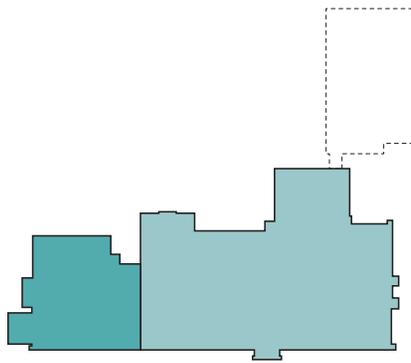
First Addition (1930)

The school was expanded shortly after opening, with six additional classes. The addition matches the architectural style of the original building.

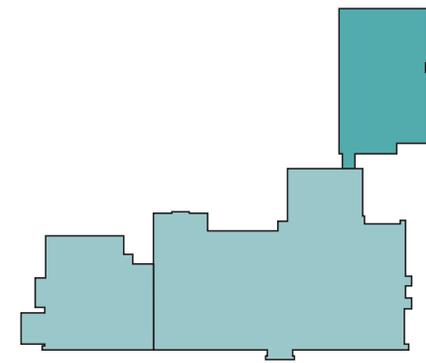
Second Addition (1950s)

At an unknown date prior to 1990, an adjacent 1950s-era 1-story commercial building was annexed by the school. The existing building was attached to the gymnasium via a small corridor. Sanborn maps show that the annex was previously used for printing and light manufacturing.

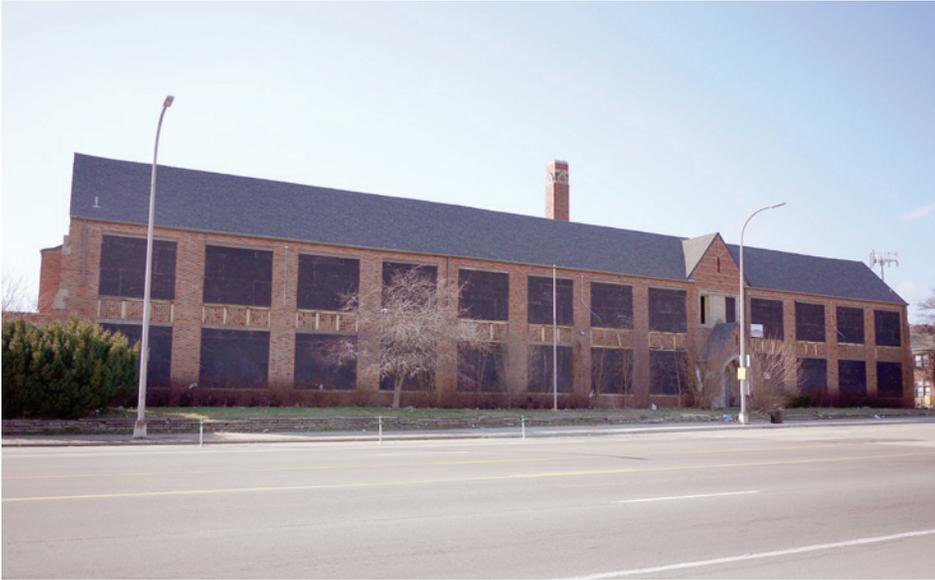
East elevation as seen from Livernois. While most schools have open space between the building and the street, Ruthruff has very small setbacks along Livernois and Chicago to the north.

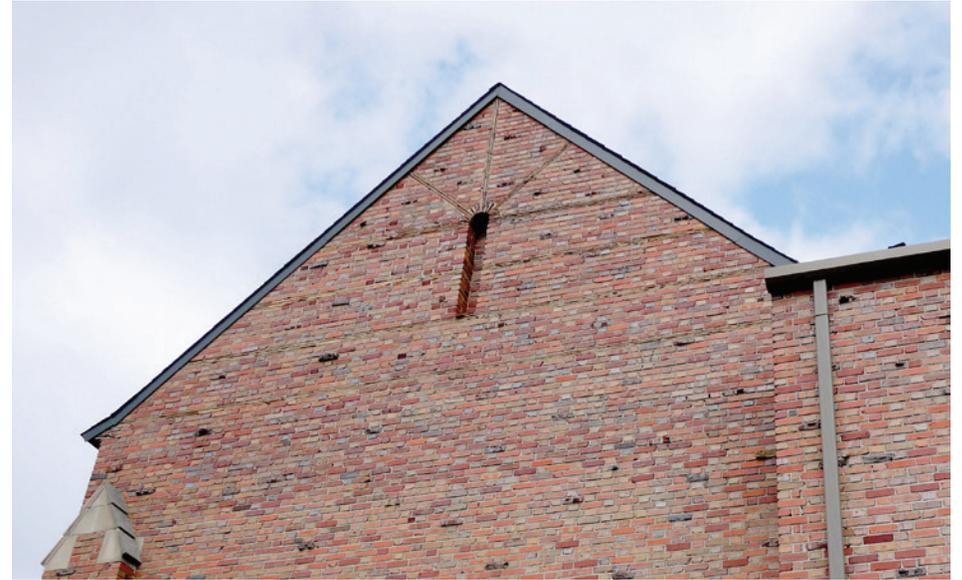
A detail of the unique tudor-revival brick details on the south elevation.

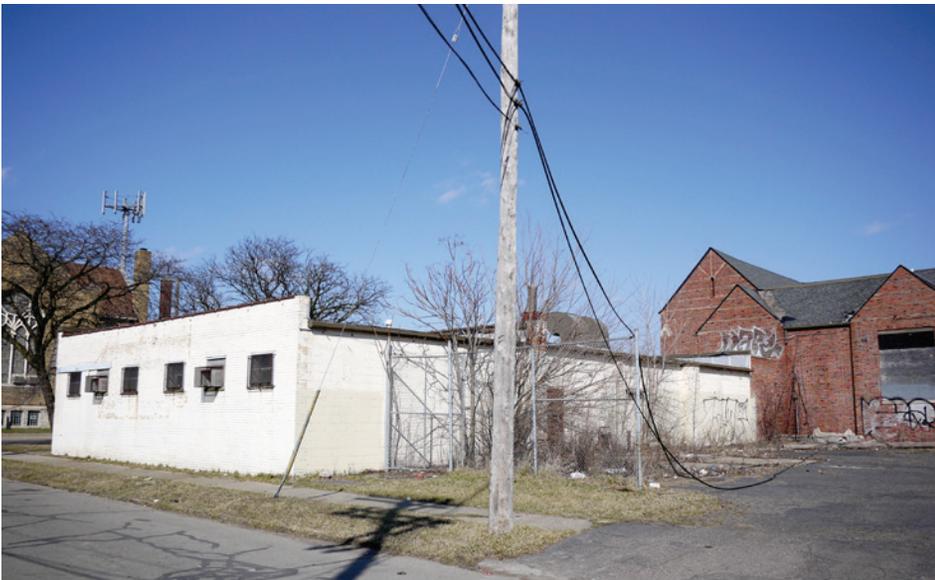
A 1950s-era commercial building adjacent to the school (formerly a commercial printer) was annexed by the school and connected to the gym.

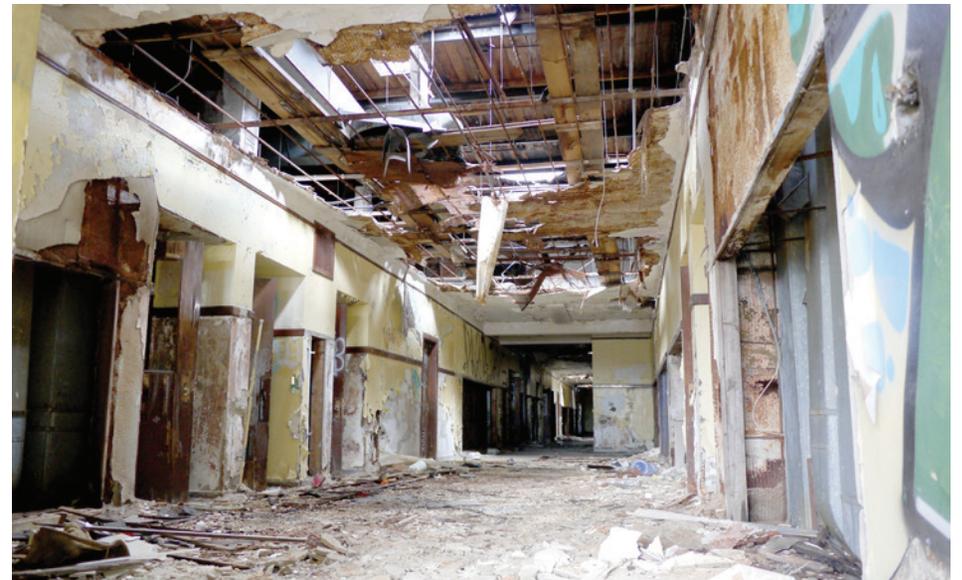
The second-floor main corridor. The school's main hallways are a generous 13 feet wide. A deteriorated roof has led to widespread water damage throughout the second floor.

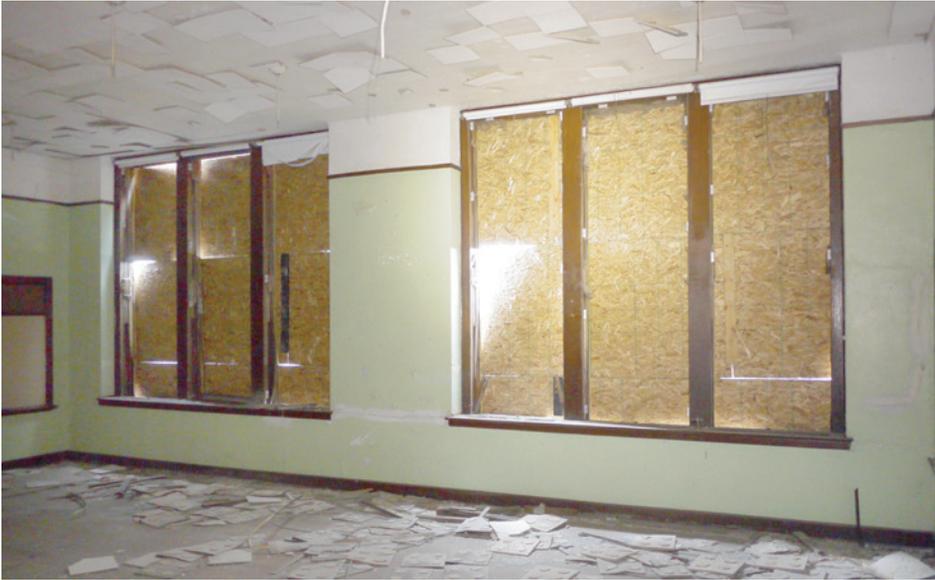
Typical classroom windows, showing original wood frames. The window assemblies were replaced with aluminum replacements, which have since been scrapped.

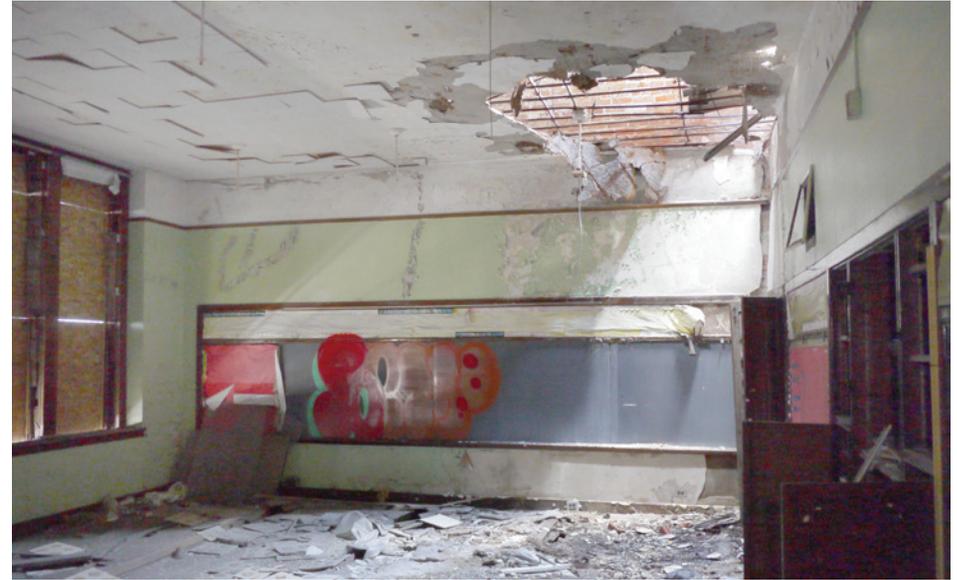
A hole in the ceiling of this second floor classroom reveals a red brick wall and soaring attic space above. The ceiling could be removed to create a loft-like space.

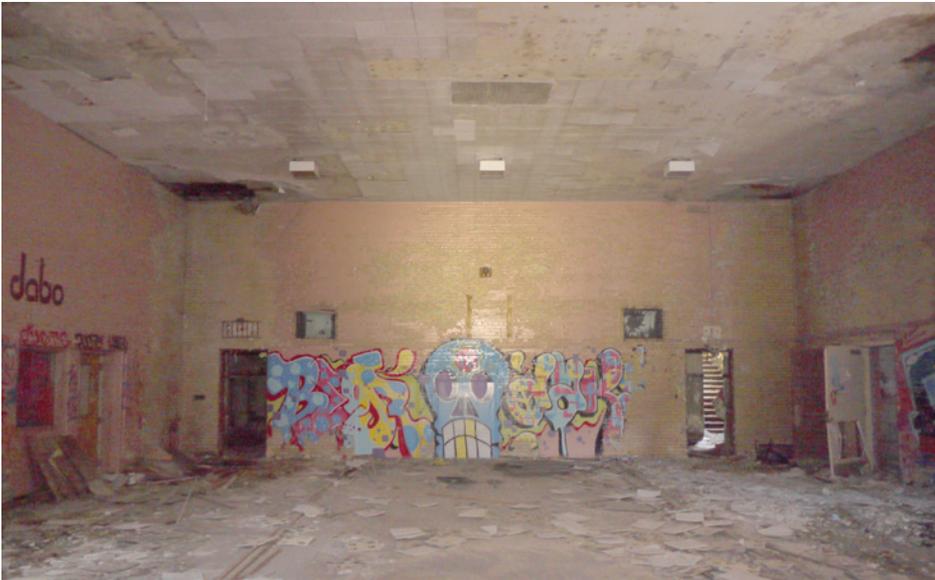
The gymnasium is a brick box with nearly 17-foot high ceilings and 11-foot-tall windows at the western end.

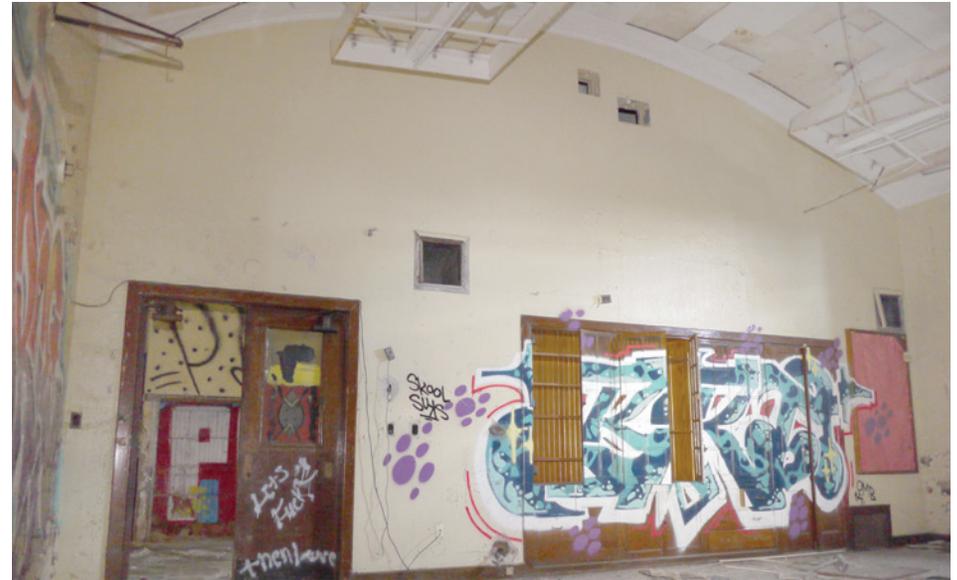
A small barrel-vaulted auditorium is on the second floor above the kindergarten. The stage has been closed off with drywall.
