7 Parker

Address: 12744 Elmira
 Parcel: 22020616
 District: 7
 SNF Area: n/a
 Owner: City of Detroit
 Site Area: 6.72 ac
 Gross Floor Area: 55,400 sf
 Floors: 2
 Plan Type: T
 School Type: Elementary
 Year Built: 1927, 1973
 Zoned: R1
 Base Rehab Cost (est): \$1.8M
 Total Rehab Cost (est): \$13.0M

Building Overview

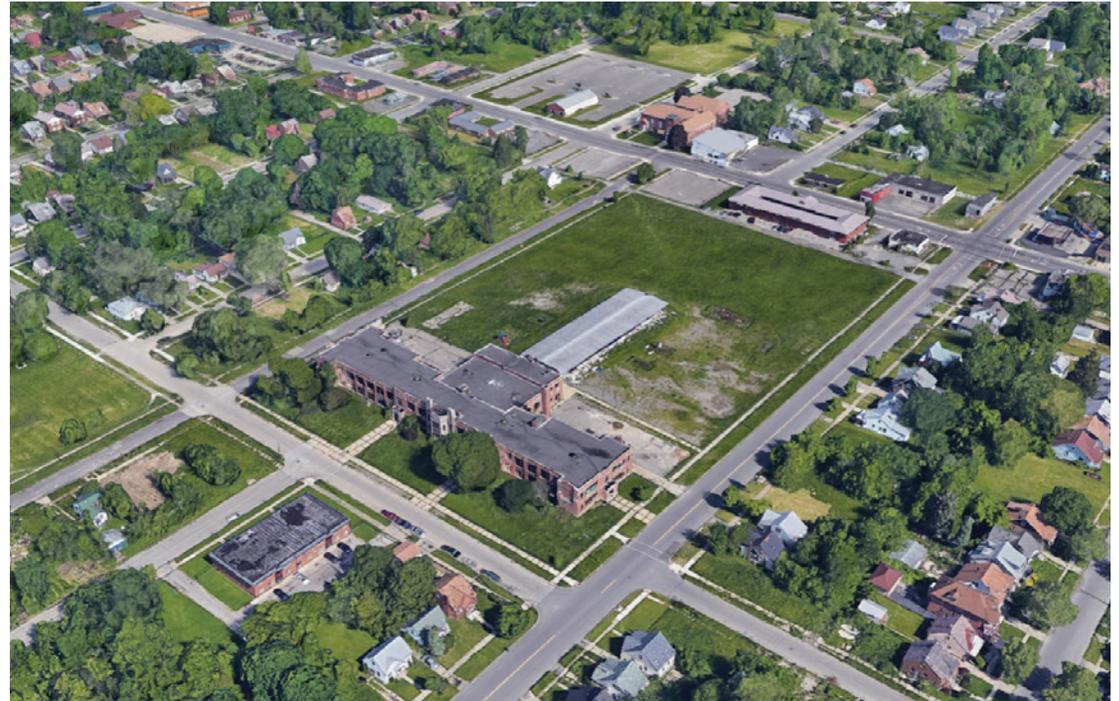
Symmetrical 2-story T-plan with long primary wing.

Imposing gothic-style facade with a castle-like tower over the central entrance.

Classrooms double-loaded along primary south wing; gym, auditorium, and cafeteria clustered to north.

1-story steel-frame addition extends off the rear of the building. The addition has been completely scrapped, leaving only the roof and steel frame.

Extensive interior damage from water infiltration and scrapping; most damage located on first floor southwest wing. Open holes in roof.

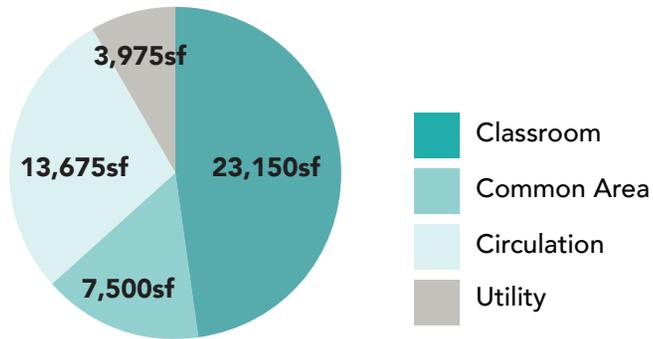
Existing Floorplan and Program

48,385 sf net floor area
(does not include 1973 addition)

- Concrete column and beam
- Brick masonry bearing walls (gym/auditorium)
- Steel frame (addition)

- Concrete tee-joint and slab
- Steel truss with wood plank (gym/auditorium)
- Gravel-surface bituminous BUR
- Internal drains

- Multi-wythe brick
- Limestone/cast stone accents
- Wood window frames

- Concrete tee-joint and slab

- Plaster/metal lathe on gypsum block

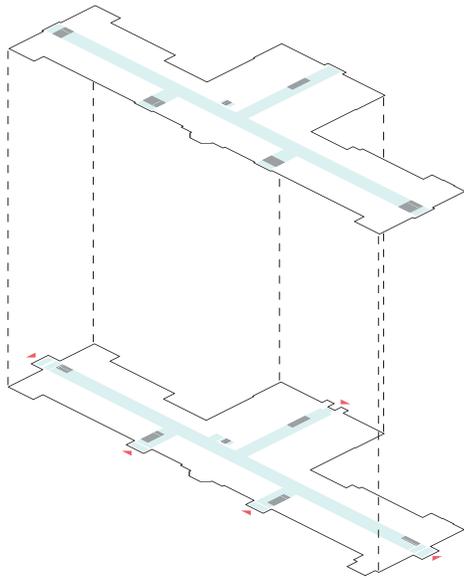
Circulation

Parker has a symmetrical T-plan, consisting of a long double-loaded south wing, and a short double-loaded wing for large shared spaces. There are two main entrances in the center of the south wing, and three additional entrances at the ends of each wing. A stairwell is located near each entrance.

Corridors are 13' wide.

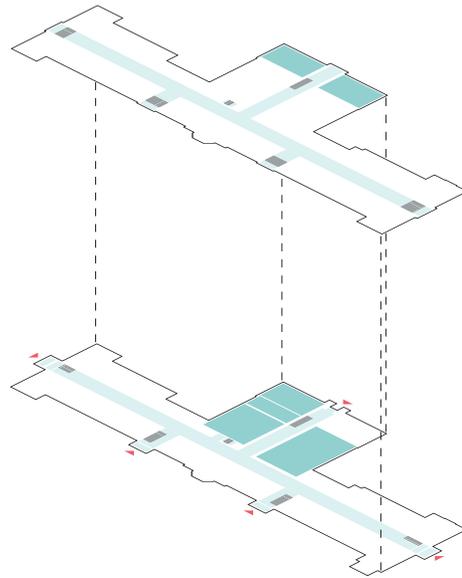
Common Areas

This school features a cluster of large common areas in the north wing. Both the gym and auditorium are 40x60' spaces with 19' ceilings. There are four 40x23' auxiliary spaces behind the gym/auditorium, 2 on each floor. These include kitchen, cafeteria, and two multipurpose rooms.

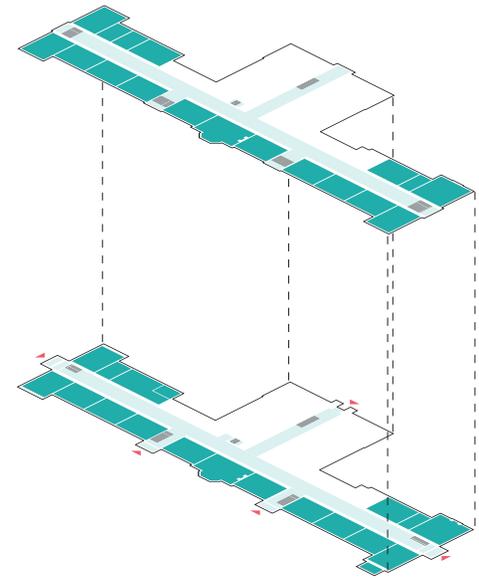
Classroom Areas

Classrooms are located on both levels and are spread along the length of the south wing. The majority of the classrooms face south, with a small number on the far east and west corners facing north.

Typical classrooms are 22x30' with 12' ceilings.

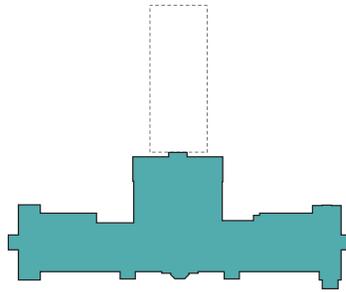
Original Unit (1927)

Unlike many other Detroit public schools, the large, historic Parker building was built in a single phase in 1927. The school opened with a capacity of 1400 students.

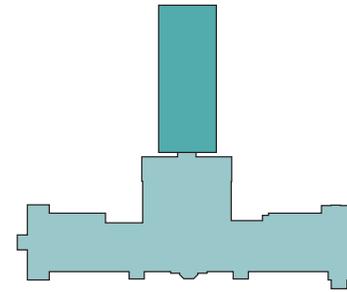
First Addition (1973)

A large, single-story double-loaded classroom wing was added to the north. The wing was a prefabricated steel-frame building attached to the rear door of the school. Only the structure and roof still stand; walls, windows, mechanicals, and other materials have all been stripped away.

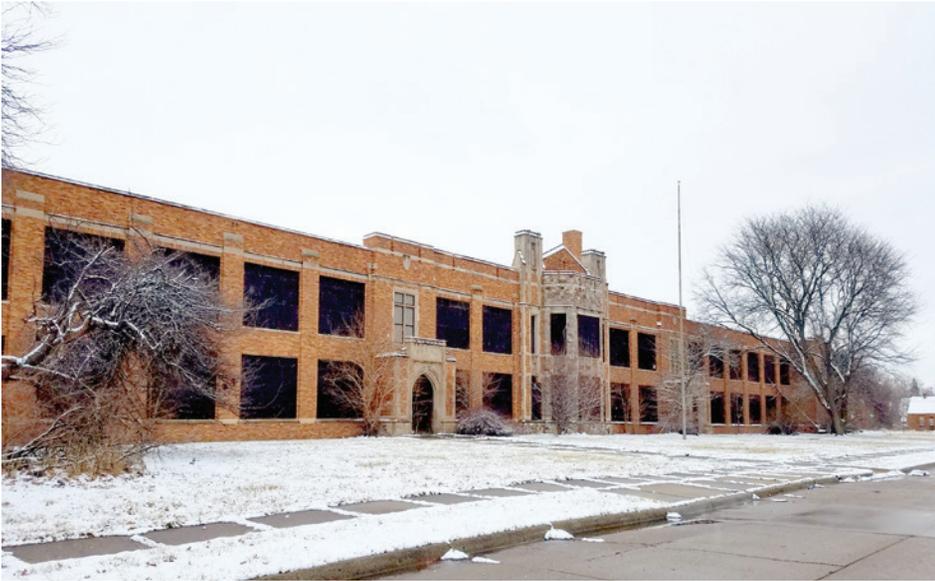
View of the front (south) elevation from Elmira St. The majority of classrooms are arranged along the south elevation.

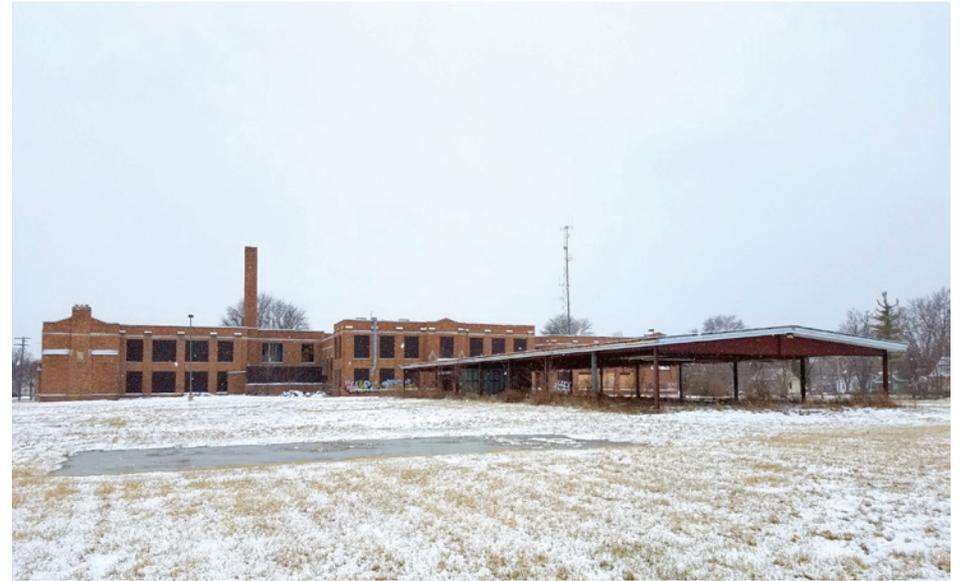
A long prefab classroom wing was added to the rear (north) side of the school. Only the structure and roof remain. This image also shows a portion of the unusually large school yard behind the school.

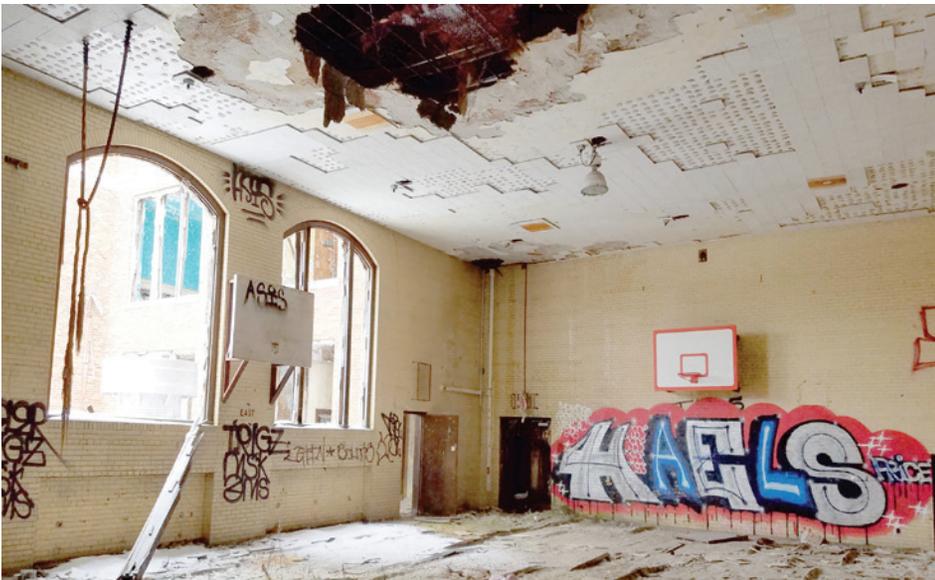
The gym is a mass-masonry brick box with tall arched windows. The wood roof deck has deteriorated, resulting in water damage to the ceiling and floors.

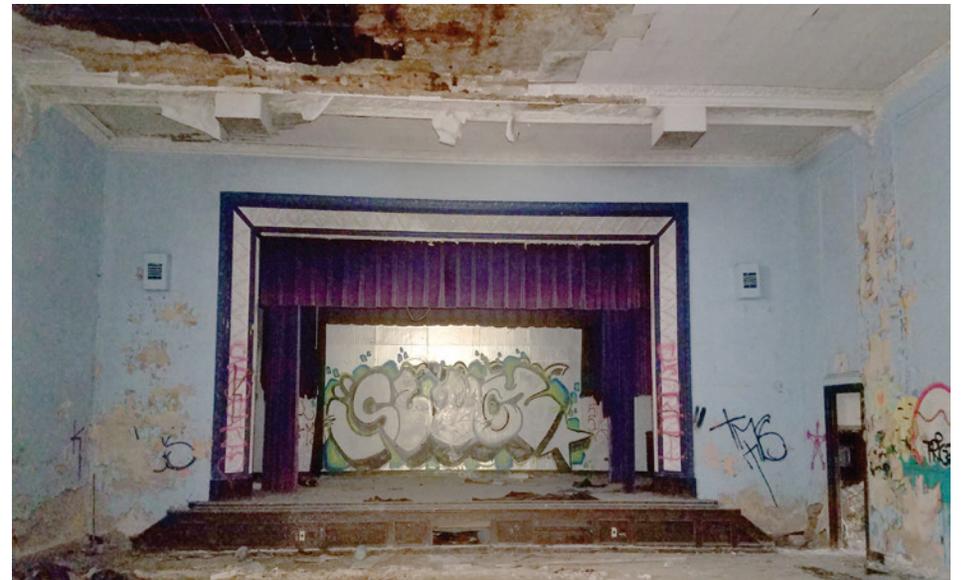
A view of the auditorium. A large section of the ceiling had collapsed due to water infiltration.

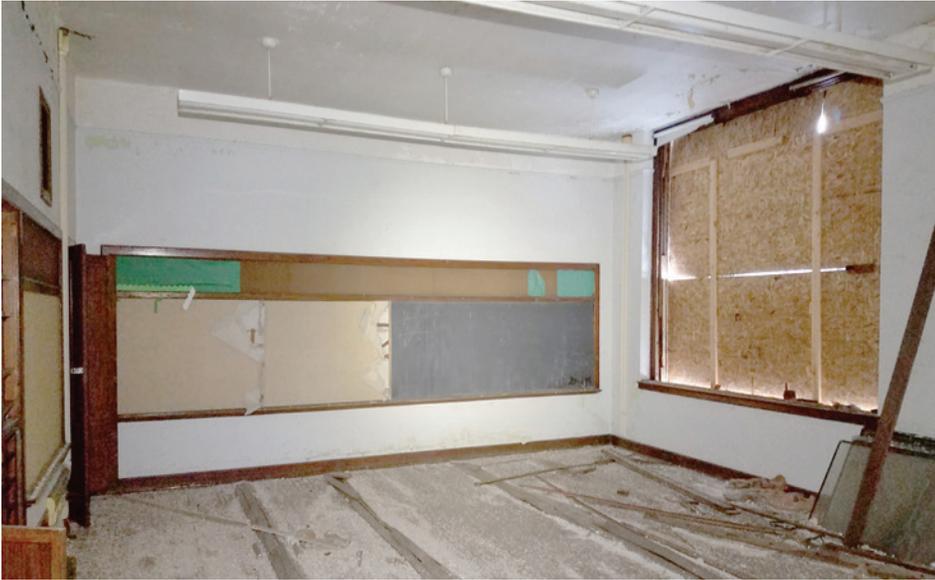
A typical classroom with finishes in good condition. Many other classrooms have suffered from water damage.

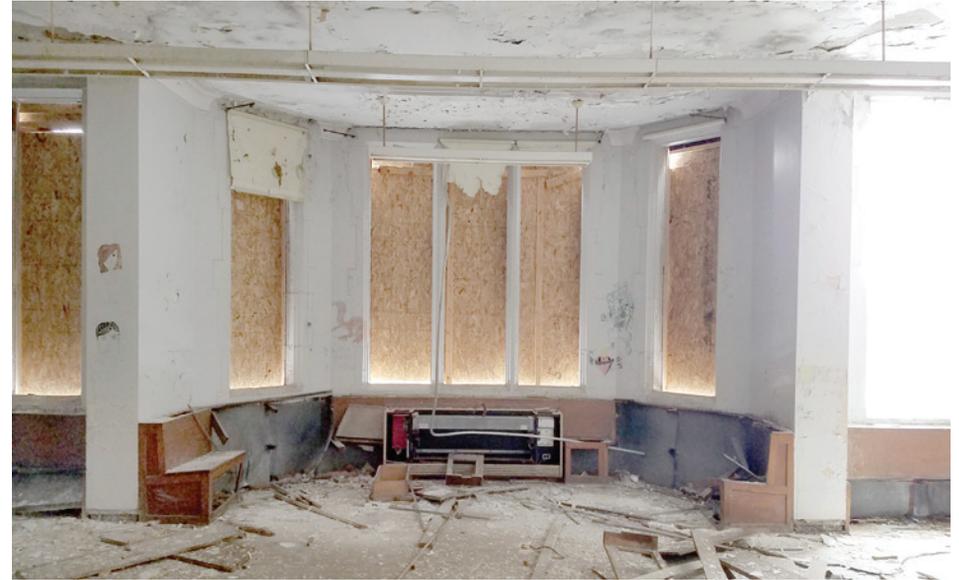
A special classroom (formerly "teacher rest") located on the second floor in the center of the main wing. This room and the library below both feature a bay window and fireplace.

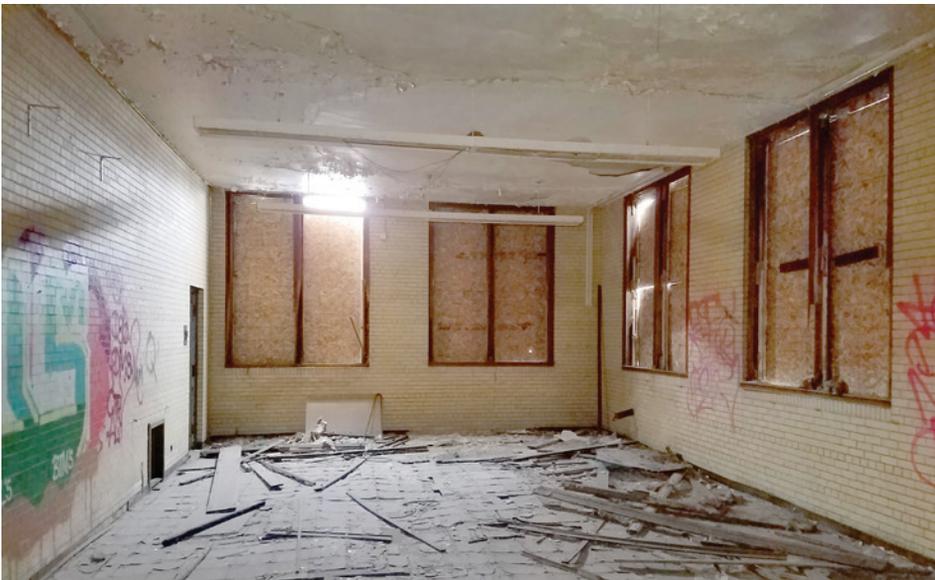
The "play room" is a large auxiliary space located behind the auditorium. Parker has four such spaces clustered in the north wing.

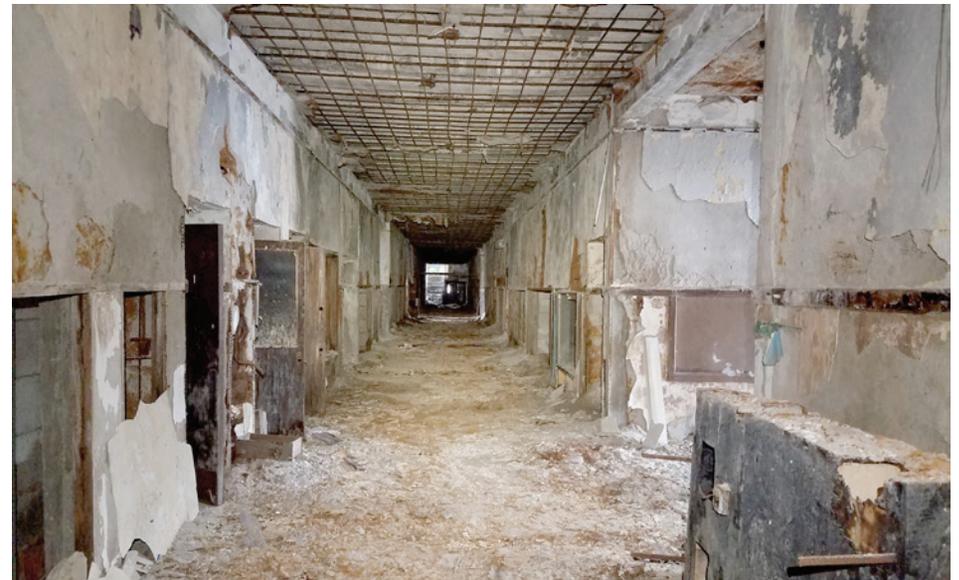
The interior has suffered from a great deal of water infiltration on both floors. The first floor main corridor shown above has had major deterioration of its plaster finishes; gypsum block non-bearing walls are also vulnerable to water.
