# 4 Hutchinson

Address: 5220 French  
 Parcel: 21040178  
 District: 4  
 SNF Area: n/a  
 Owner: City of Detroit  
 Site Area: 3.82 ac  
 Gross Floor Area: 56,700 sf  
 Floors: 2  
 Plan Type: I  
 School Type:  
 Year Built: 1916, 1923  
 Zoned: R2  
 Base Rehab Cost (est): \$879K  
 Total Rehab Cost (est): \$11.5M

## Building Overview

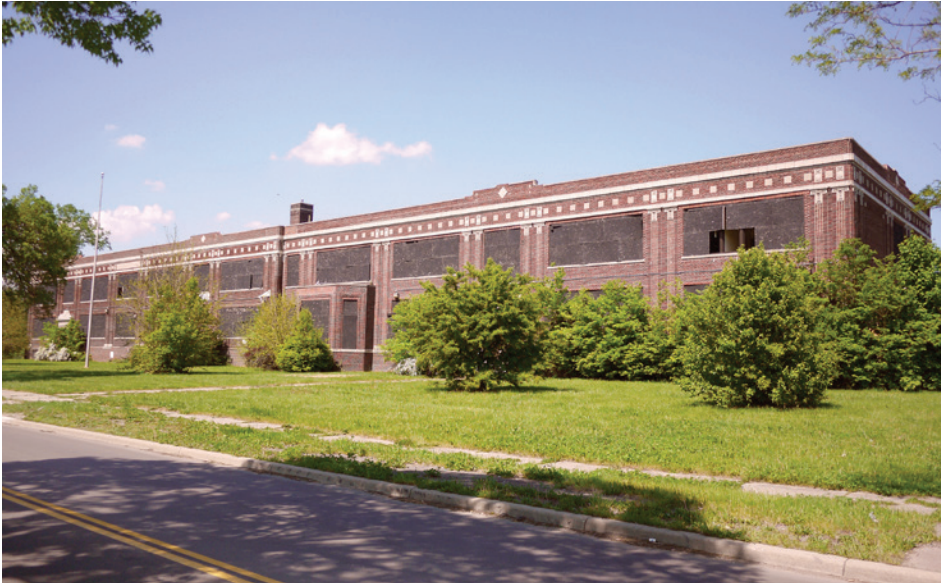
The main/west elevation, with 1923 unit in the foreground, and 1916 unit to the far left of the frame. Although the structural systems of the two wings is different and the two units have different floor heights, care was taken to preserve a unified appearance on the exterior.

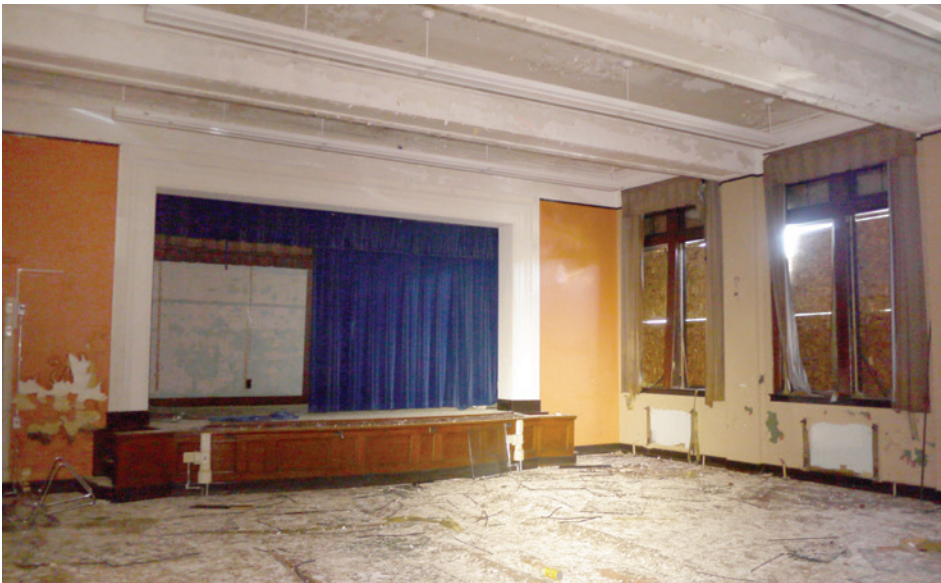
The auditorium is smaller than typical historic elementary schools, and features a miniature raised stage and a flat floor with no fixed seating.

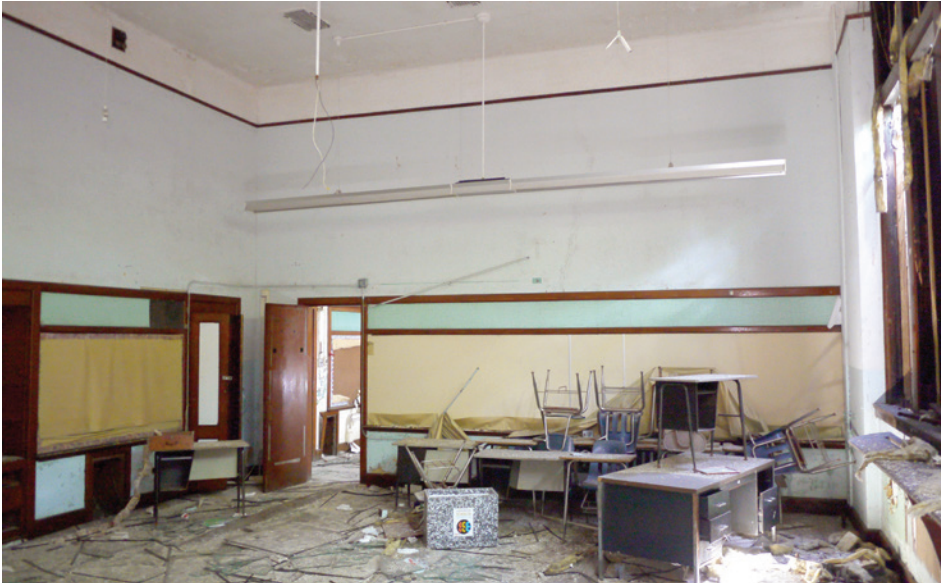
First floor classrooms in the 1923 (south) wing have 16-foot-tall ceilings, and high ceilings, giving the spaces a cavernous feel.

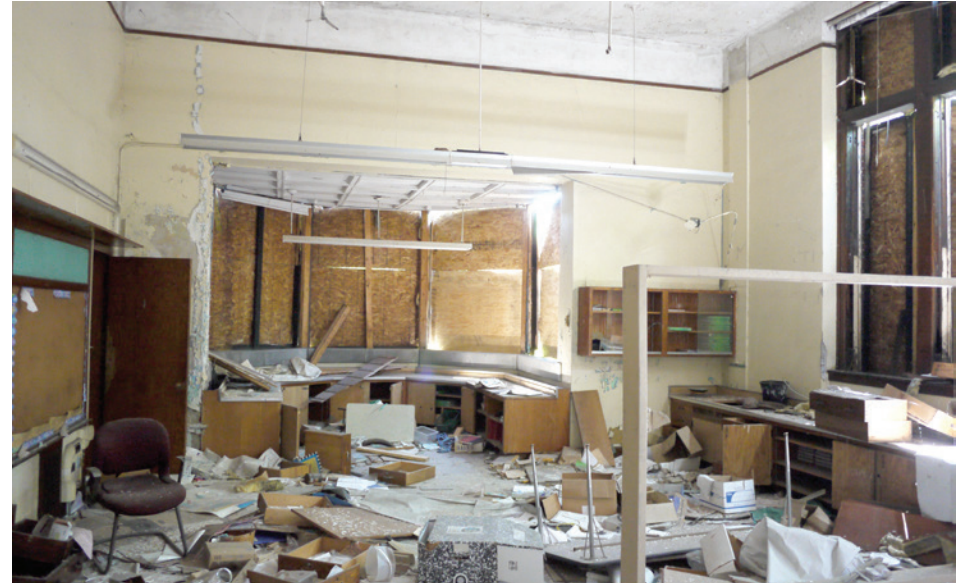
The first floor science room in the 1923 (south) wing includes a fully-enclosed conservatory and 16' tall ceilings.
