7 Weatherby

Address: 12099 Fielding
Parcel: 22103299.002
District: 7
SNF Area: n/a
Owner: City of Detroit
Site Area: 2.98 ac
Gross Floor Area: 27,400 sf
Floors: 2
Plan Type: L
School Type: Elementary
Year Built: 1956
Zoned: R1
Base Rehab Cost (est): \$428K
Total Rehab Cost (est): \$6.6M

Building Overview

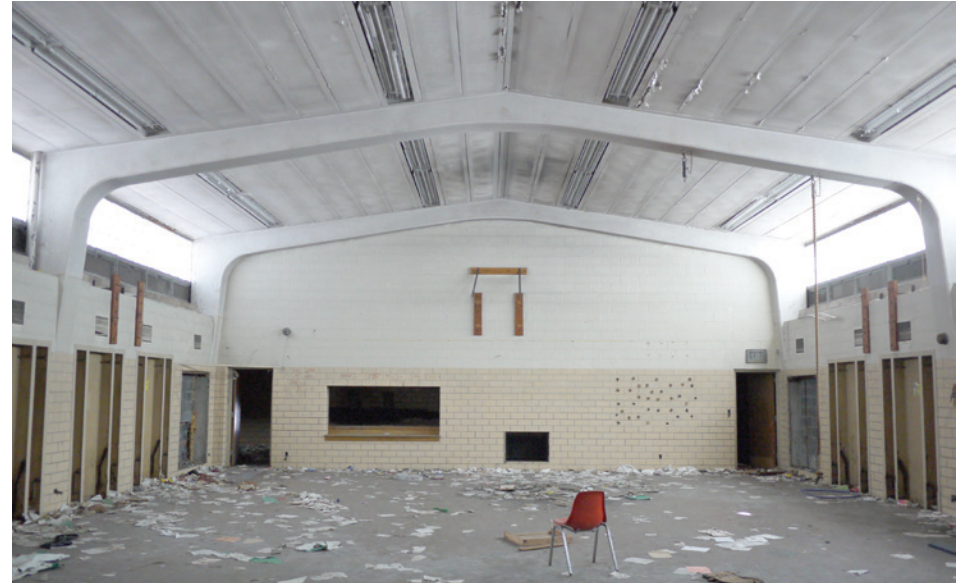
The gym is small but brightly lit, thanks to east and west-facing glass block clerestory windows. The slightly peaked ceiling makes the space feel taller and more open.

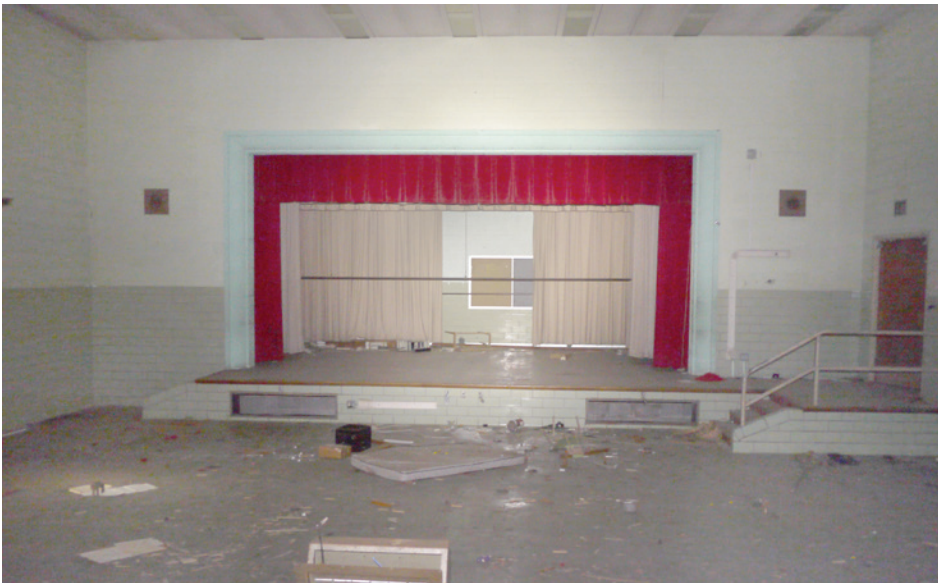
The auditorium is small, with a low stage and a flat sunken floor. The space is a simple box with painted CMU and green glazed tile matching the corridors.

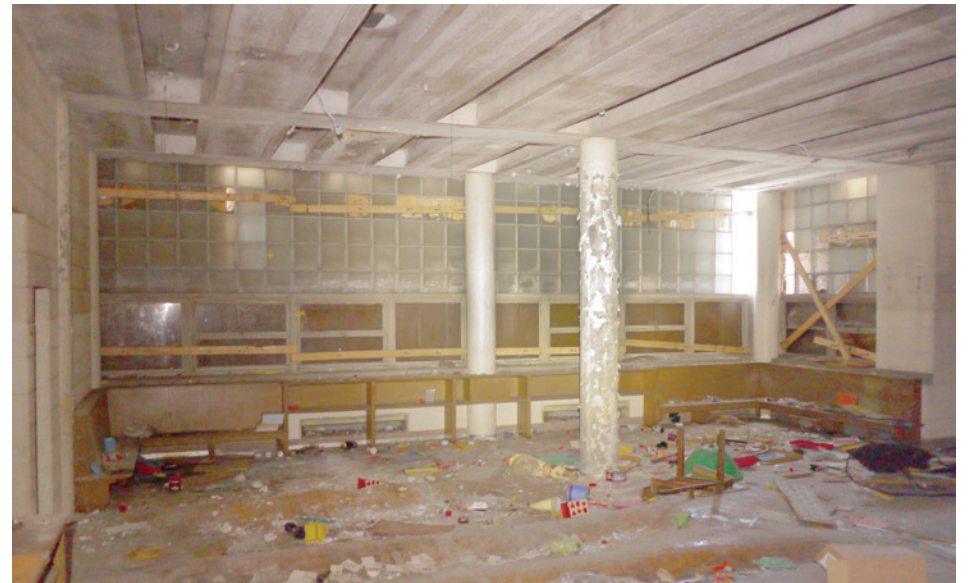
The kindergarten is a large space that features a wide bump-out with windows on three sides.

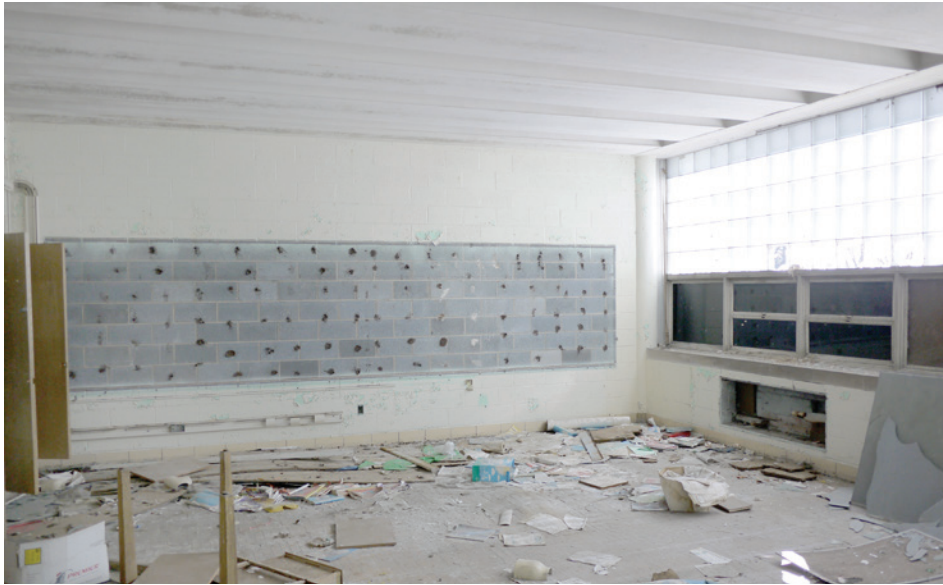
Classrooms are typical of 1950s-era schools, with concrete block construction, and wall-to-wall ribbon windows comprised of glass block over steel-framed operable lites.

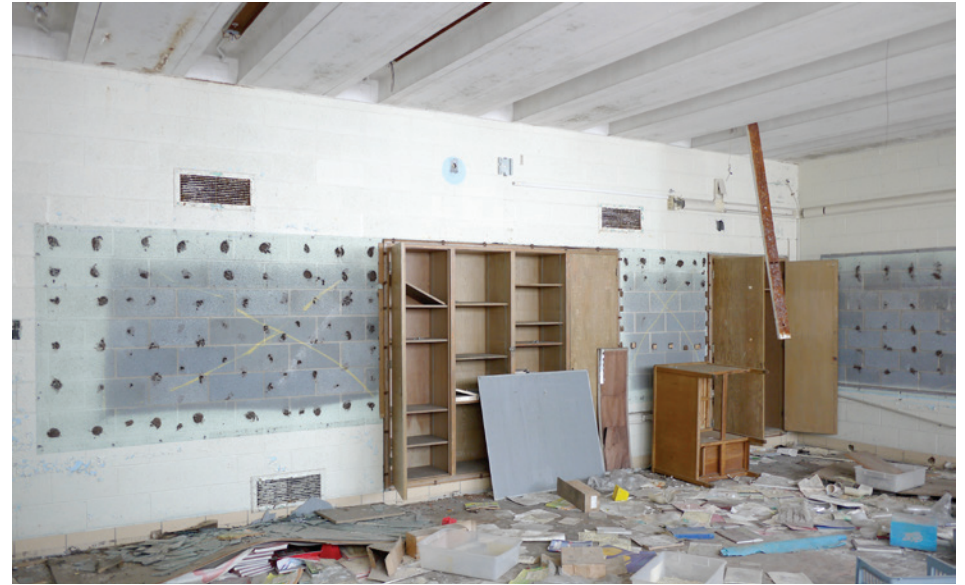
Classroom finishes are simple, including simple wood cabinetry, VCT floors, and an exposed-structure ceiling that incorporates fluorescent tube lights in between the joists.

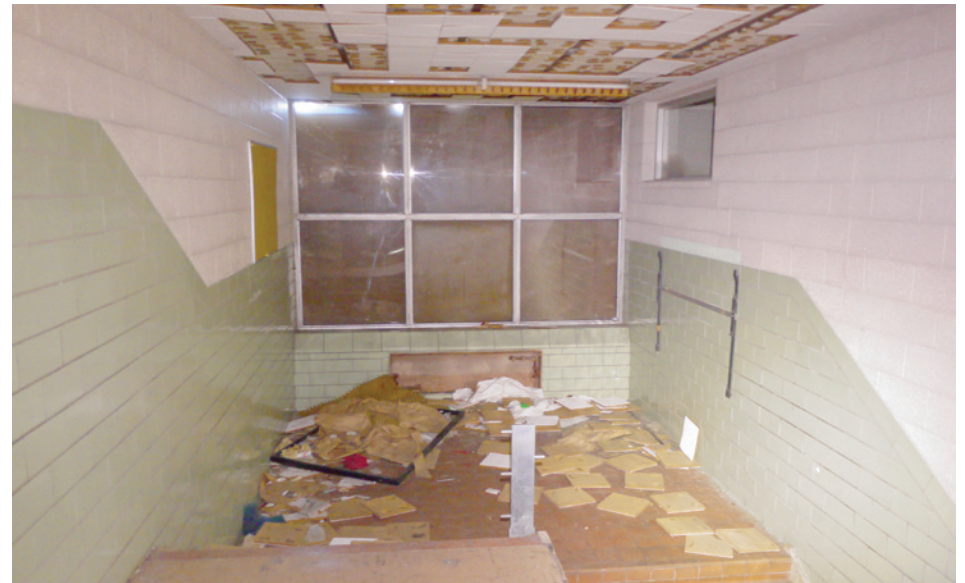
This stairwell features a spacious landing with large steel-framed windows that would have provided ample natural light and views to both first and second-floor corridors.
