# 4 Guyton

Address: 355 Philip  
 Parcel: 21059093  
 District: 4  
 SNF Area: Jefferson-Chalmers  
 Owner: City of Detroit  
 Site Area: 4.46 ac  
 Gross Floor Area: 46,100 sf  
 Floors: 2  
 Plan Type: L  
 School Type: Elementary  
 Year Built: 1922, 1925  
 Zoned: R1  
 Base Rehab Cost (est): \$1.6M  
 Total Rehab Cost (est): \$11.3M

# Building Distress

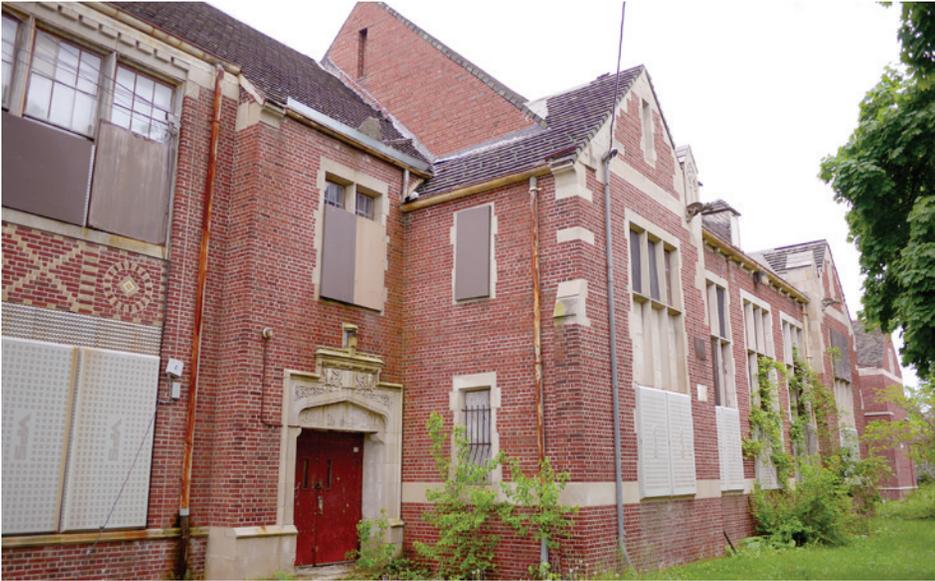
Guyton features an ornate tudor-style exterior. The front (east) elevation is shown above, with the large auditorium windows visible on the right.

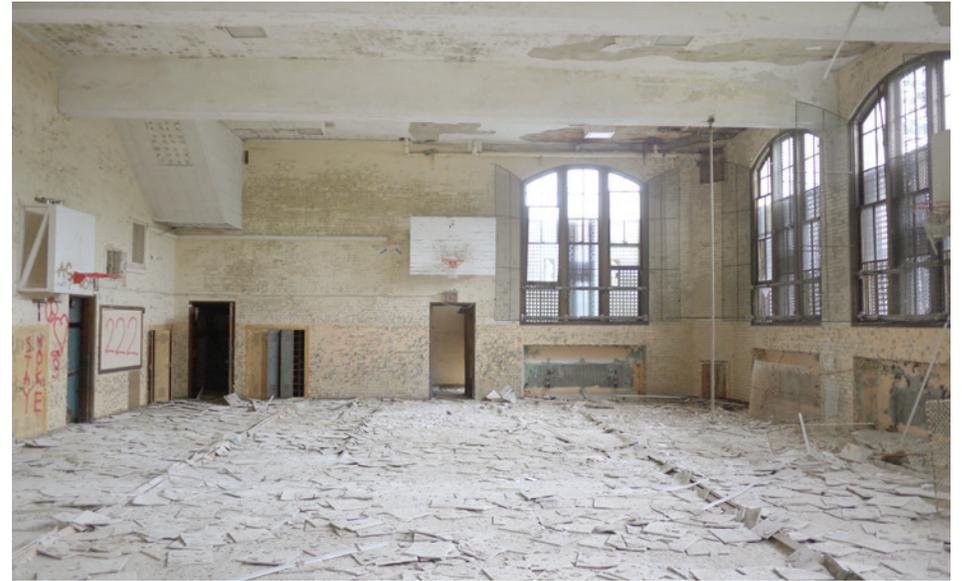
The gymnasium has large arched windows on the south, west, and north elevations that fill the space with light. The ceilings are 18'8" tall.

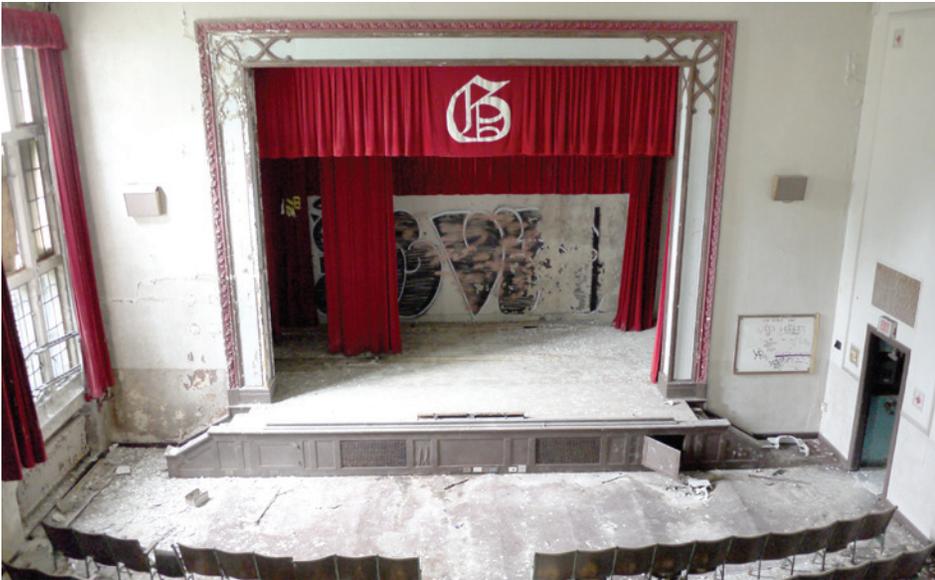
Guyton's auditorium is larger than the typical elementary school auditorium, with more than 22' high ceilings that accommodate a towering stage with ornate plaster details.
