VACANT HISTORIC SCHOOL BUILDINGS DISPOSITION PLAN

Building Envelope and Structural Assessment Report

Stephens Elementary School

Basic Property Information: COD 5-Stephens-5974 Seneca

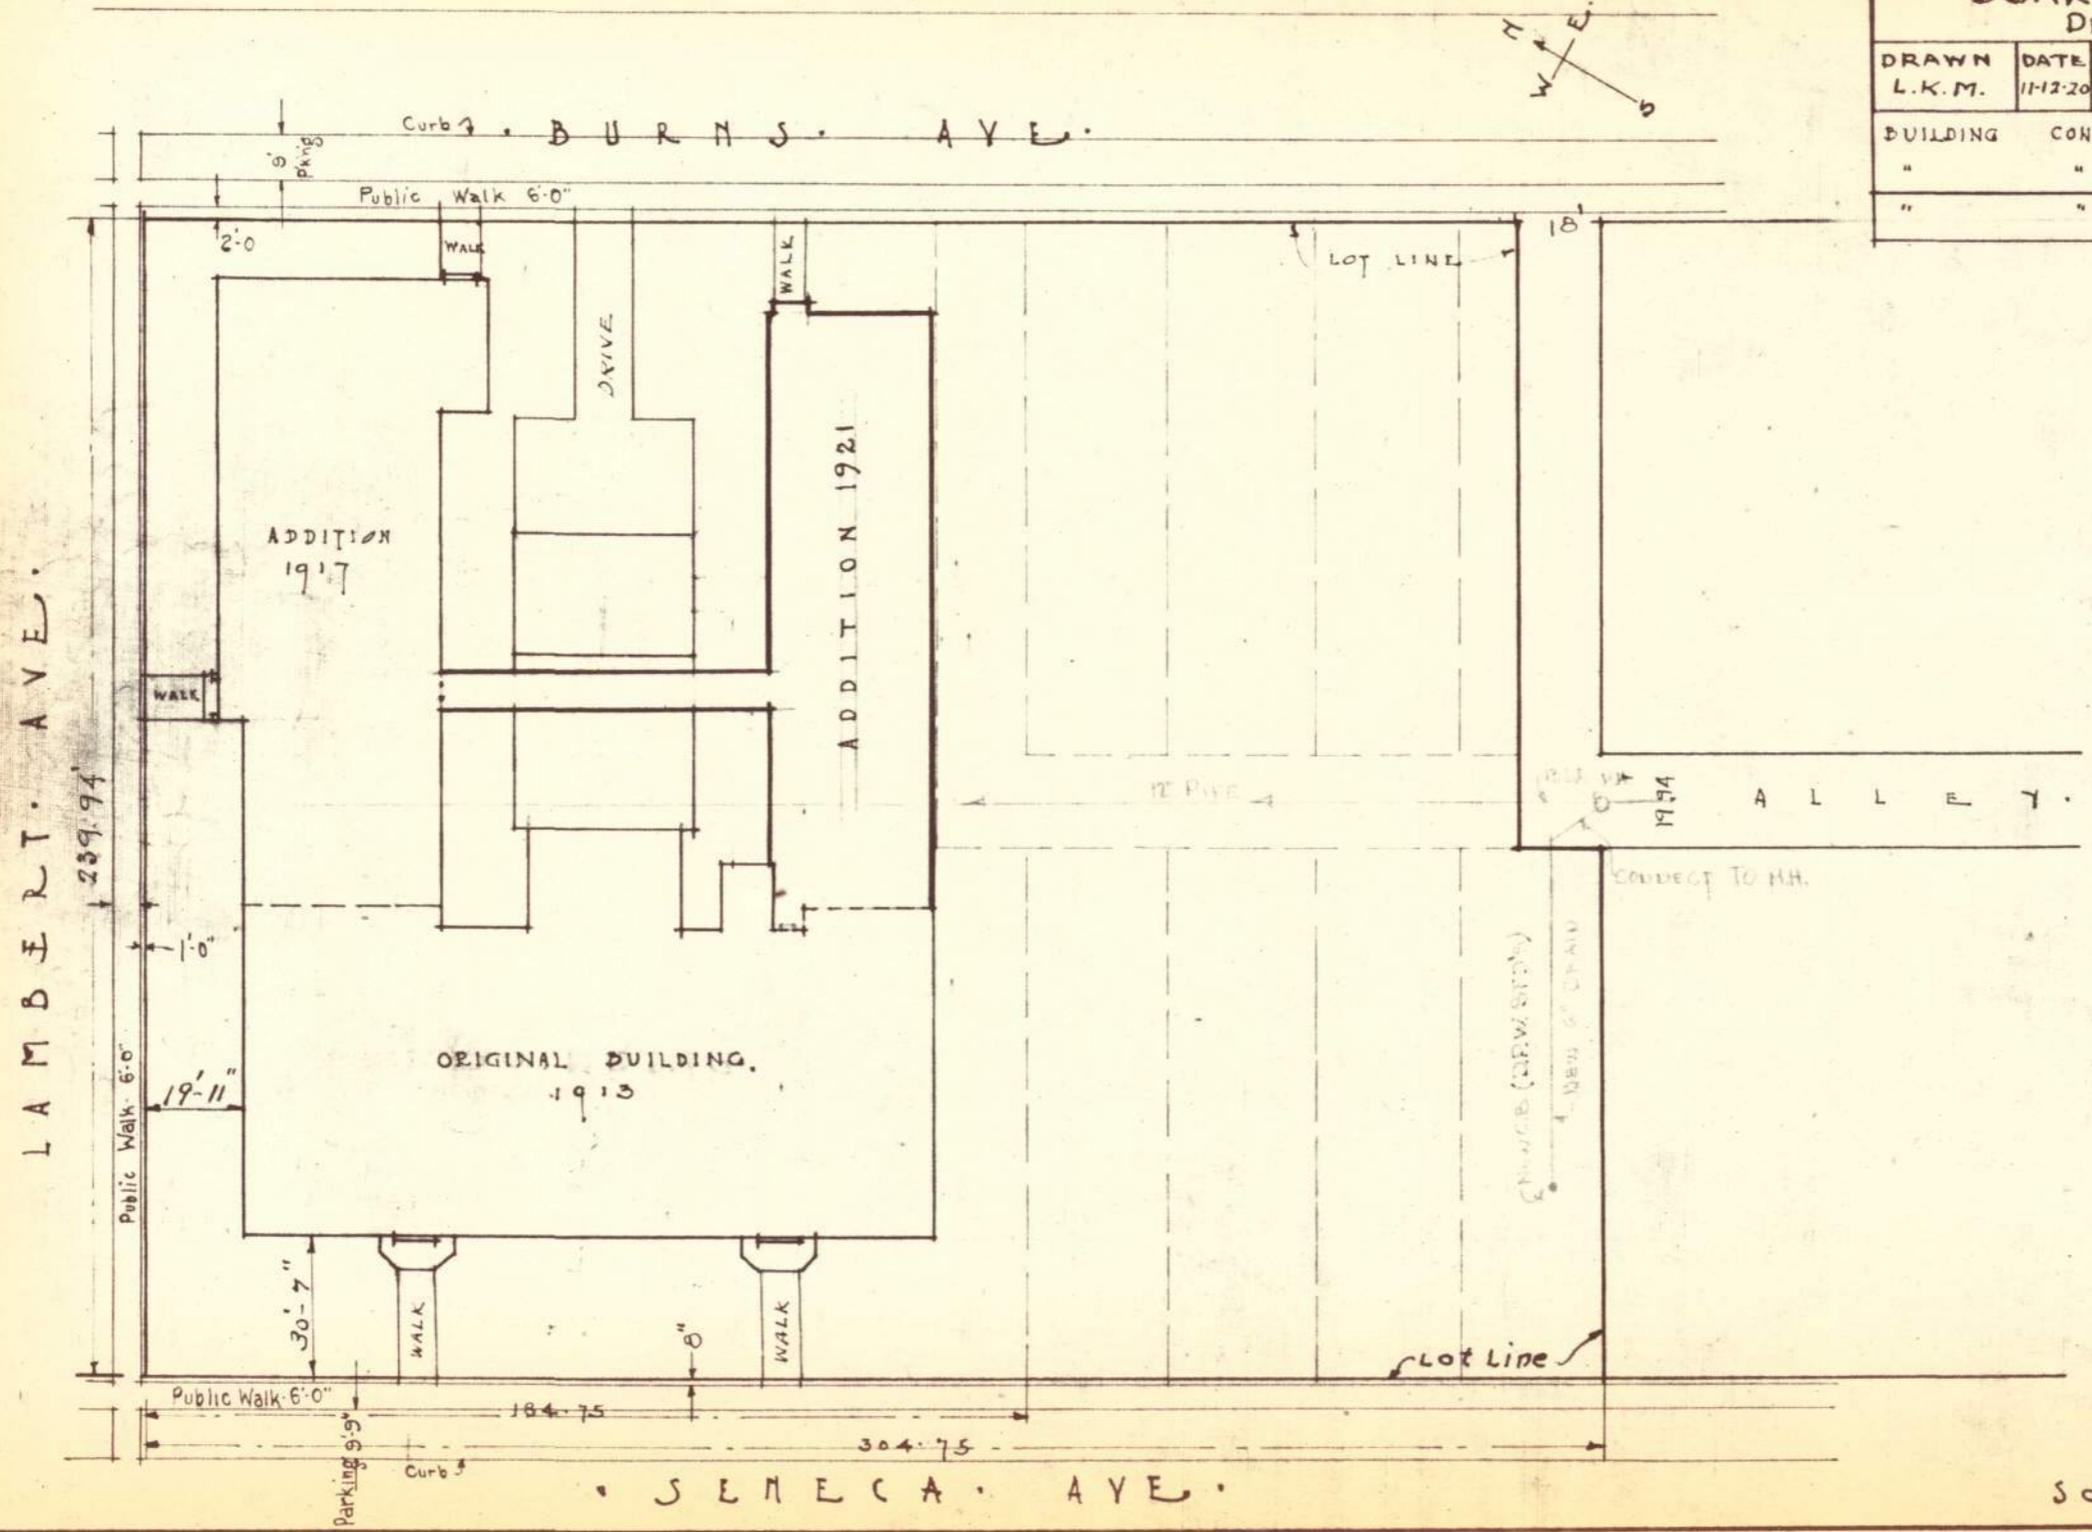
DRAWN	DATE	CHECKED	DATE	APPROVED	DATE
L.K.M.	11-12-20	Ⓔ	11-12-20		
BUILDING	CONST.	1913	BRICK WALL/	CONCR. SLAB	
"	"	1917	"	"	"
"	"	1921	"	"	"
"	"	1922	"	"	"

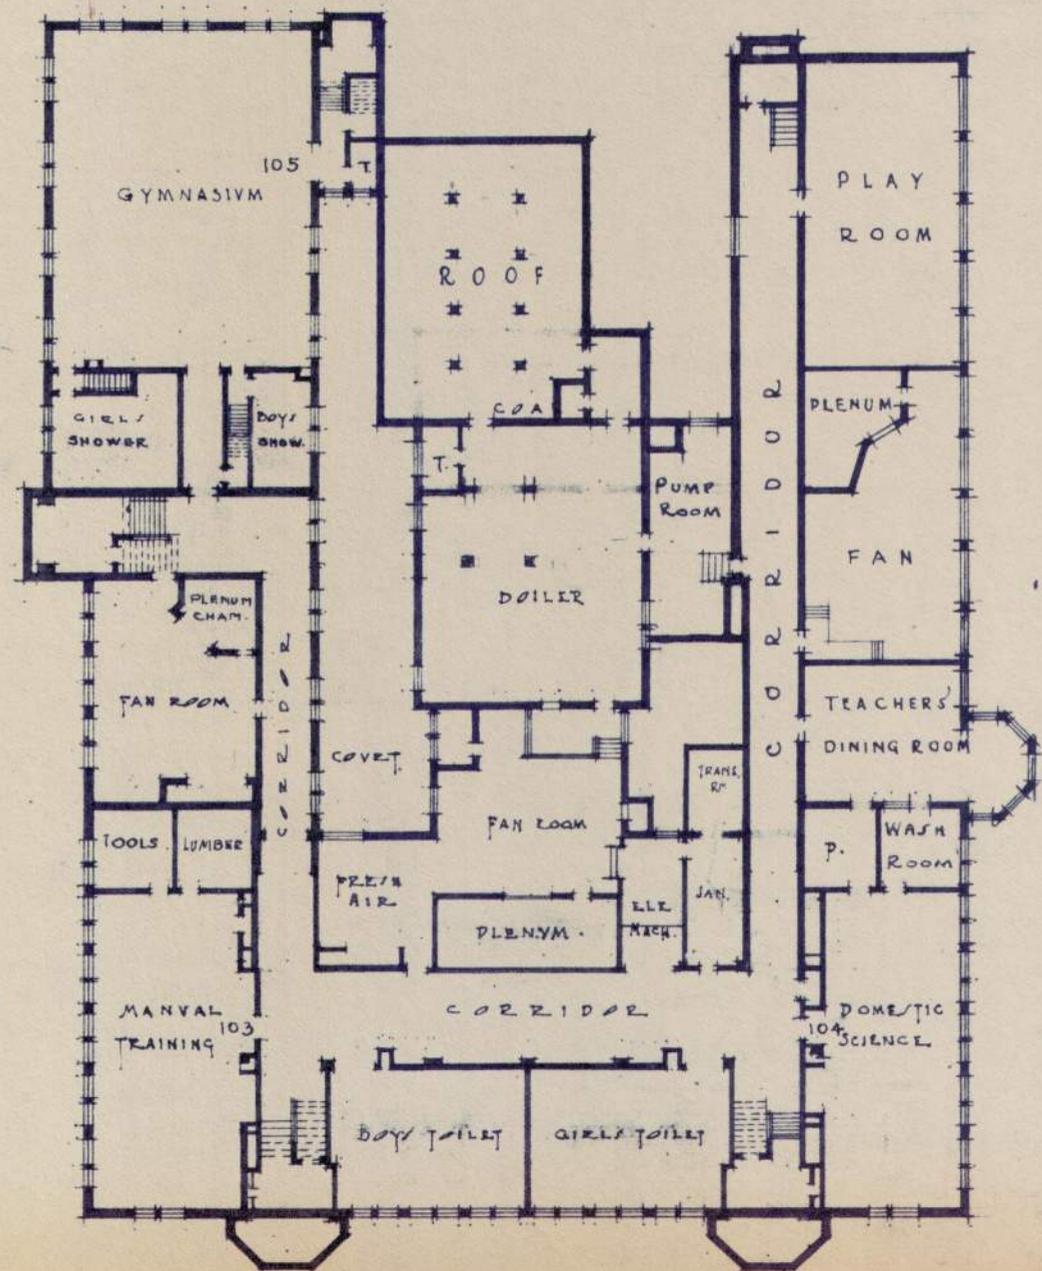
BASEMENT PLAN

STEPHENS SCHOOL
 BASEMENT FLOOR PLAN Scale $\frac{1"}{32} = 1'-0"$
 DEPT. OF ARCHITECTURAL ENGINEERING
 BOARD OF EDUCATION
 DETROIT, MICH.

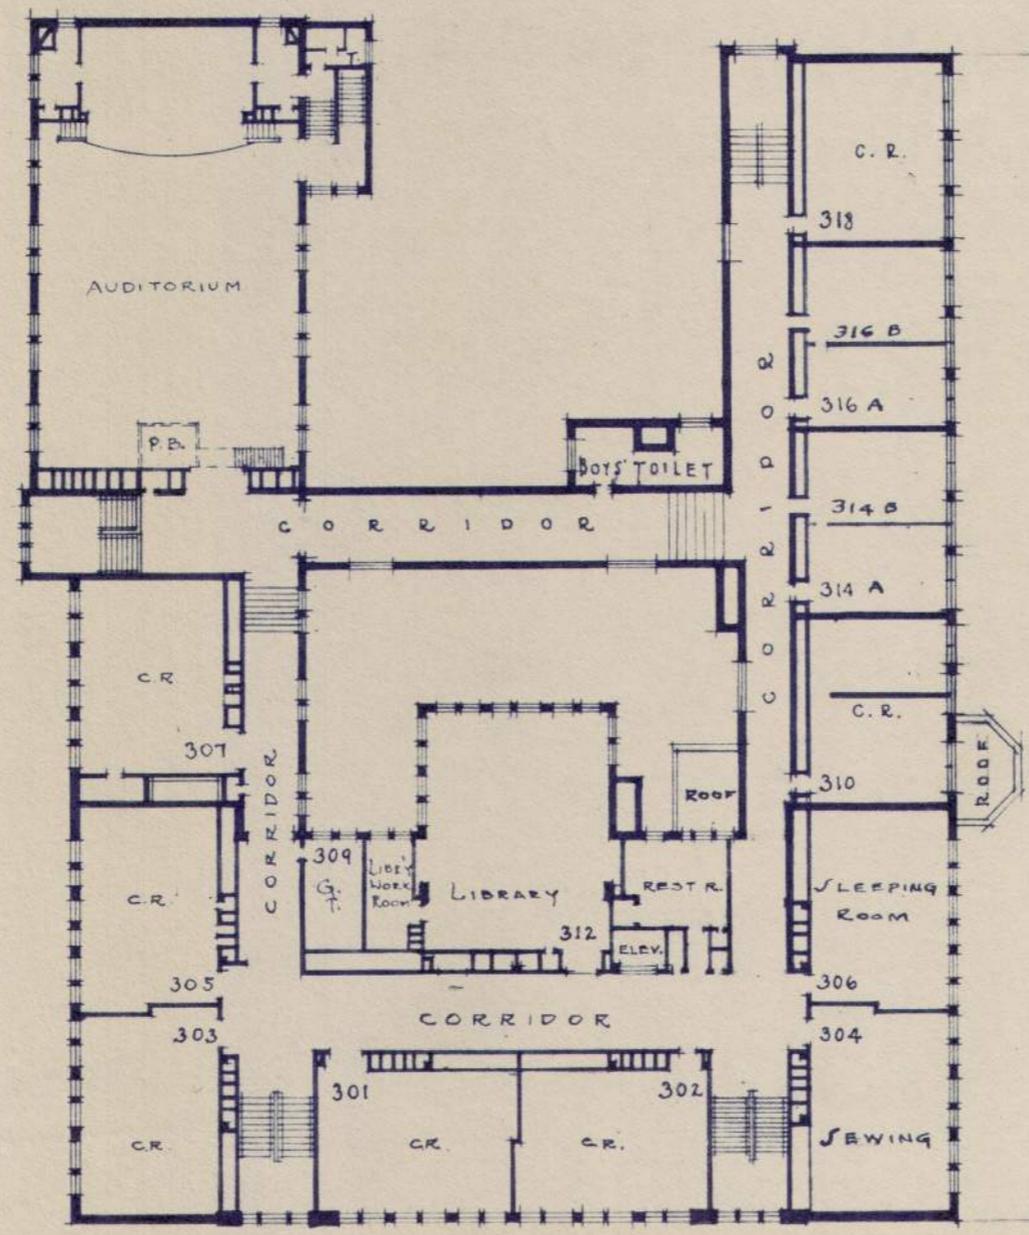
STEPHEN S. SCHOOL
 SECOND FLOOR PLAN scale $\frac{1}{32}''=1'-0''$
