VACANT HISTORIC SCHOOL BUILDINGS DISPOSITION PLAN

Building Envelope and Structural Assessment Report

Sampson Elementary School

Basic Property Information: COD 6-Sampson-6075 Begole

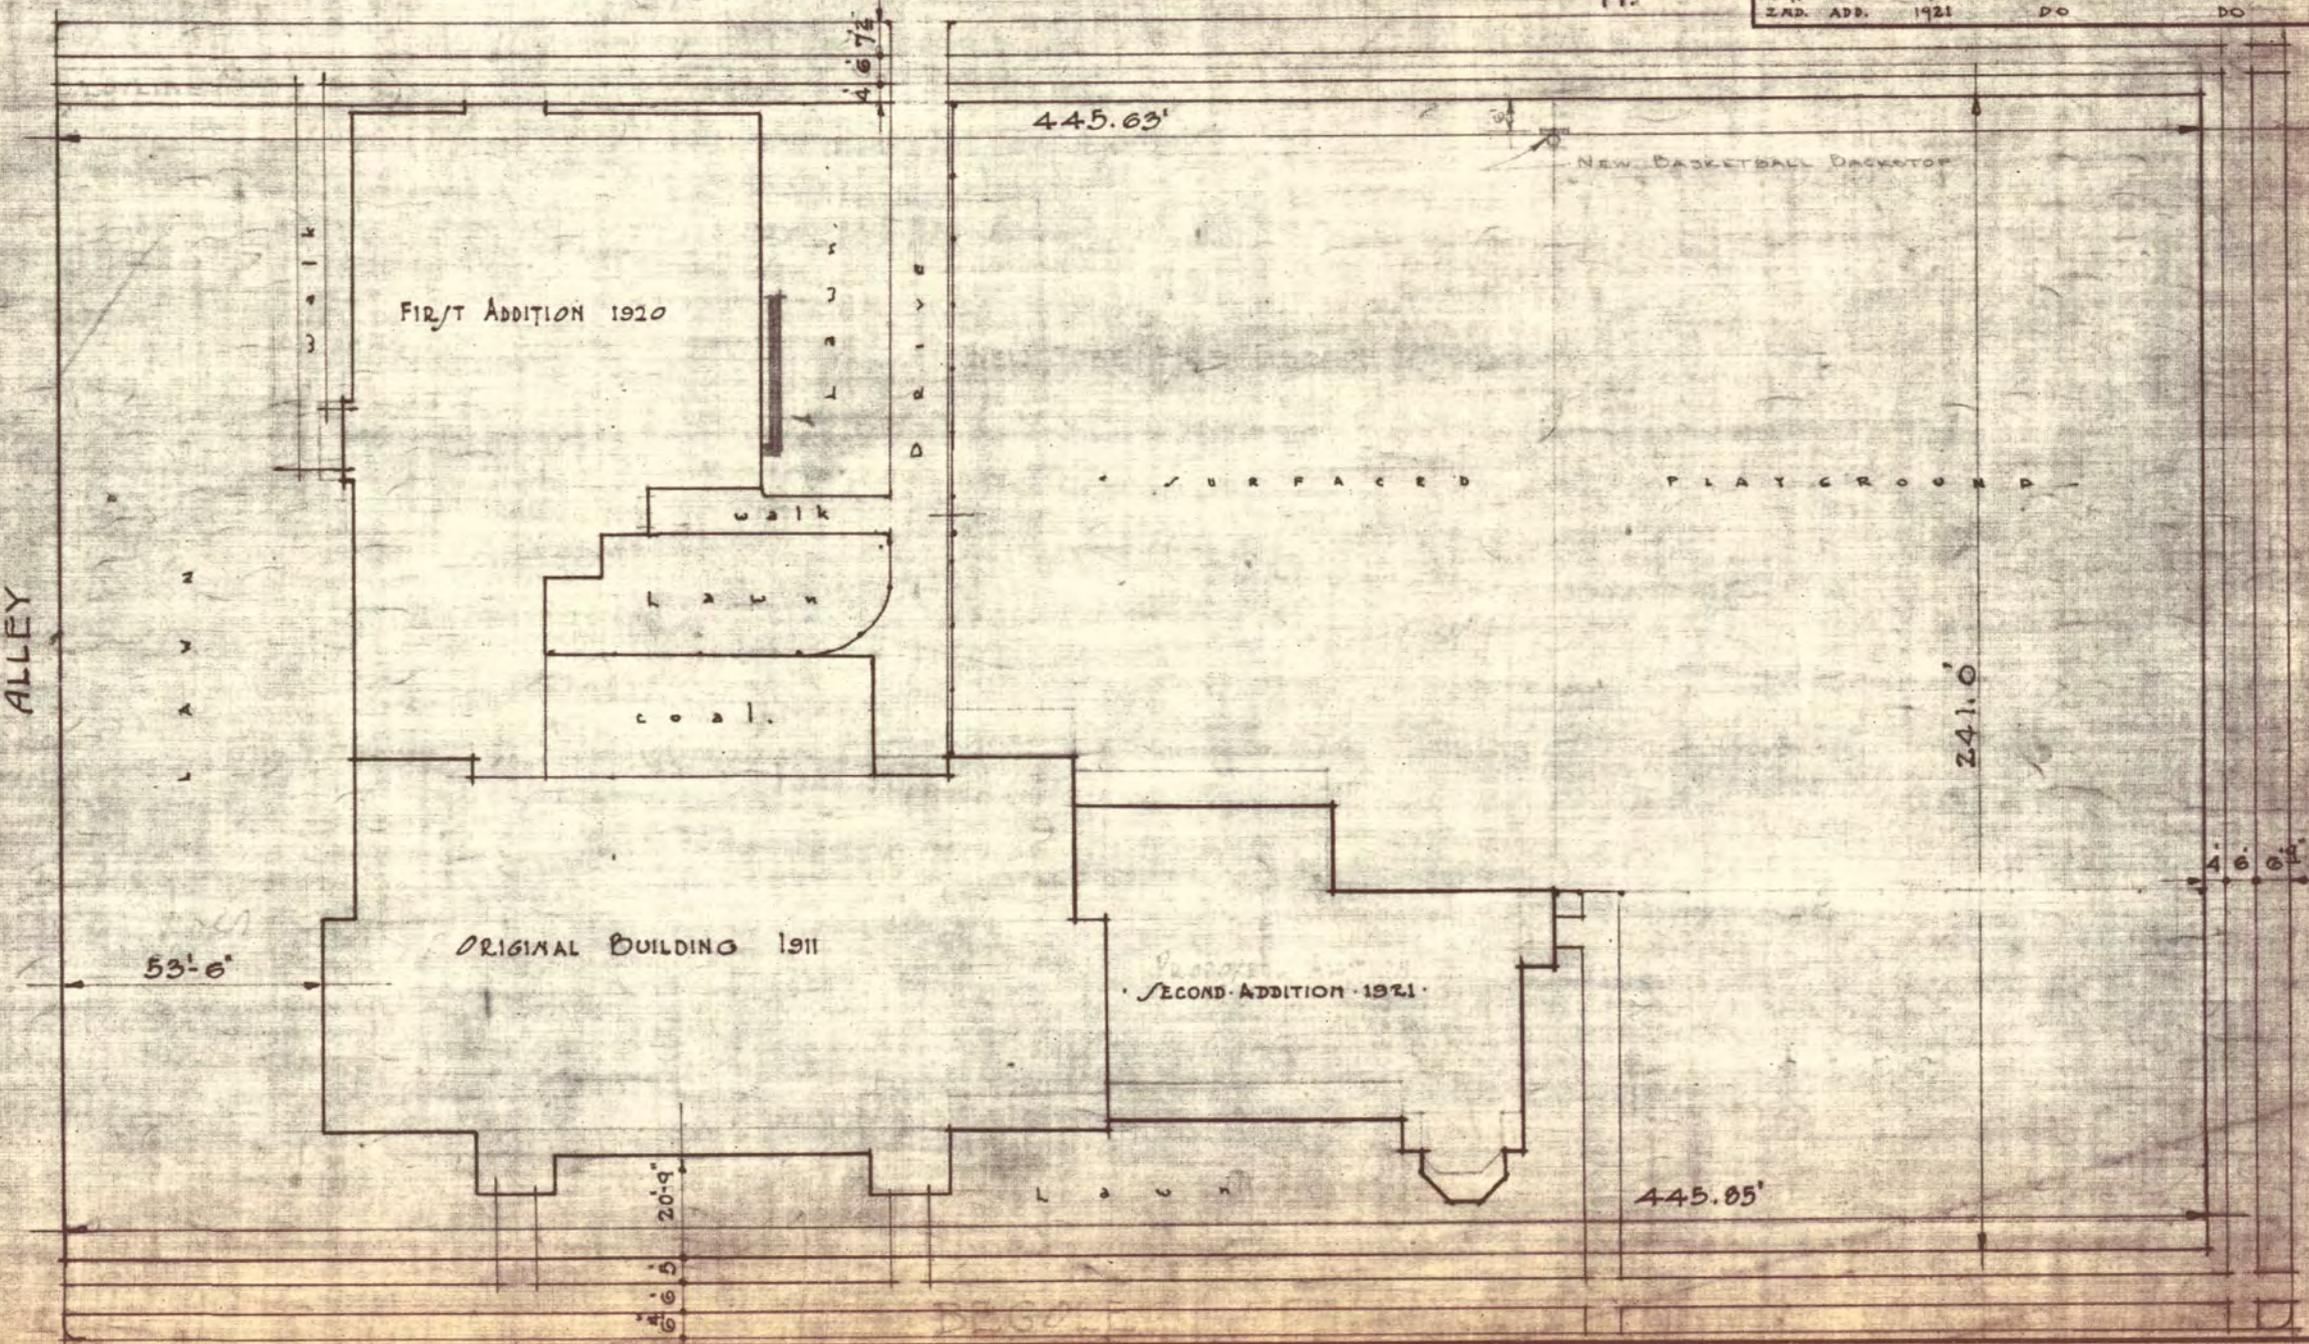
FIRST ADDITION 1920

ORIGINAL BUILDING 1911

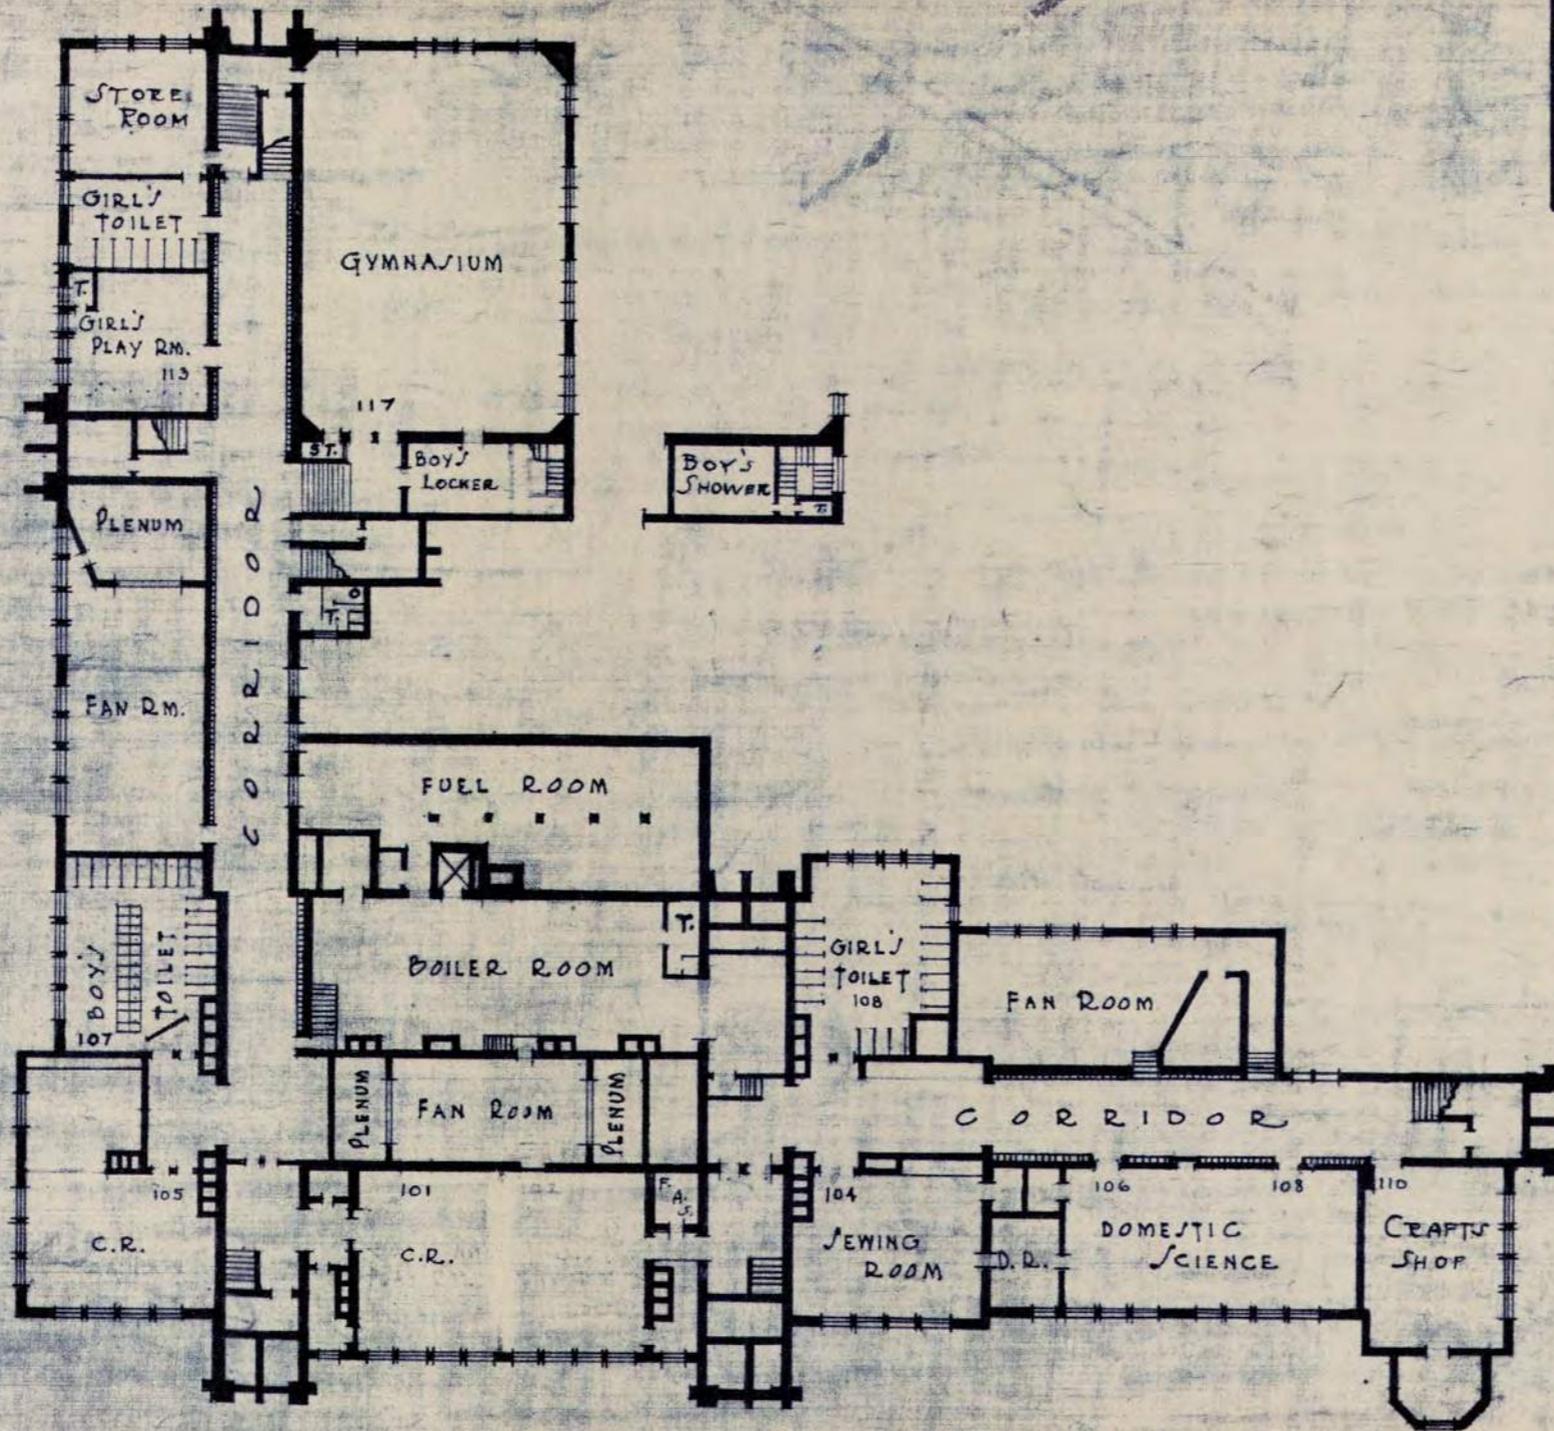
BASEMENT PLAN
 SCALE - 1/32" = 1'-0"

ORIG. BLDG.	1911	BRICK WALLS	WOOD JOIST
FIRST ADD.	1920	DO.	CONC. SLABS
SECOND ADD.	1921	DO.	DO.
