## VACANT HISTORIC SCHOOL BUILDINGS DISPOSITION PLAN

Building Envelope and Structural Assessment Report

Macomb Elementary School

### Basic Property Information: COD 4-Macomb-12051 Evanston

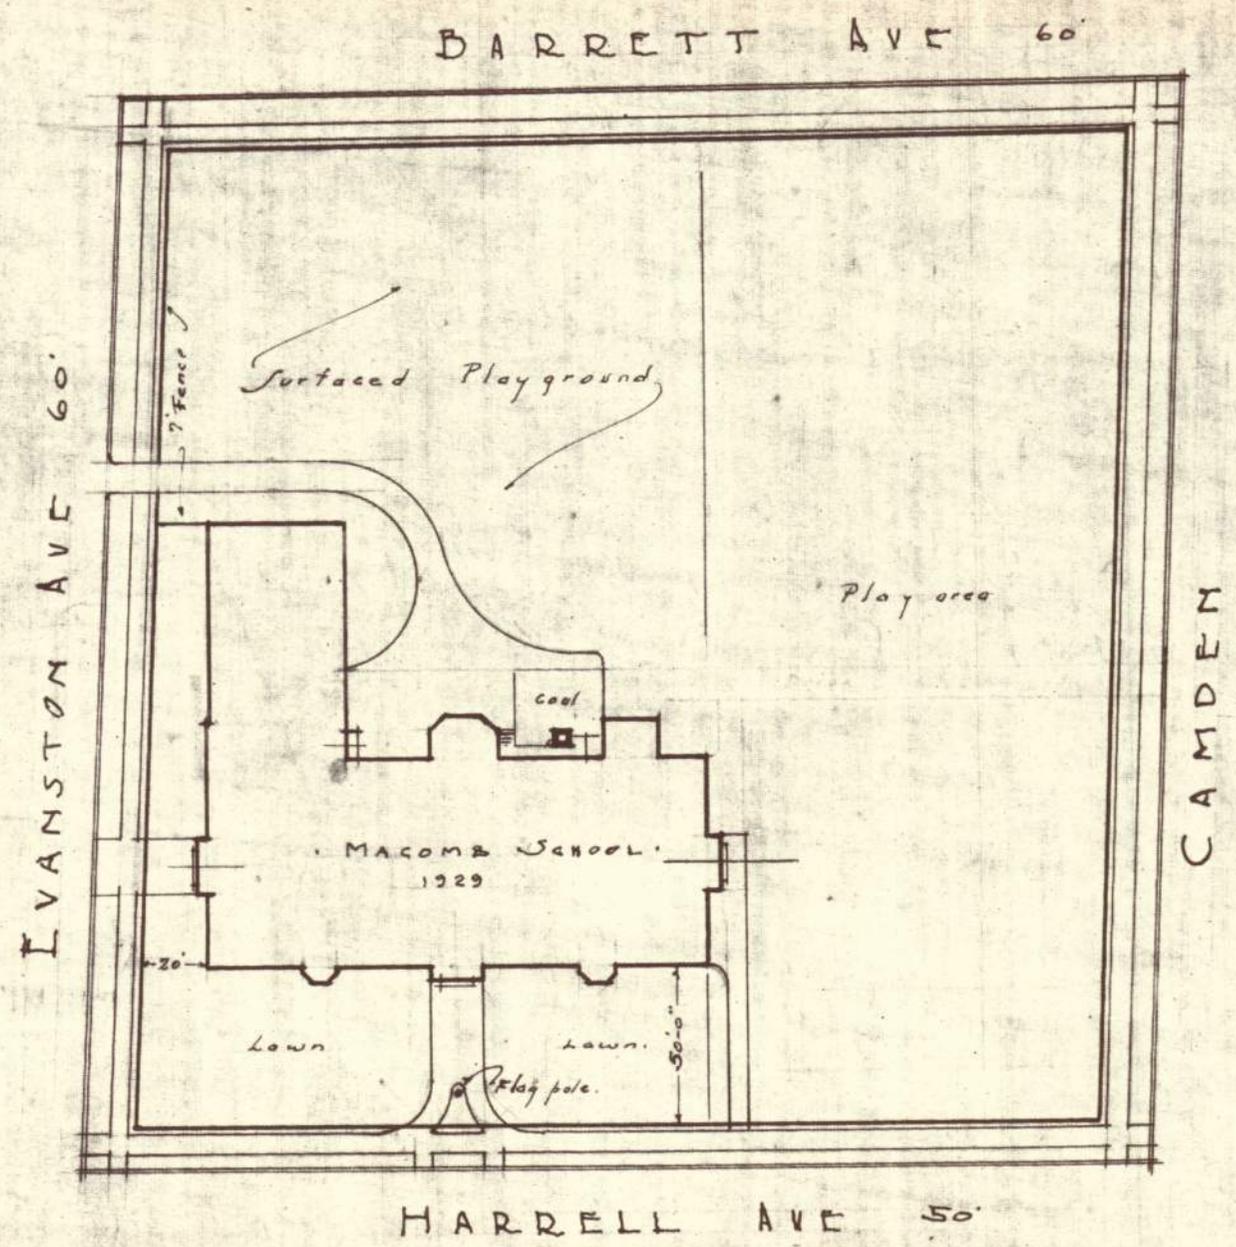
PLOT PLAN  
ALEXANDER MACOMB SCHOOL  
BOARD OF EDUCATION  
DETROIT  
Department of Building & Grounds  
Drawn by J.H. March 4, 1929.

SCALE 1" = 60'  
2.13 Acres.
