VACANT HISTORIC SCHOOL BUILDINGS DISPOSITION PLAN

Building Envelope and Structural Assessment Report

Arthur Middle School

Basic Property Information: COD 4-Arthur-10125 King Richard

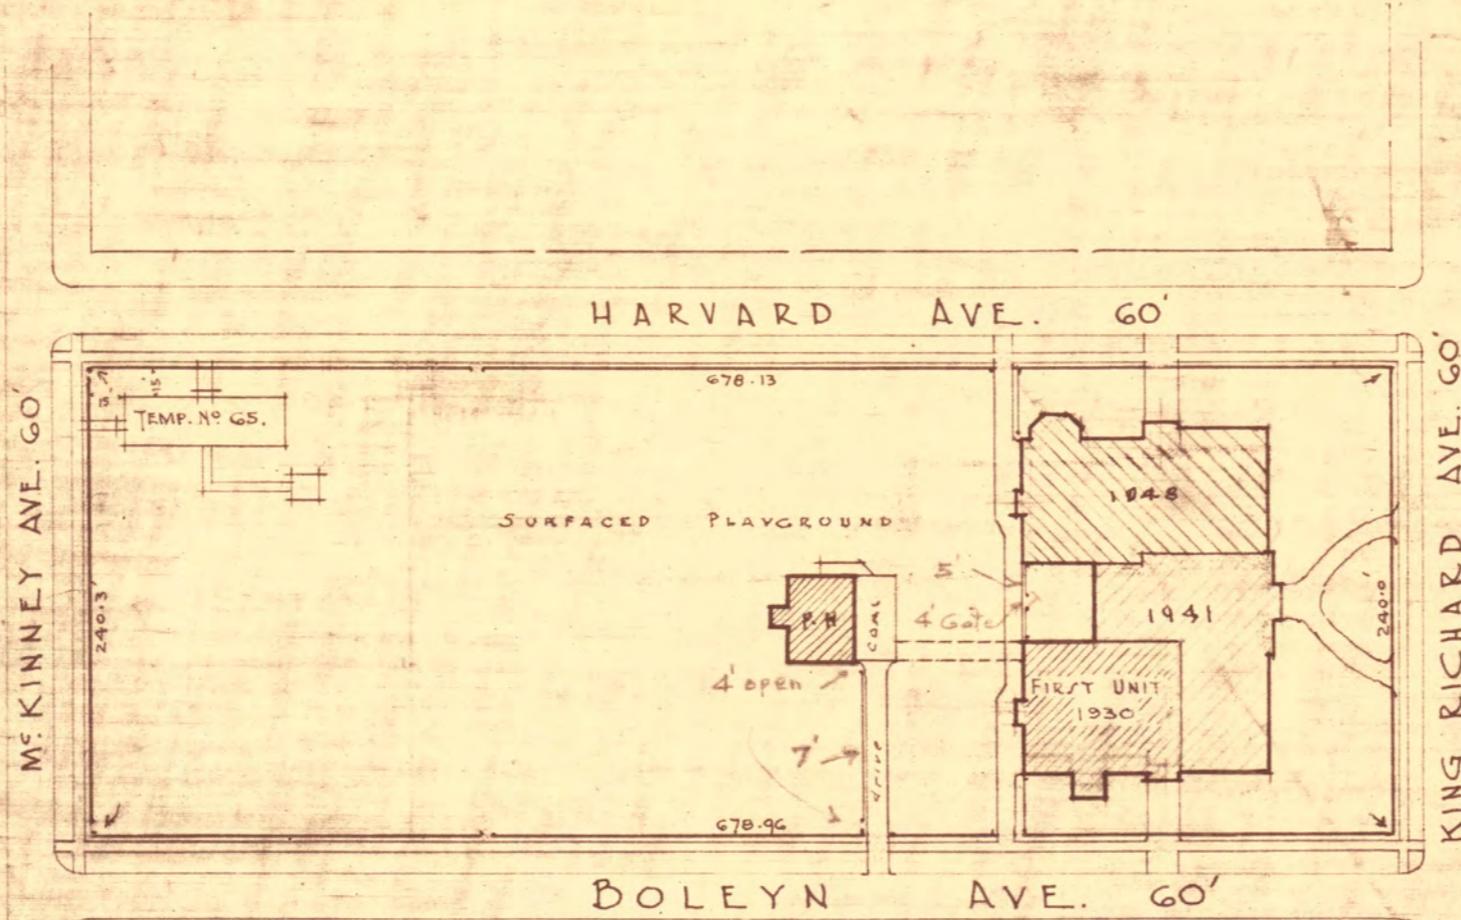
PLOT PLAN
 CLARA B. ARTHUR SCHOOL
 BOARD of EDUCATION
 CITY of DETROIT.
 Dept of Building & Grounds
 Drawn by H. [Signature] Sept. 27/30
 Revised by H. [Signature] Feb. 1948

Scale 1" equals 100'

APX 80' - 7' Fence
2 END POSTS

40' - 5' Fence
 2 END POSTS
 2 GATE
 1 4' GATE
