## VACANT HISTORIC SCHOOL BUILDINGS DISPOSITION PLAN

### Building Envelope and Structural Assessment Report

#### Chandler Elementary School

#### Basic Property Information: COD 5-Chandler-9227 Chapin

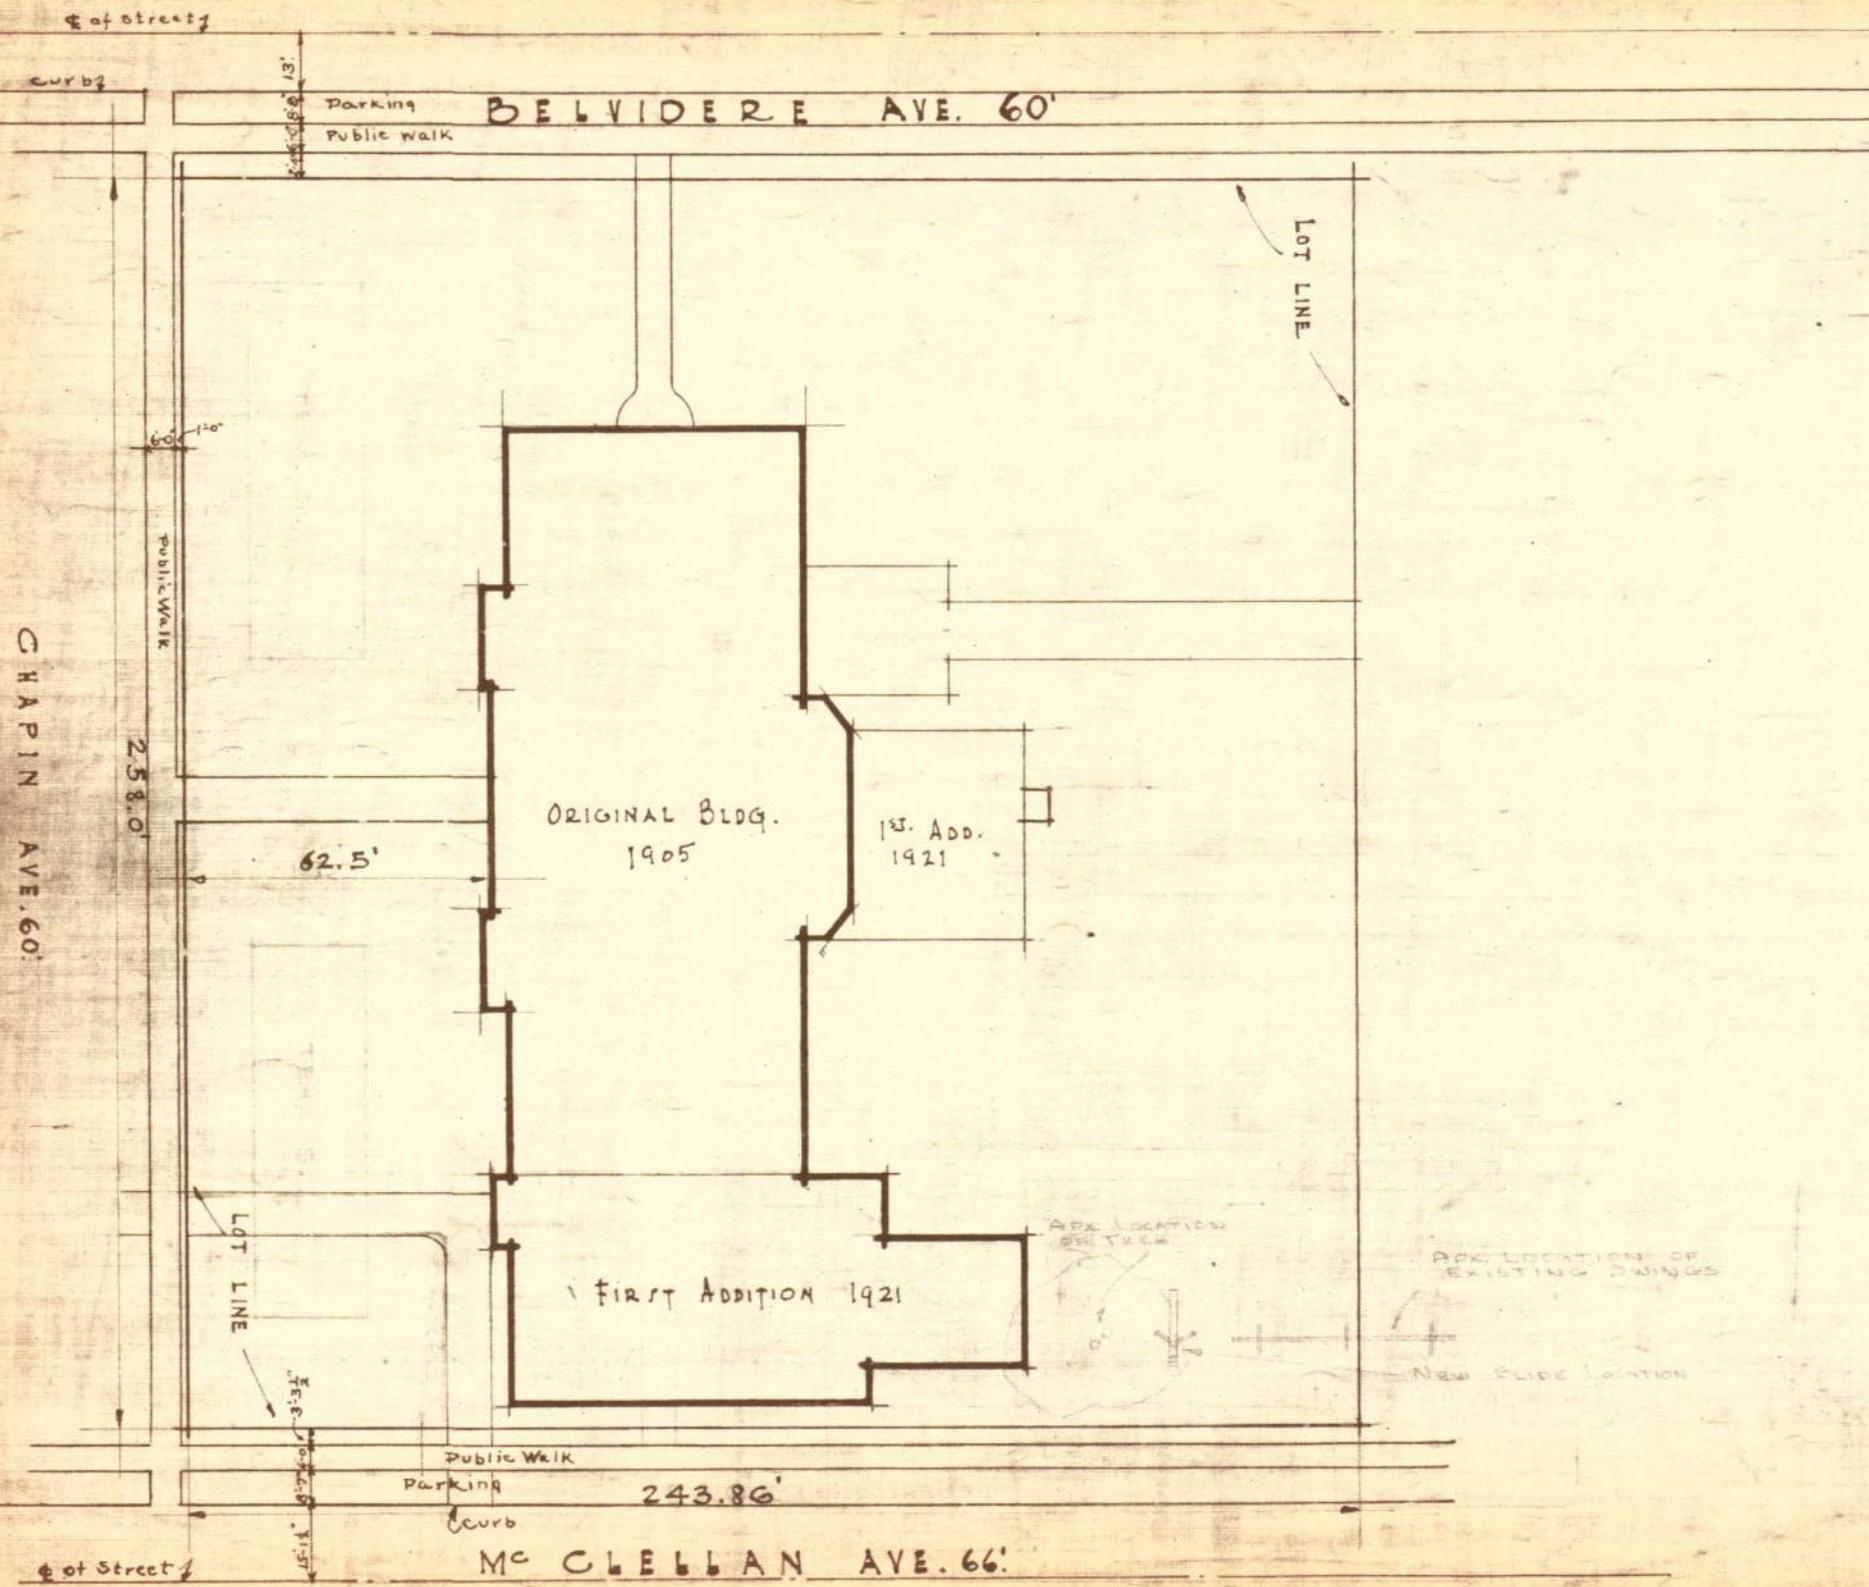
Z. CHANDLER SCHOOL  
 BASEMENT PLAN  
 SCALE  $\frac{1}{32} = 1'-0"$

BUILDING CONSTR.	1905	1921
FIRST ADDITION		BRICK WALLS WOOD FLOORS BRICK WALLS - CONC. SLAB

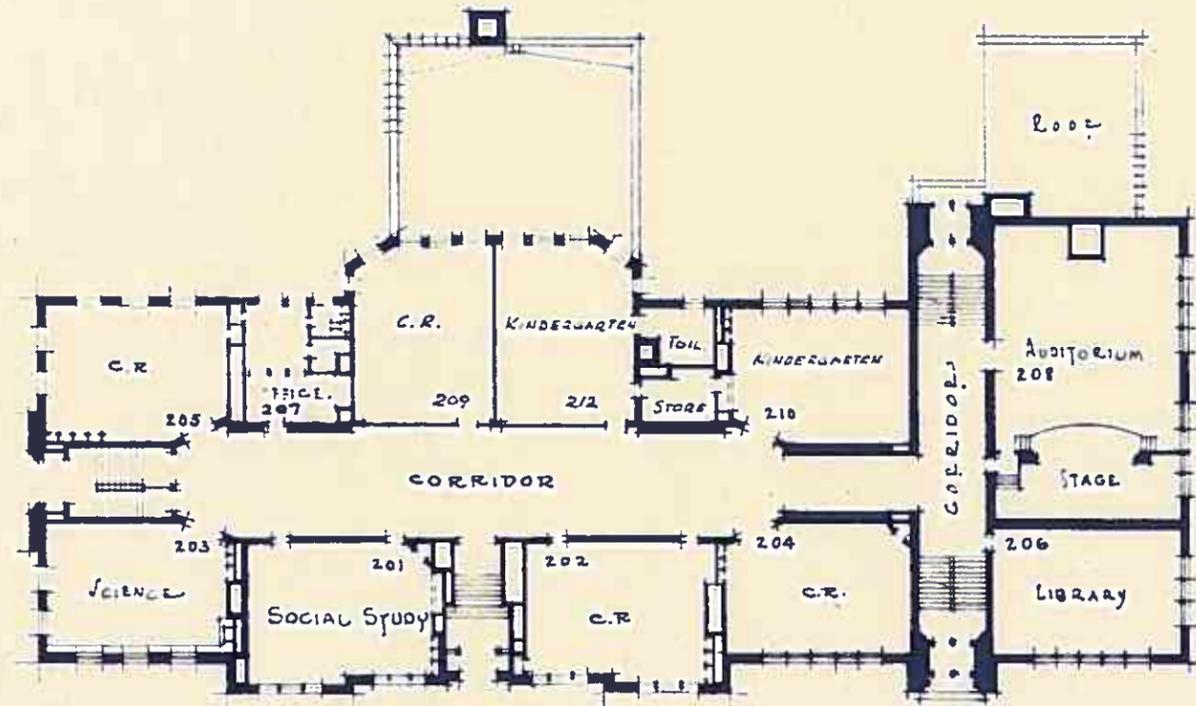
**FIRST FLOOR PLAN**  
 scale  $\frac{3}{32}'' = 1'-0''$

DRAWN	DATE	TRACED	DATE	CHECKED	DATE
•••	12-31-20	•••	12-31-20		
BUILDING CONSTR.		1905	BRICK WALLS		WOOD FLOORS
