## VACANT HISTORIC SCHOOL BUILDINGS DISPOSITION PLAN

City of Detroit RFP# 19BW2717

Building Envelope and Structural Assessment Report

Higginbotham/Commerce High School

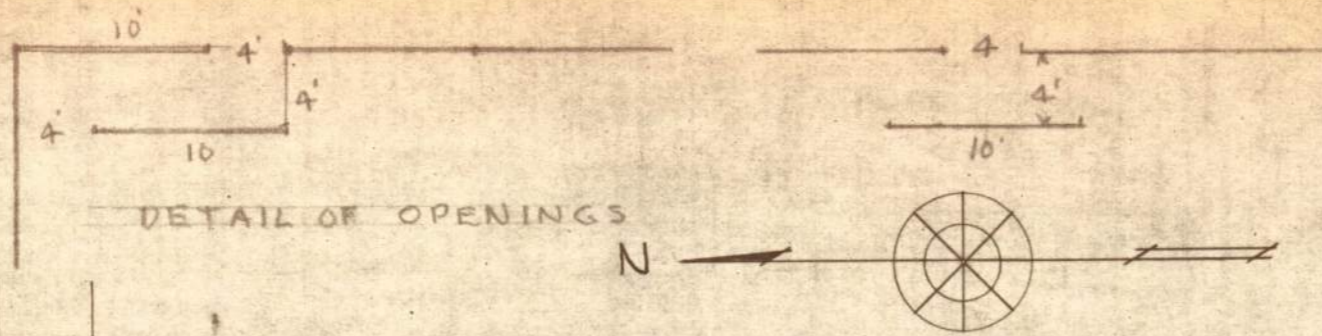
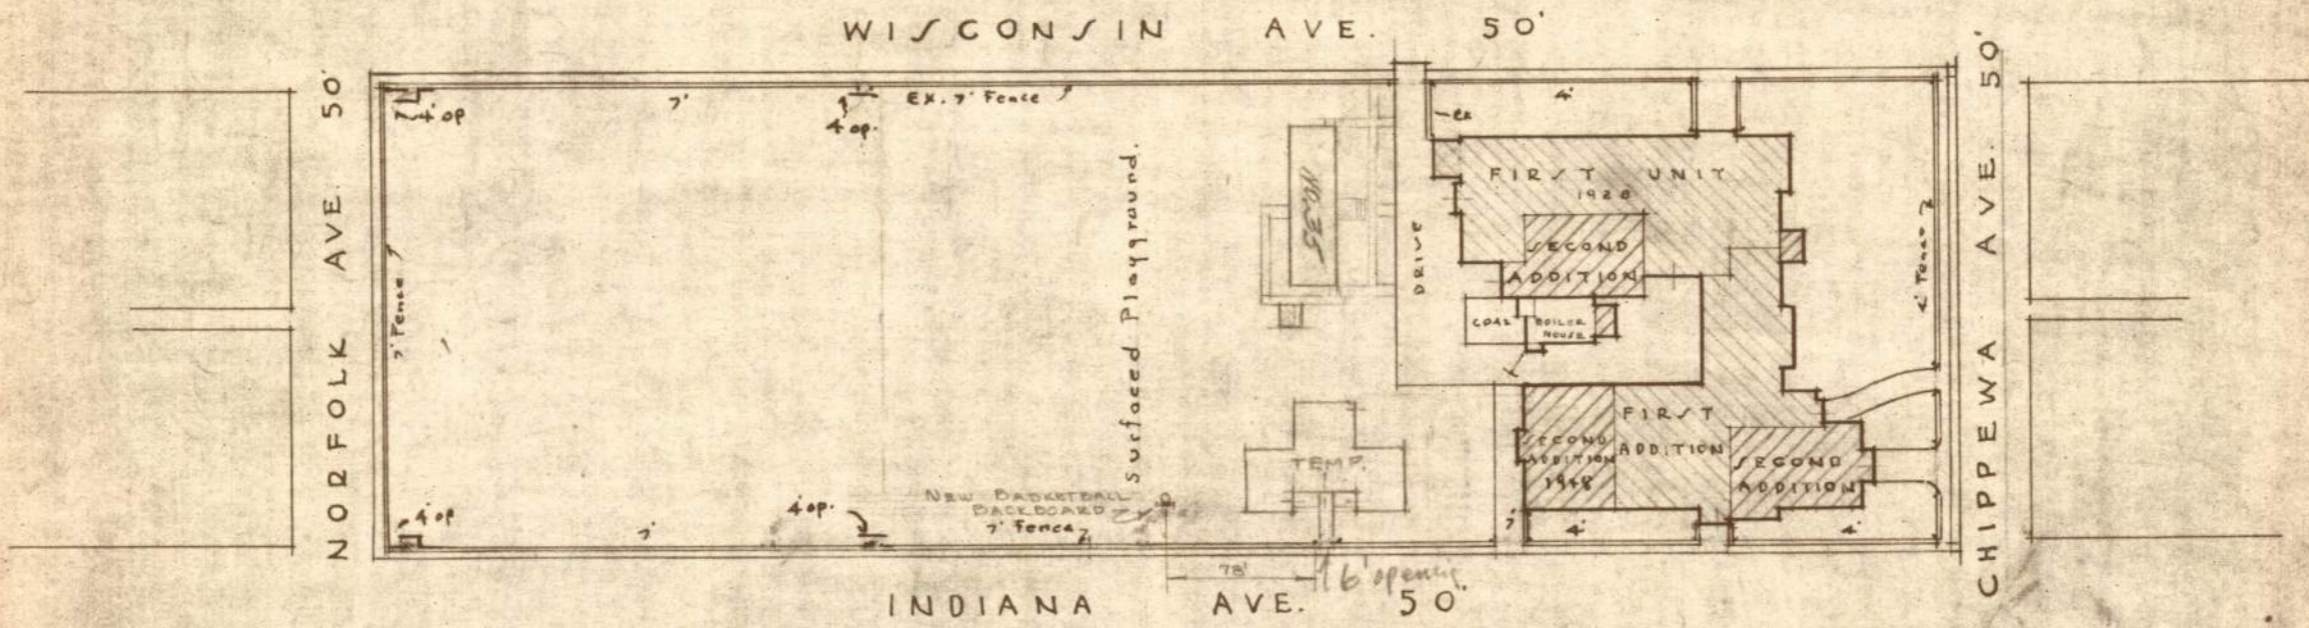
PLOT PLAN  
 HIGGINBOTHAM SCHOOL  
 BOARD of EDUCATION  
 DETROIT, MICHIGAN  
 DEPARTMENT OF BUILDING PLANNING  
 DRAWN BY G.H.M.  
 Revised by S.H. Feb. 1948

SCALE 1" = 100'

4.54 ACRES

APX. 1128' - 7' Fence  
 16 End Posts  
 6 Cor. "

APX. 740' - 4' Fence  
 8 End Posts  
 6 Cor. "
