VACANT HISTORIC SCHOOL BUILDINGS DISPOSITION PLAN

Building Envelope and Structural Assessment Report

New Middle School/AFPA East

Basic Property Information: COD 3-New-17142 Rowe

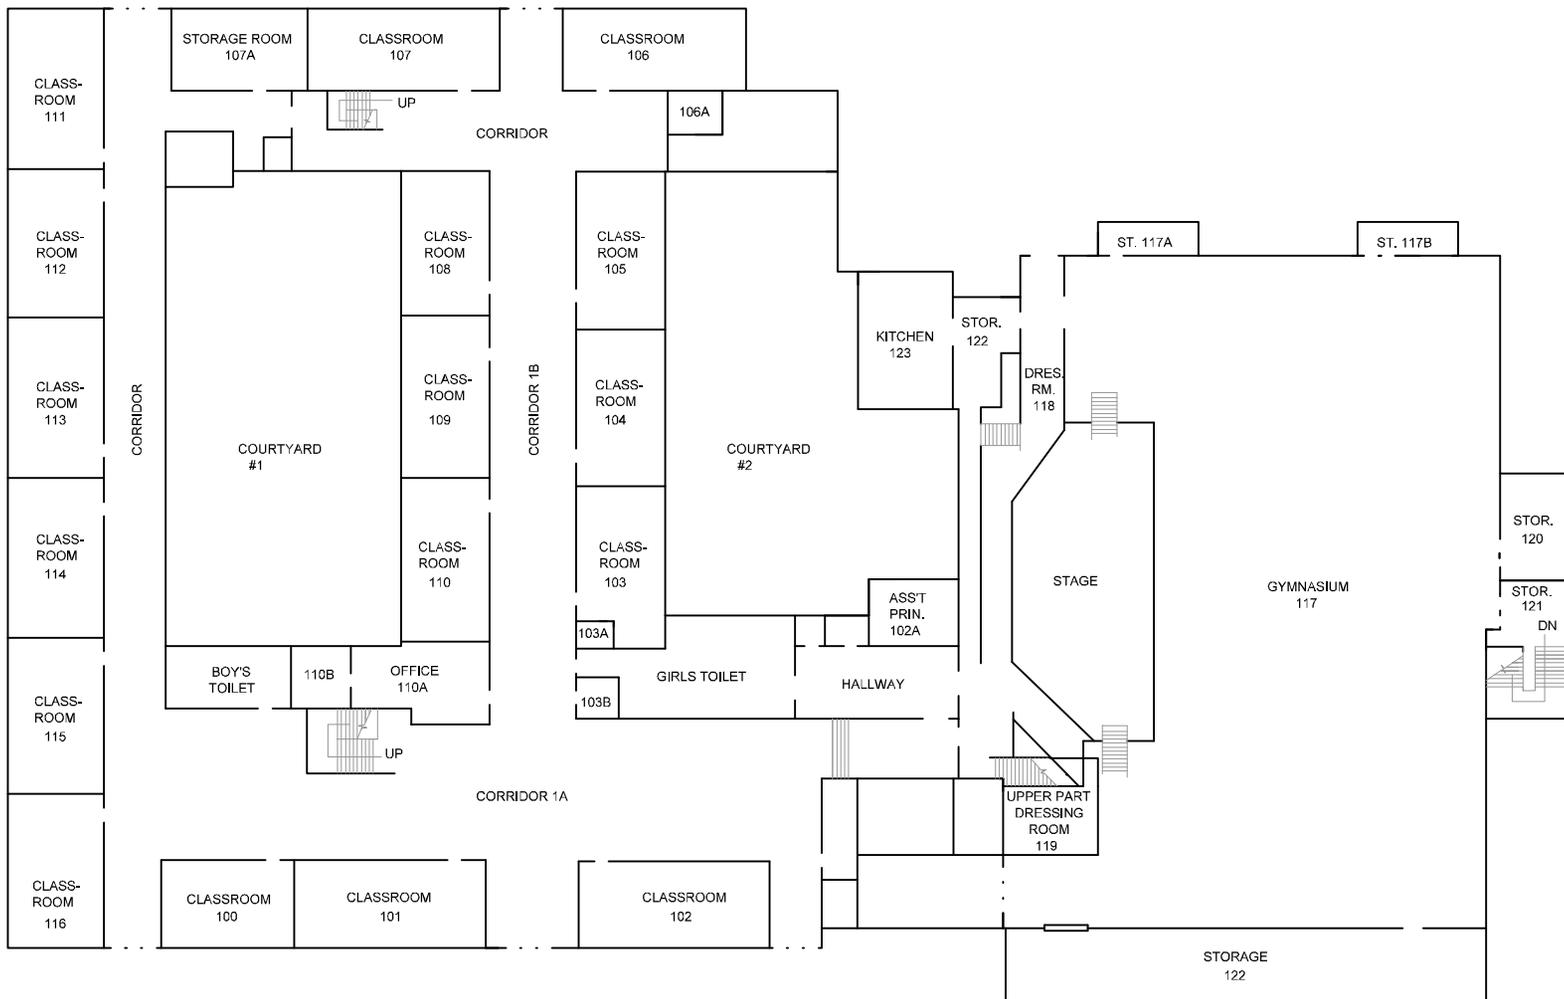
FIRST FLOOR

Several inaccuracies were found of the line drawing floor plans provided; a detailed survey to verify the layout of the basement, first and second floor levels is recommended.
