VACANT HISTORIC SCHOOL BUILDINGS DISPOSITION PLAN

Building Envelope and Structural Assessment Report

Parkman Elementary School

Basic Property Information: COD 7-Parkman-15000 Mackenzie

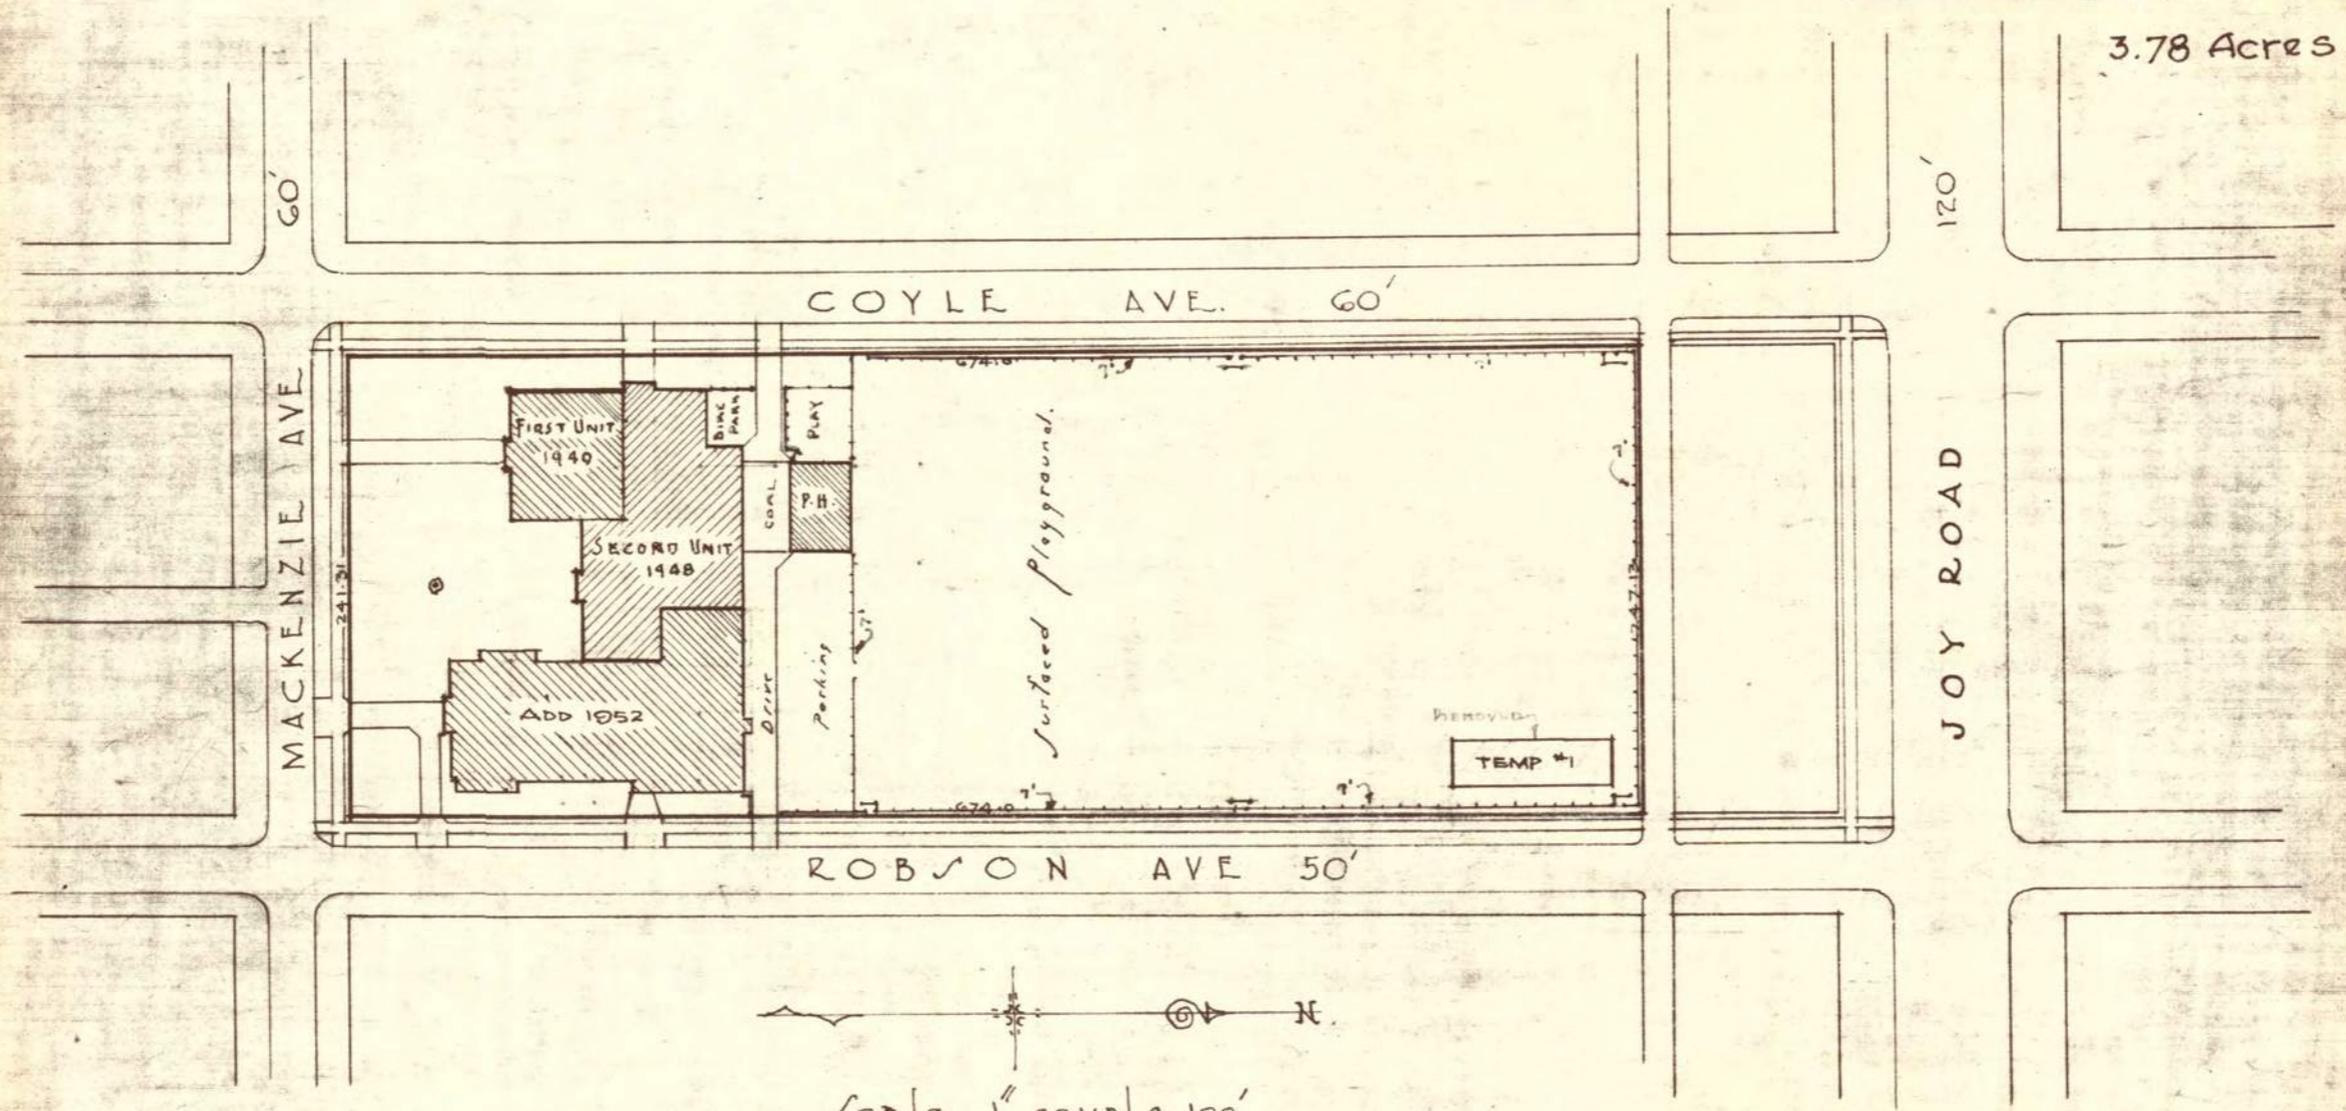
PARKMAN SCHOOL
 PLOT PLAN
 ARCHITECTURAL PLANING DEPT.
 BOARD OF EDUCATION
 DETROIT MICHIGAN
 Drawn by oct 23/30
 Revised by 5/4/48
 Revised 5/19/55 DC.
 Revised 6/24/55 DC.

3.78 Acres.
